[Docket No. 91-ANE-29; Amendment 39-9470; AD 91-21-01 R1]

Airworthiness Directives; Textron Lycoming Model TIO-540-S1AD Reciprocating Engines

91-21-01 R1 Textron Lycoming:

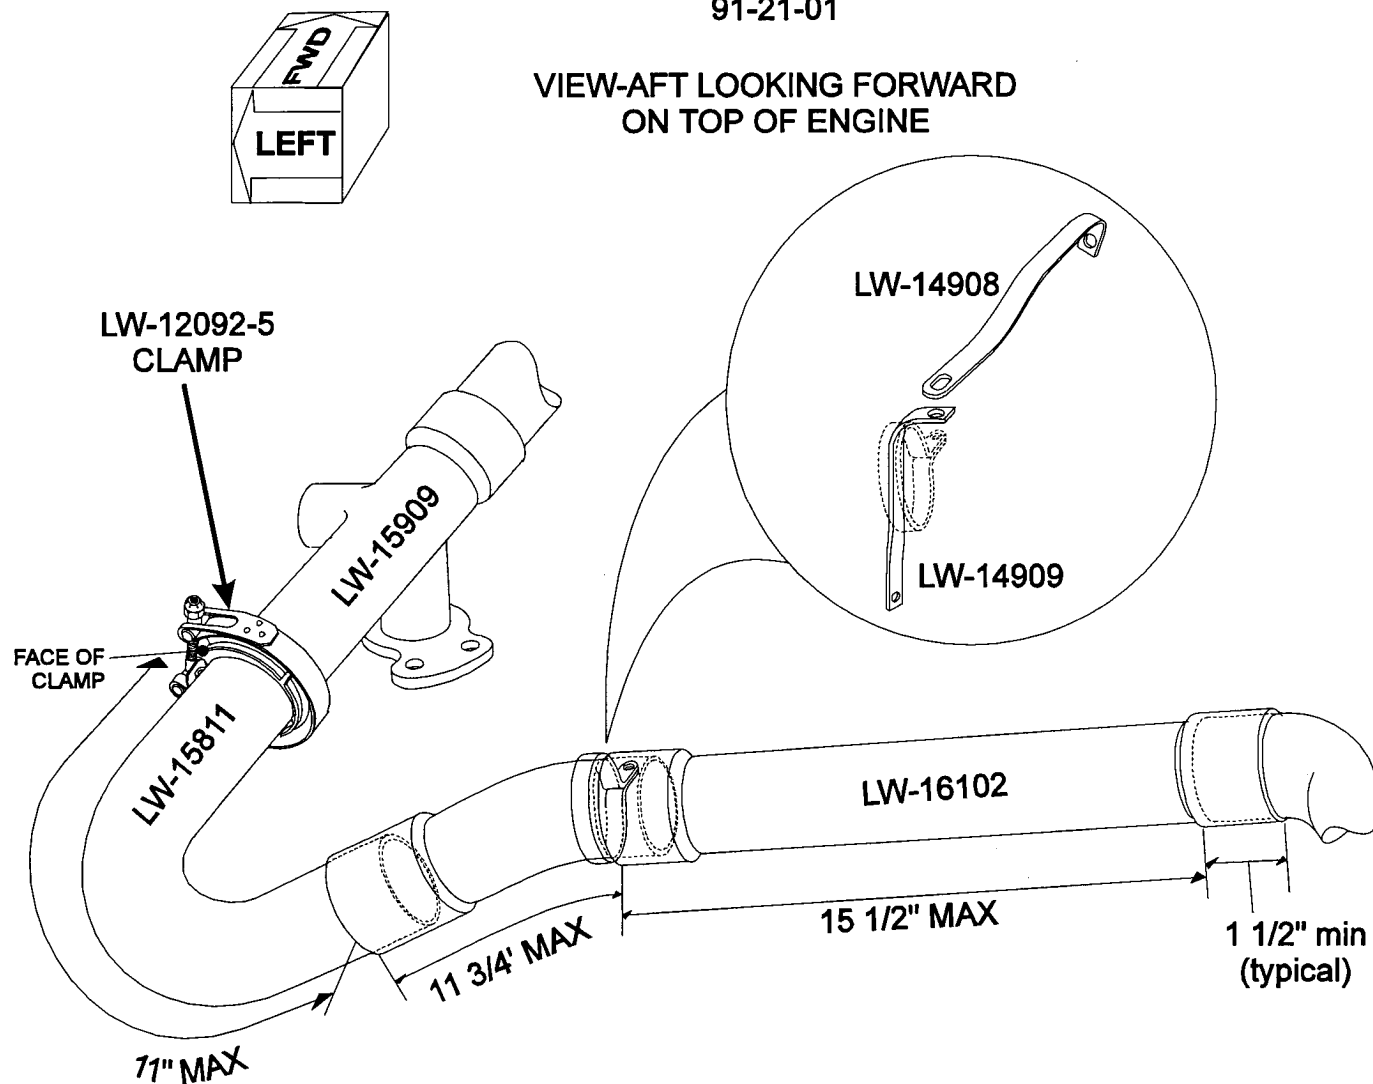
APPENDIX I
91-21-01VIEW-AFT LOOKING FORWARD
ON TOP OF ENGINE

(ii) Inspect the exhaust system for proper slip joint engagement by measuring distances between pipe end points in accordance with Appendix 1 of this AD.

(ii) Thereafter, at intervals not to exceed 100 TIS, perform exhaust system inspections specified in paragraph (a)(2)(i) and (a)(2)(ii) of this AD. Operators need determine the minimum engagement of only exhaust pipes LW-16102 and LW-16103 by referring to Appendix 1 of this AD.

(iii) If damage is observed in the exhaust system or measurements exceed allowable dimensions, repair or replace parts with serviceable parts, as necessary, prior to further flight.

(iv) Reassemble and align exhaust system in accordance with Textron Lycoming SB No. 484, dated January 30, 1989, and Appendix 1 of this AD.
