[Docket No. 93-CE-54-AD; Amendment 39-9665; AD 96-12-22]

Airworthiness Directives; Cessna Aircraft Company Engine Oil Filter Adapter Assemblies Installed on Aircraft

ACTION: Final rule.

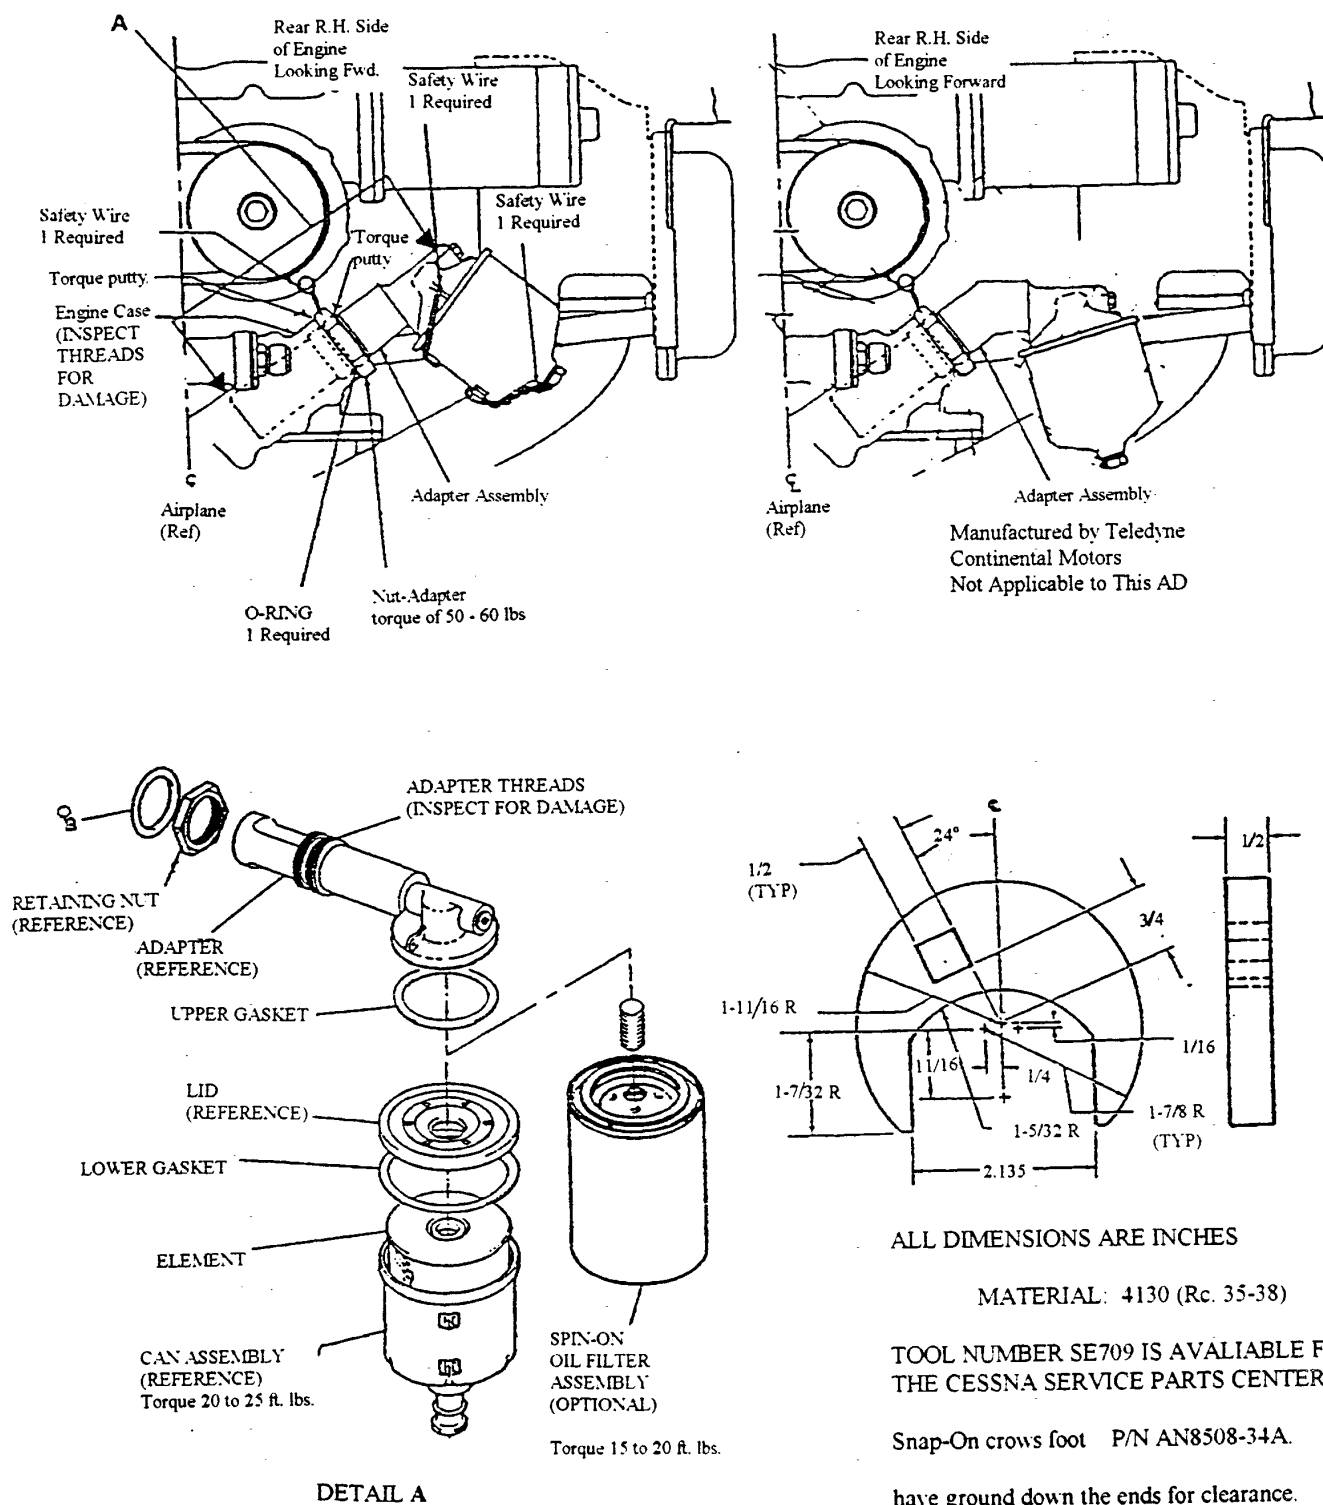
Figure 1. Oil Filter Adapter Installation

Reports of loose or separated engine oil filter adapters on several airplanes prompted the proposal.

To prevent loss of engine oil caused by loose or separated oil filter adapters, which could result in engine stoppage while in flight and loss of control of the airplane, accomplish the following:

(b) For airplanes with torque putty between the engine filter adapter assembly, nut, and oil pump housing, inspect the torque putty for misalignment, evidence of oil leakage, or cracks.

- (1) Inspect the adapter locking nut installation for evidence of oil leakage.
- (2) Check the torque of the adapter nut installation and ensure that the torque value is within the limits of 50 through 60 foot pounds.

(3) If evidence of oil leakage is found or the torque is not within the 50 through 60-foot pound limit, prior to further flight, remove the adapter and filter assembly, and:

- (i) Inspect the threads of the adapter assembly and engine for signs of damaged or cracked threads; and
- (ii) Replace any adapter assembly and engine oil pump housing (if necessary) that have evidence of thread damage or cracks.

(4) Apply torque putty between the engine filter adapter assembly, nut, and oil pump housing as specified in Figure 1 of this AD.
