DEPARTMENT OF TRANSPORTATION

Federal Aviation Administration

[Docket No. 96–SW–08–AD; Amendment 39–9740; AD 96–18–15]

Airworthiness Directives; Bell Helicopter Textron, A Division of Textron Canada Ltd. Model 222, 222B, 222U, and 230 Helicopters

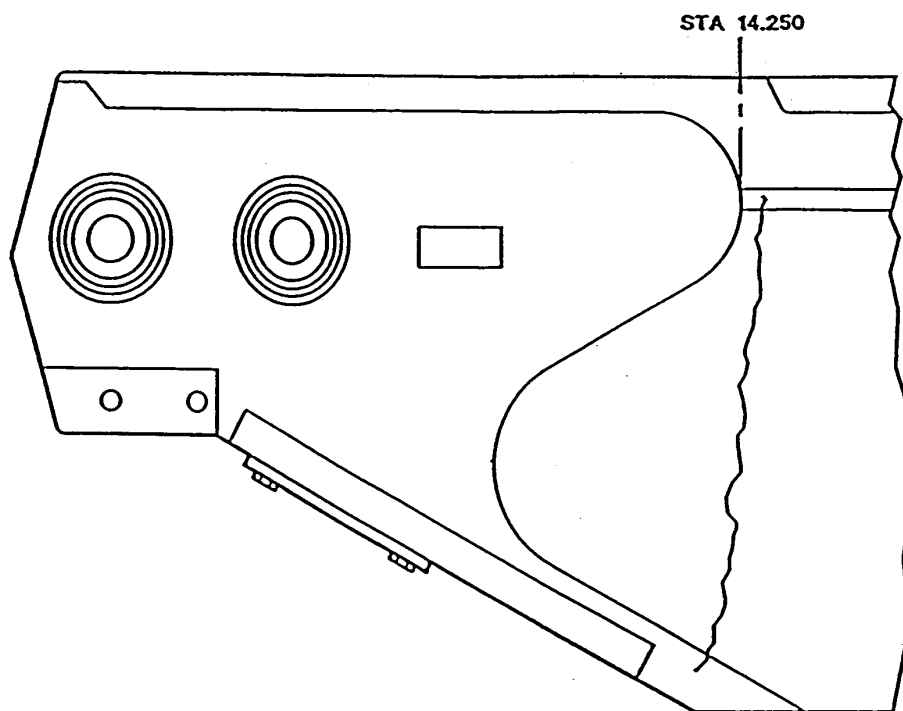
FIGURE 1. SKIN CRACK IN TAIL ROTOR BLADE

Since the issuance of AD 96-01-08, a crack has been discovered in the tail rotor blade of another serial-numbered Model 230 helicopter, that originated from a small indentation that occurred during the manufacturing process. As a result of this discovery, additional part-numbered blades have been determined to be affected.

Compliance: Required before further flight, unless accomplished previously. To prevent failure of a tail rotor blade (blade) due to a fatigue crack (see Figure 1), loss of the tail rotor and tail rotor gear box, and subsequent

(2) If any crack is discovered, remove the blade and replace it with an airworthy blade.

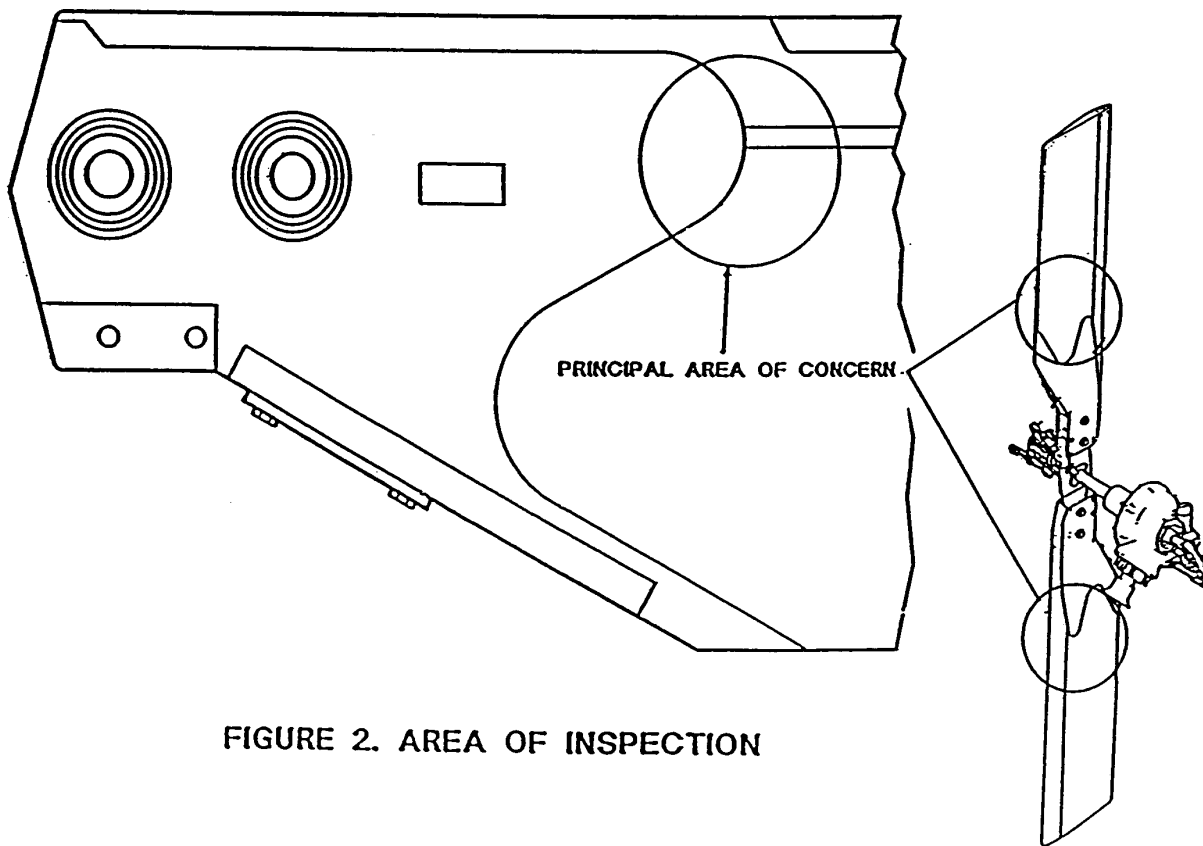
FIGURE 2. AREA OF INSPECTION

(a) Clean the painted surfaces of the blades in an area approximately 6 inches spanwise on either side of the doubler tip. Visually check both surfaces of each blade for cracks by pushing the blade tip away from the surface being checked until it contacts the flapping stop and then holding the blade firmly against the stop. Pay particular attention to the area reaching from the doubler tip to 1 inch outboard, centering on an area 2 inches aft of the blade leading edge (see Figure 2).

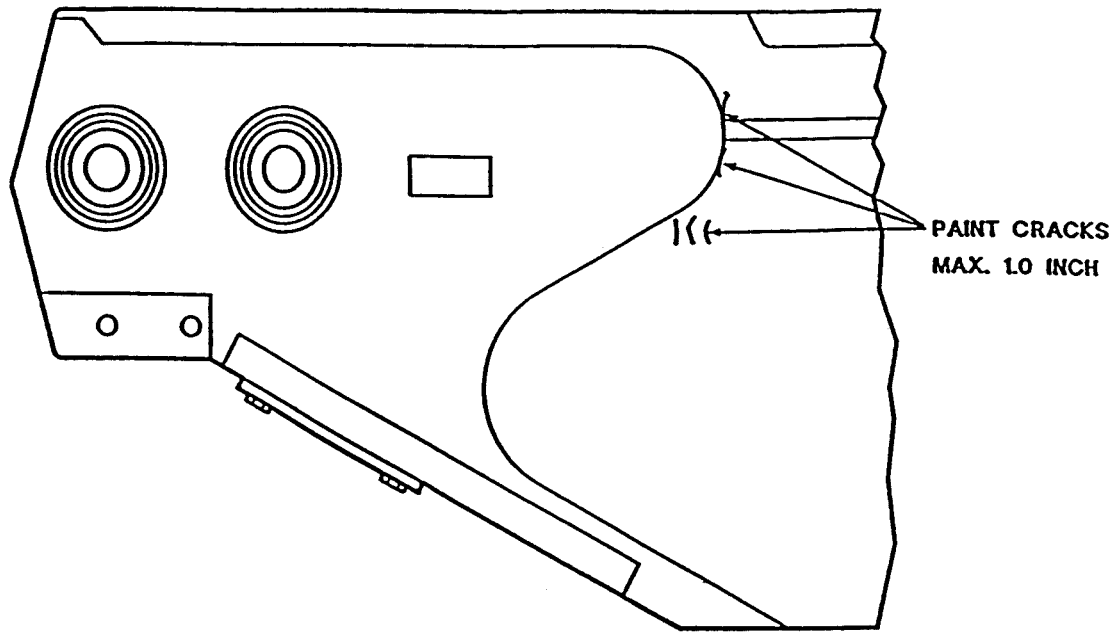
FIGURE 3.

(c) If the visual check described in paragraph (a) reveals any crack outboard of the doubler tip (Station 14.250), or any chordwise crack inboard of the doubler tip that is longer than 1 inch (see Figure 3), accomplish the following:
