[Docket No. 97-CE-35-AD; Amendment 39-10070; AD 97-12-06]

Airworthiness Directives; Cessna Aircraft Company Model 172R Airplanes

97-12-06 Cessna Aircraft Company: Amendment 39-10070; Docket No. 97-CE-35-AD.

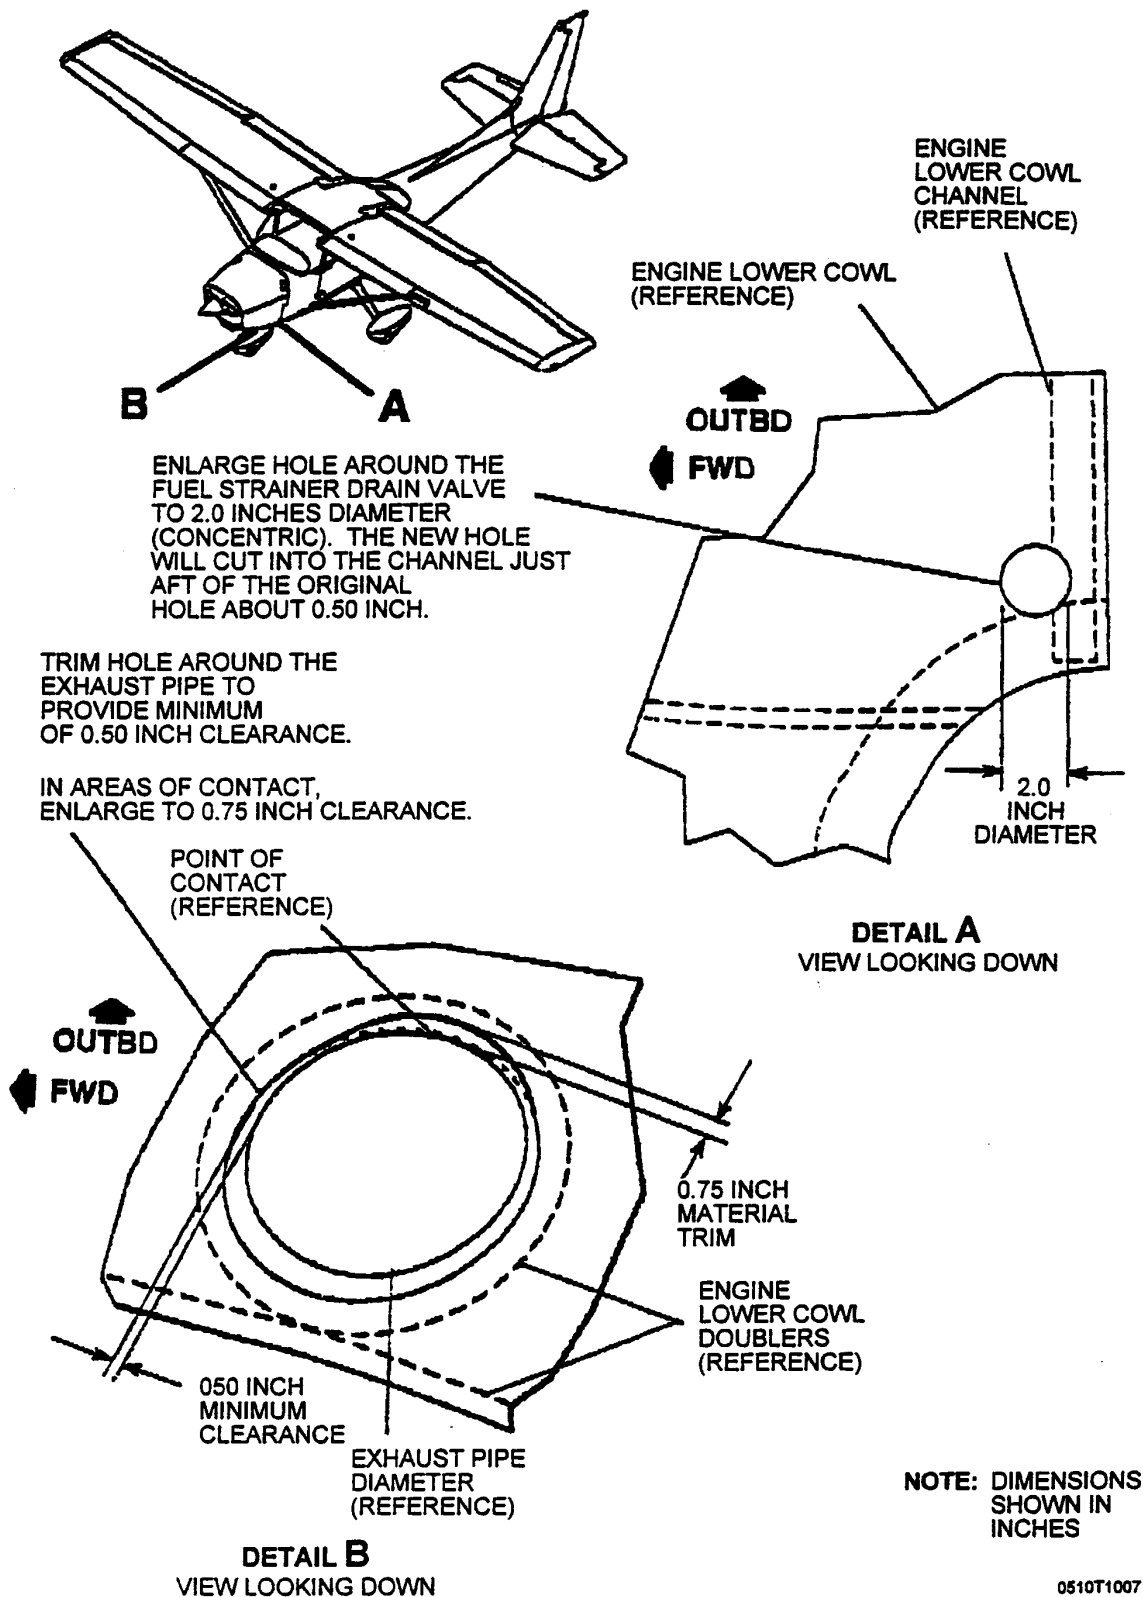
Engine Lower Cowling Modification
Figure 1

Further examination of the design of the Model 172R airplanes shows that this condition exists when the tailpipe vibrates, during some starting conditions, into the cowl. The cowl then rubs against the gascolator drain valve, knocking the gascolator drain valve off the gascolator, and causing fuel to drain from the airplane at an extremely high flow rate. This results in engine stoppage with consequent forced landing or crash landing.

(2) If no evidence of rubbing is found, repeat the check in paragraph (a) before each flight, and within the next 10 hours time-in-service (TIS) after the effective date of this AD, modify the gascolator and cowl area in accordance with Figure 1 of this AD.
