**Boeing:** Docket 97-NM-157-AD. Revises AD 97-09-15, Amendment 39-10011.

[Docket No. 97-NM-238-AD]

#### Airworthiness Directives; Boeing Model 737-100, -200, -300, -400, and -500 Series Airplanes

**ACTION:** Notice of proposed rulemaking (NPRM).

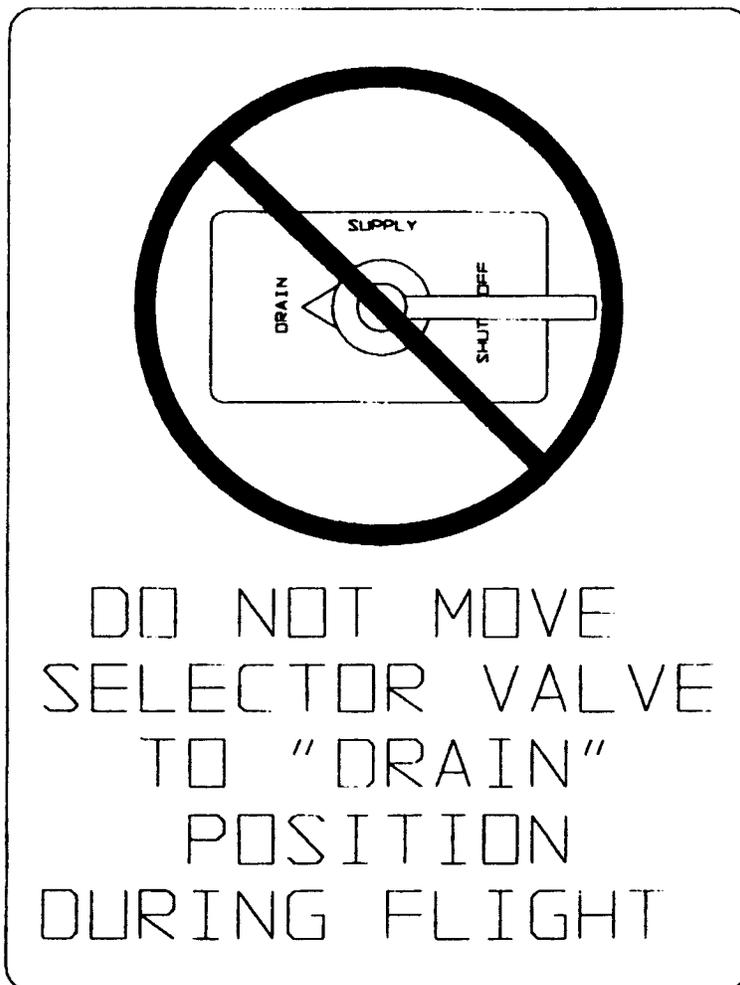
The FAA has received several reports that ice has formed on the skin of Boeing Model 737 series airplanes due to drainage of potable water through an incorrectly positioned selector valve for the forward lavatory water supply. Two of these incidents resulted in engine flameout and two other incidents resulted in damage to the horizontal stabilizer.

The selector valve is a three-position ("DRAIN," "SUPPLY," and "SHUTOFF") selector valve for the forward lavatory water supply. It is possible to place the selector valve in the "DRAIN" position instead of the "SHUTOFF" position during flight, which results in the contents of the potable water supply tank draining onto the skin of the airplane. This condition, if not corrected, could result in the formation of ice that could dislodge from the airplane and, consequently, cause damage to the engines, airframe, or horizontal stabilizer and/or pose a hazard to persons or property on the ground.

(a) Within 6 months after the effective date of this AD, install a placard (as shown in Figure 1 of this AD) on the door beneath the forward lavatory sink that warns the cabin crew not to put the selector valve for the forward lavatory water supply in the "DRAIN" position during flight. The installation shall be accomplished in accordance with a method approved by the Manager, Seattle Aircraft Certification Office (ACO), FAA, Transport Airplane Directorate.
