[Docket No. 96-CE-72-AD]

Airworthiness Directives; All Models of The New Piper Aircraft, Inc. (Formerly Piper Aircraft Corporation) Airplanes Equipped With Wing Lift Struts

ACTION: Notice of proposed rulemaking (NPRM).

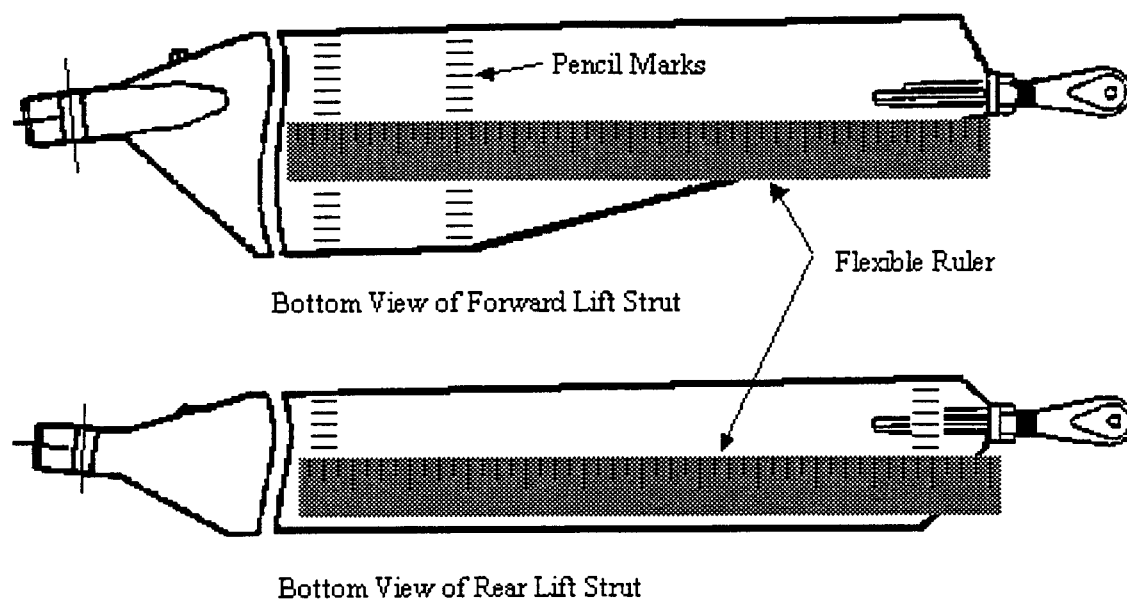
Figure 1

1. Clean the lower 18 inches of the wing lift struts using a cleaner that will remove all dirt and grease. Dirt and grease will adversely affect the accuracy of the inspection technique. Light sanding or polishing may also be required to reduce surface roughness as noted in the **Equipment Requirements** section.

8. A measurement of 0.024 inch or less shall require replacement of the strut prior to further flight.

9. If at any time during testing an area is encountered where a valid thickness measurement cannot be obtained due to a loss of signal strength or quality, the area shall be considered suspect. These areas may have a remaining wall thickness of less than 0.020 inch, which is below the range of this setup, or they may have small areas of localized corrosion or pitting present. The latter case will result in a reduction in signal strength due to the sound being scattered from the rough surface and may result in a signal that includes echoes from the pits as well as the backwall. The suspect area(s) shall be tested with a Maule "Fabric Tester" as specified in Piper Service Bulletin No. 528D or 910A.
