[Docket No. 98-SW-18-AD; Amendment 39-10632; AD 98-09-11]

#### Airworthiness Directives; Eurocopter Deutschland GmbH Model EC 135 Helicopters

**AD 98-09-11 Eurocopter Deutschland GmbH:** Amendment 39-10632. Docket No. 98-SW-18-AD.

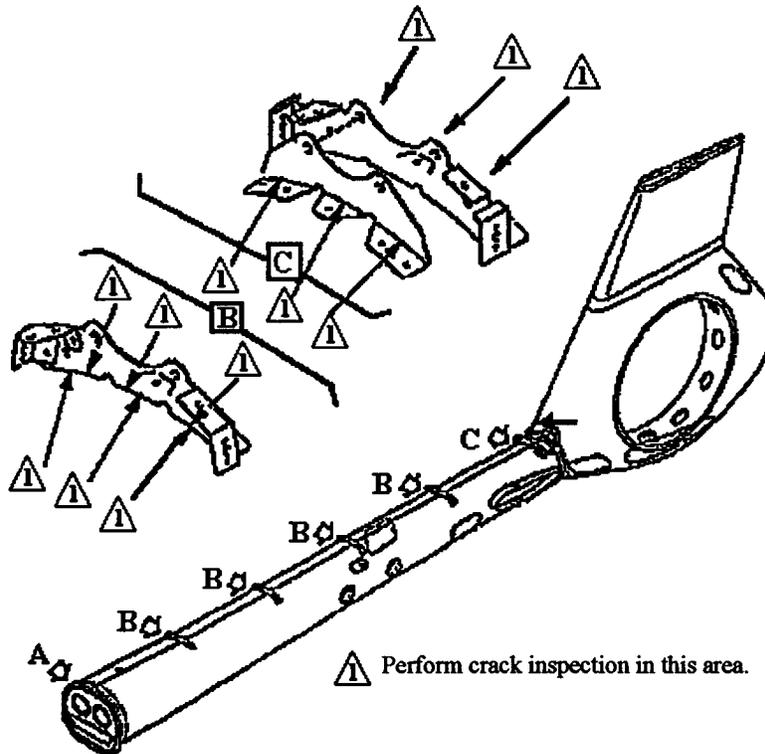
Inspection of Bearing Supports  
Figure 1

To detect loose tail rotor drive shaft bearing (bearing) attachment bolts, or cracked bearing supports, which could result in loss of drive to the tail rotor and subsequent loss of control of the helicopter, accomplish the following:

(3) If a lock plate tab is bent open on bearing supports A, B, or C (shown in Figure 1), or if slippage marks are broken or missing, contact the Manager, Rotorcraft Standards Staff.

(c) Before further flight, and thereafter at intervals not to exceed 15 hours TIS, using a 6-power or higher magnifying glass and a bright light, visually inspect bearing supports B and C as shown in Figure 1 for cracks. If a crack is found, replace the bearing support with an airworthy bearing support.
