[Docket No. 98-SW-35-AD; Amendment 39-10866; AD 98-15-25]

**Airworthiness Directives; Eurocopter Deutschland GmbH Model EC 135 Helicopters**

#### 98-15-25 Eurocopter Deutschland:

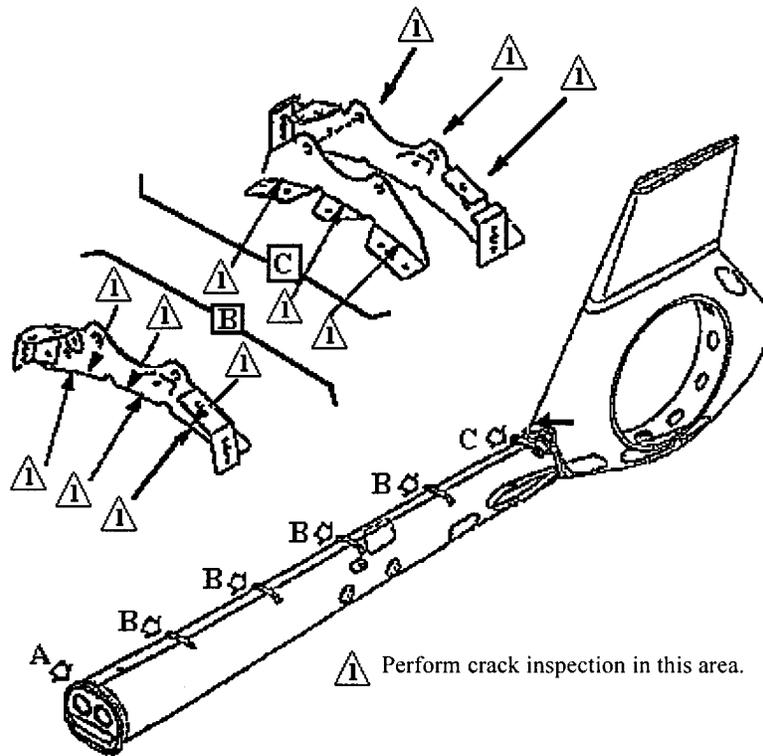
Figure 1

Since the issuance of AD 98-09-11, it has been determined that cracks can form in additional areas outside the bend radius of the bearing support, and that the cracks can form and propagate to failure within the previously-required 15 hours TIS inspection interval.

(3) If a lock plate tab is bent open on bearing supports A, B, or C (shown in Figure 1), or if slippage marks are broken or missing, contact the Manager, Rotorcraft Standards Staff, FAA, telephone (817) 222-5110, fax (817) 222-5961.

(c) Before further flight, and thereafter at intervals not to exceed 3 hours TIS, using a 6-power or higher magnifying glass and a bright light, visually inspect bearing supports B and C as shown in Figure 1, from the bend radius to the attaching screws and rivets connecting the bearing supports to the tailboom. If a crack is found, replace the bearing support with an airworthy bearing support.
