DEPARTMENT OF TRANSPORTATION**Federal Aviation Administration****14 CFR Part 39**

[Docket No. 98-SW-31-AD; Amendment 39-11101; AD 99-07-15]

Airworthiness Directives; Bell Helicopter Textron, Inc.-manufactured Model HH-1K, SW204, SW204HP, SW205, SW205A-1, TH-1F, TH-1L, UH-1A, UH-1B, UH-1E, UH-1F, UH-1H, UH-1L, and UH-1P Helicopters

ACTION: Final rule; request for comments.

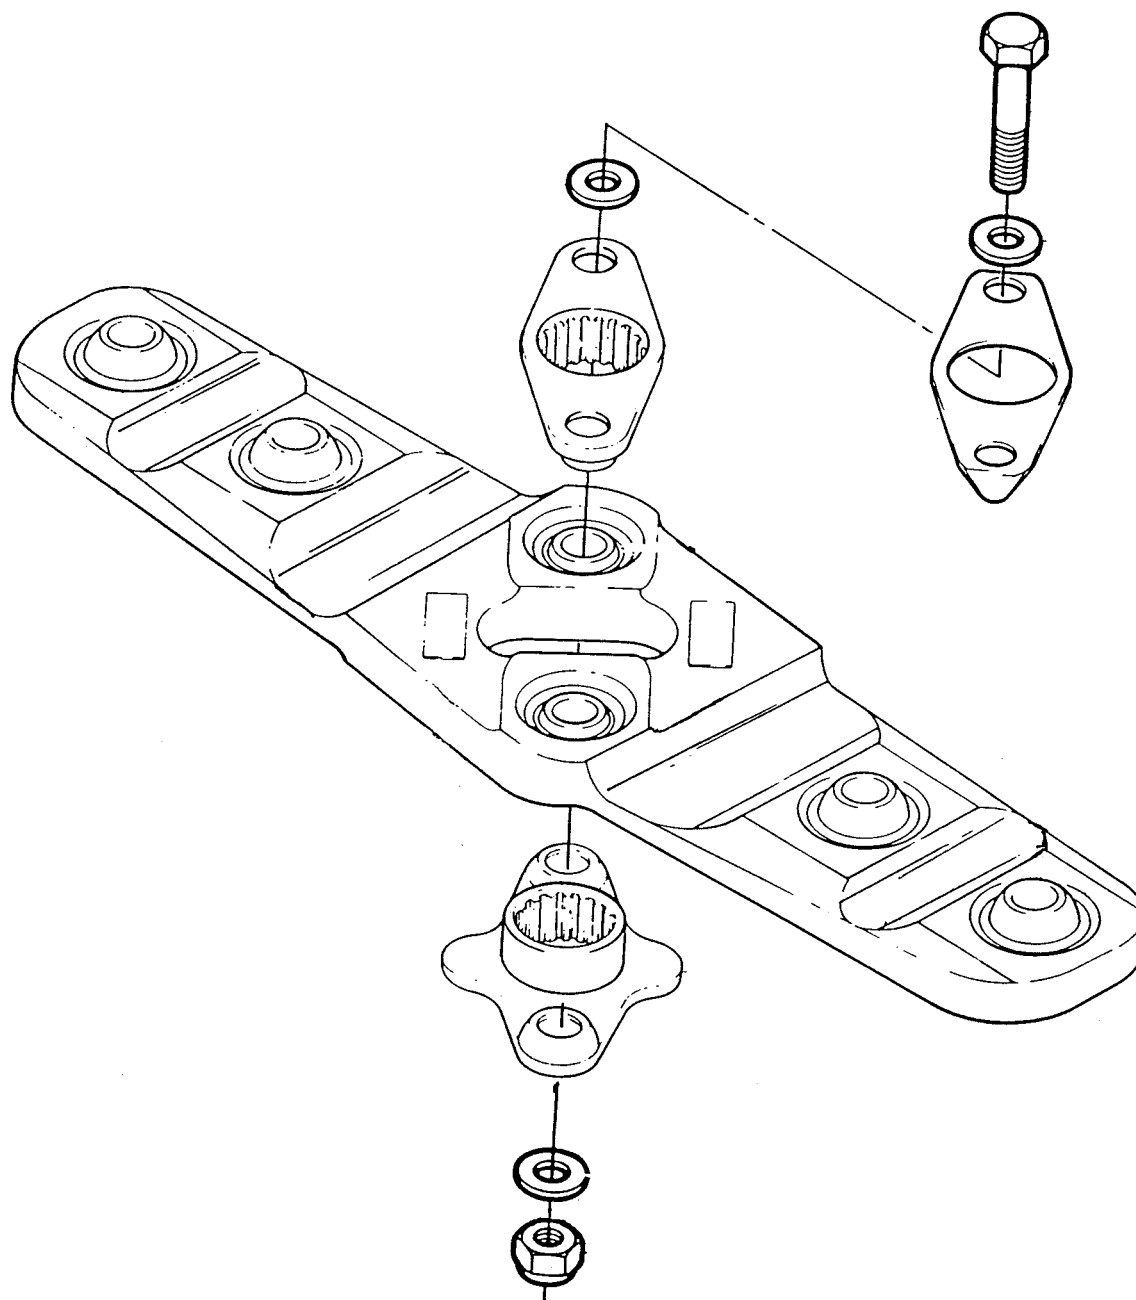
FIGURE 1. 212-010-704 and -744 Style Yoke Assy

(b) Identify the trunnion assembly or flapping stop that is installed on the aircraft tail rotor assembly to determine if it is a flapping stop or trunnion and, if it is a flapping stop, to determine if the correct flapping stop is installed (see Figures 1 and 2).

Note 3: Helicopters with yoke assemblies, P/N 212-010-704-all dash numbers or P/N 212-010-744-all dash numbers, have trunnion assemblies installed that look similar. Trunnion assemblies, P/N 205-012-716-001 and P/N 212-010-703-001, are manufactured from machined material and do not have the proper characteristics to act as a yield indicators for the yoke assembly. When installed, these trunnion assemblies may be identified by the presence of a flanged bushing (split lines) at each bolt hole, readily visible externally when viewed inboard of the trunnion halves adjacent to each bearing. The trunnion assembly, P/N 212-010-738-001, is manufactured from a casting and does not incorporate bushings at the bolt locations. No bushing will be visible when viewing the assembled trunnion. Helicopters with yoke assemblies, P/N 212-011-702-all dash numbers, are assembled with a flapping stop configuration. The original flapping stop, P/N 212-011-713-001 has been redesigned. The redesigned flapping stop, P/N 212-011-713-103, will act as a yield indicator to provide visual verification of a yoke assembly that has been subjected to excessive out-of-plane bending loads (see Figure 5).

(d) When the yoke assembly is replaced, for helicopters with a yoke assembly, P/N 212-011-702-all dash numbers, install an airworthy tail rotor flapping stop, P/N 212-011-713-103, and for helicopters with yoke assemblies, P/N 212-010-704-all dash numbers or P/N 212-010-744-all dash numbers, install an airworthy trunnion assembly, P/N 212-010-738-001. If any incident as described in paragraph (a) of this AD occurs after the effective date of this AD and prior to compliance with paragraph (c), then compliance with paragraphs (c) and (d) is required before further flight.

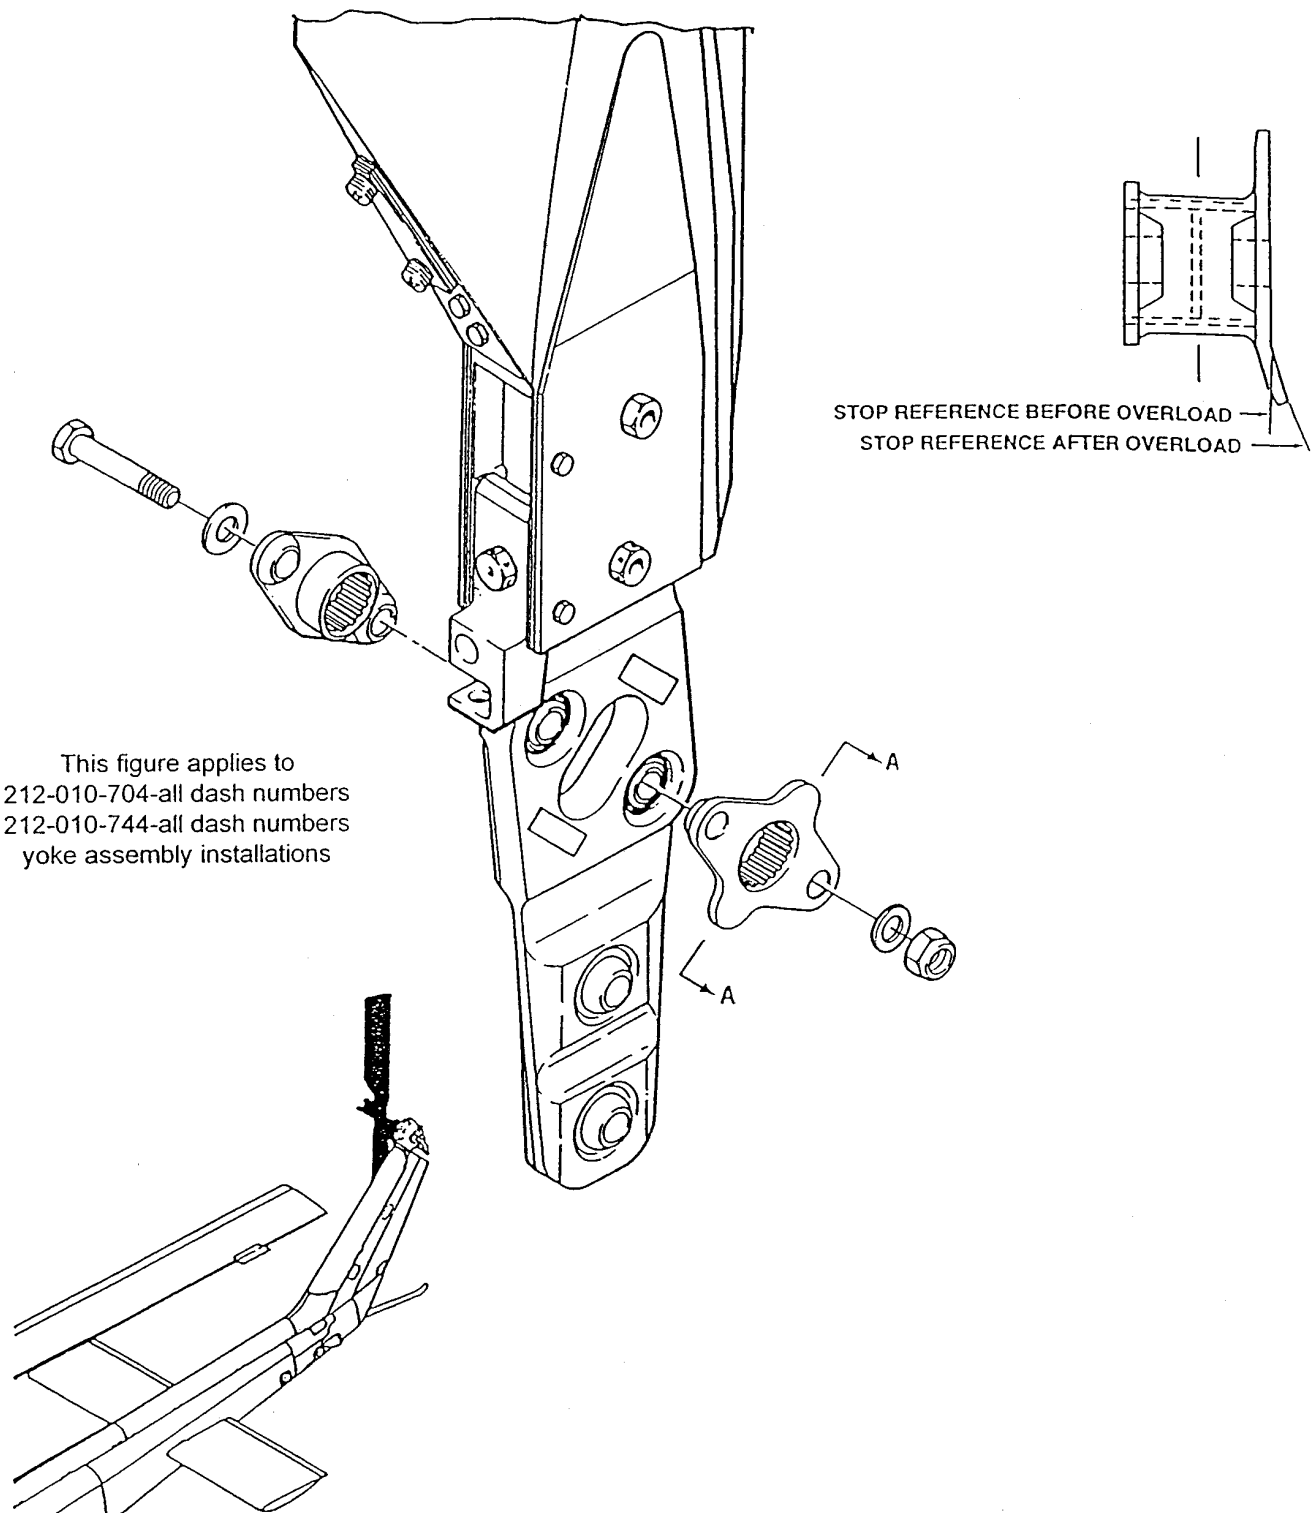
**FIGURE 3. Inspection Criteria for
212-010-704 and -744 Style Yoke Assy.**

trunnion assembly (see Figure 3) or the flapping stop (see Figure 4) for deformation. Inspect by gently placing the tail rotor yoke against one flapping stop or trunnion stop, allowing full view of the opposite stop. Repeat in opposite direction to allow viewing of the opposite stop.

(2) If either the trunnion stop or flapping stop is deformed or bent as shown in Figure 3 or Figure 4, the yoke assembly and

trunnion stop or flapping stop are no longer serviceable and must be replaced with an airworthy yoke assembly that has zero hours TIS or has passed x-ray diffraction inspection, and an airworthy flapping stop or trunnion stop.
