[Docket No. 97-SW-60-AD; Amendment 39-11102; AD 99-07-16]

Airworthiness Directives; Sikorsky Aircraft-manufactured Model CH-54A Helicopters

AD 99-07-16 Columbia Helicopter; Heavy Lift; Silver Bay Logging: Amendment 39-11102. Docket No. 97-SW-60-AD.

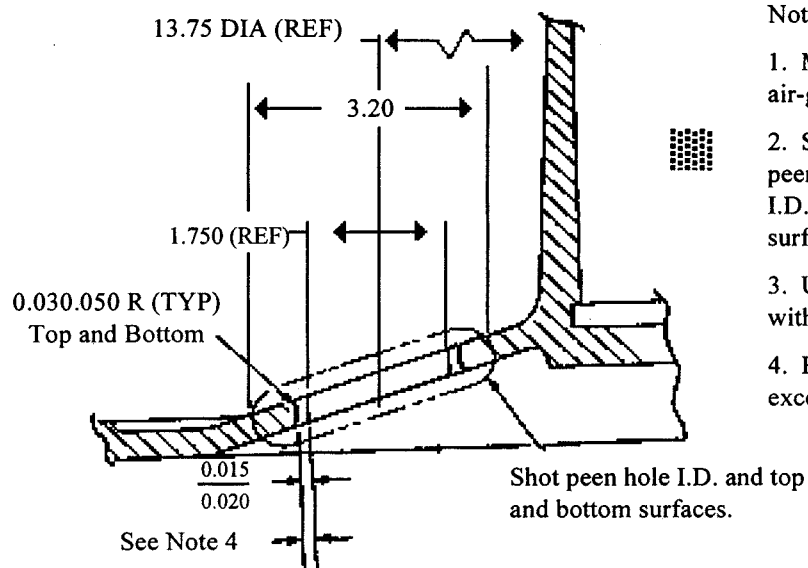
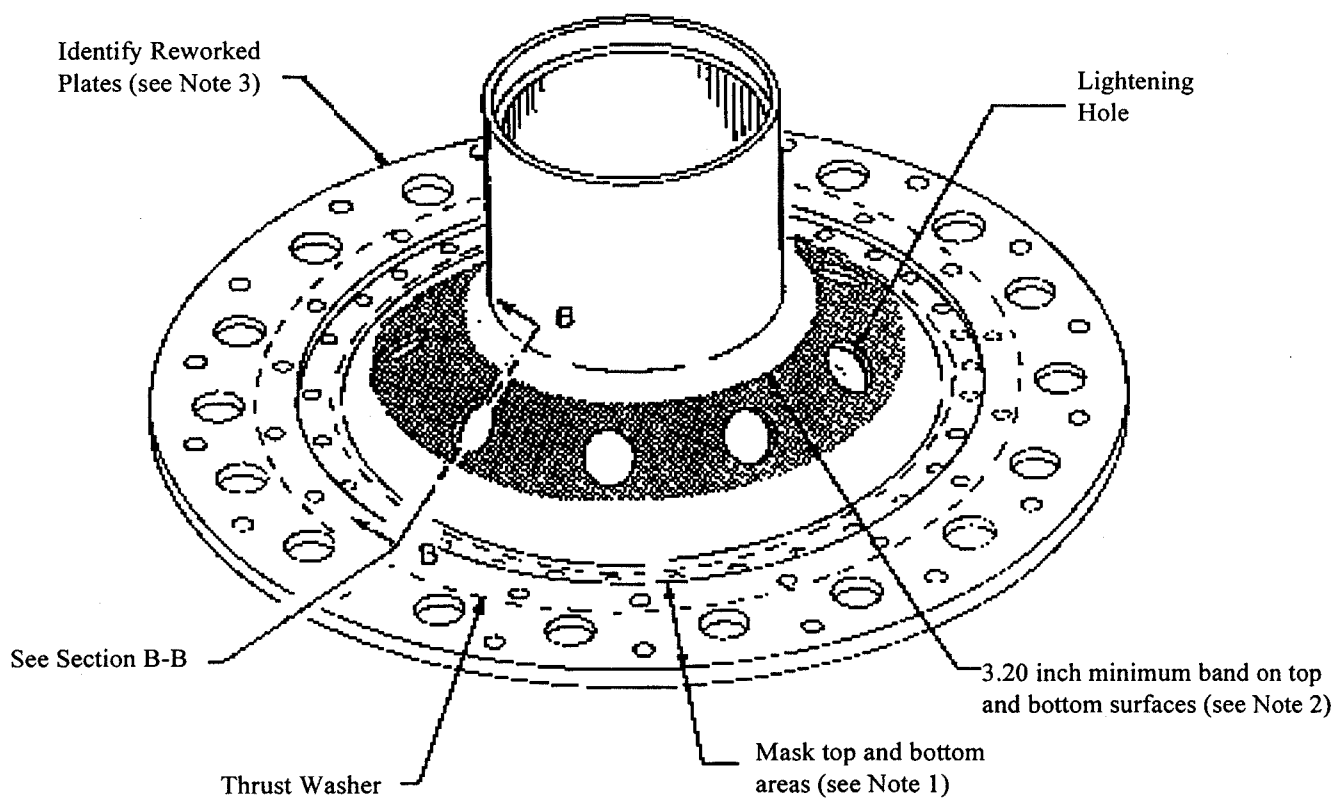
Rework of Second Stage
Lower Planetary Plate (6435-20229-102)
Figure 1

(a) On or before accumulating 1,300 hours time-in-service (TIS), conduct a fluorescent magnetic particle inspection of the plate, P/N 6435-20229-102, in the circumferential and longitudinal directions using the wet continuous method. Pay particular attention to the area around the 9 lightening holes.

Section B-B
(Typical Nine Places)

(i) Locate the center of each 1.750 inch-diameter lightening hole and machine holes 0.015 to 0.020 oversize on a side (0.030 to 0.040 diameter oversize). Machined surface roughness must not exceed 63 microinches AA rating (see Figure 1).

(ii) Radius each hole 0.030 to 0.050 inches on each edge as shown in Figure 1.

(iii) Mask the top and bottom surfaces of the plate to expose 3.20 inch minimum width circumferential band as shown in Figure 1.

(viii) Identify the reworked plate by adding “TS-107” after the part number using a low-stress depth-controlled impression-stamp with a full fillet depth of not more than 0.003 inch (see Figure 1).

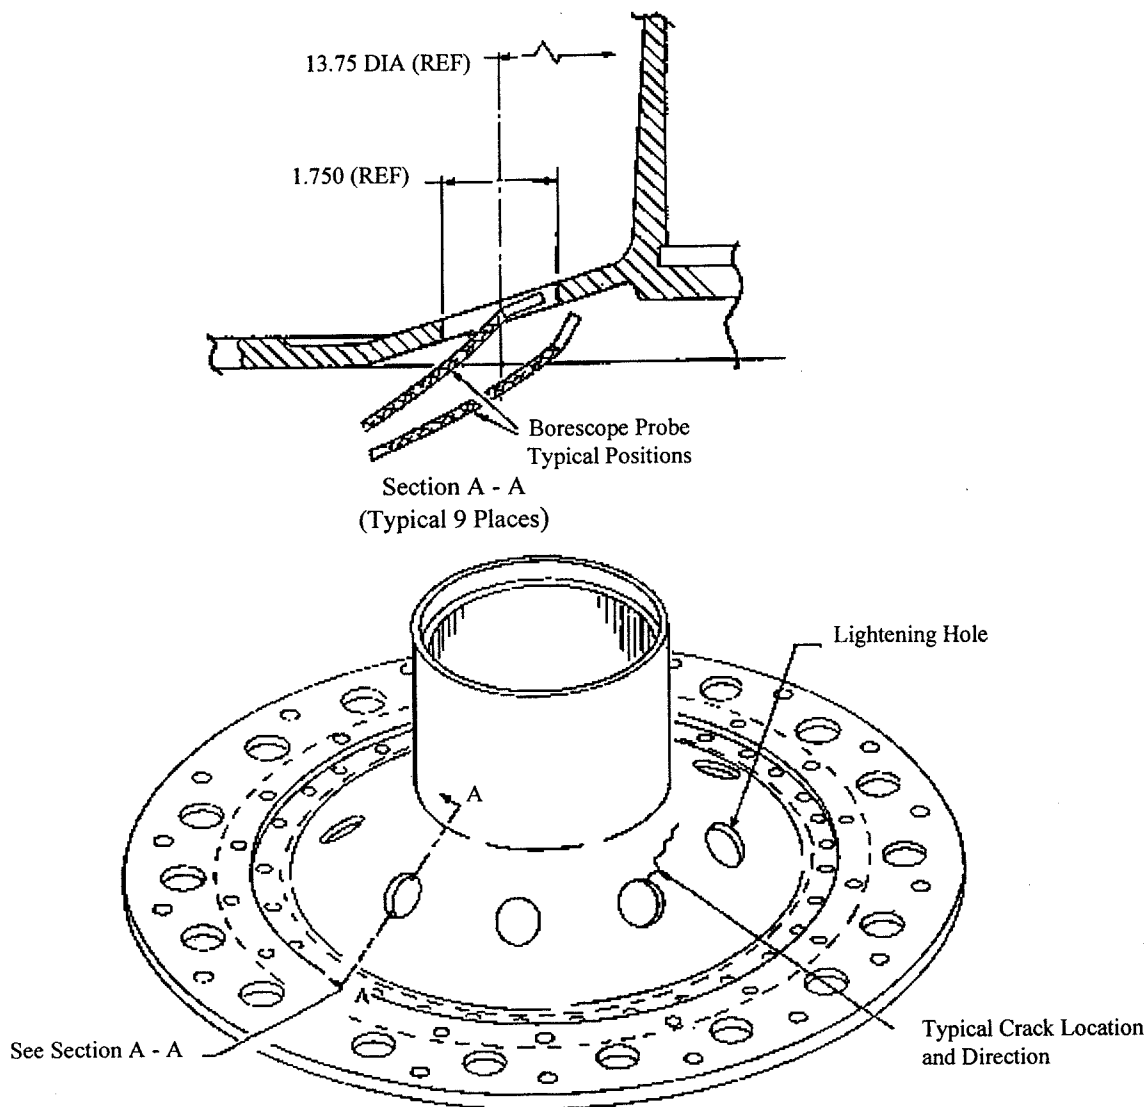
Borescope Inspection of
Second Stage Lower Planetary Plate
Figure 2

(1) Inspect the plate for a crack in the area around all nine lightening holes using a Borescope or equivalent inspection method (see Figure 2).

(2) If a crack is found, replace the plate with an airworthy plate.
