## DEPARTMENT OF TRANSPORTATION

[Docket No. 97-SW-59-AD]

#### Airworthiness Directives; Sikorsky Aircraft-Manufactured Model CH-54B Helicopters

**ACTION:** Notice of proposed rulemaking (NPRM).

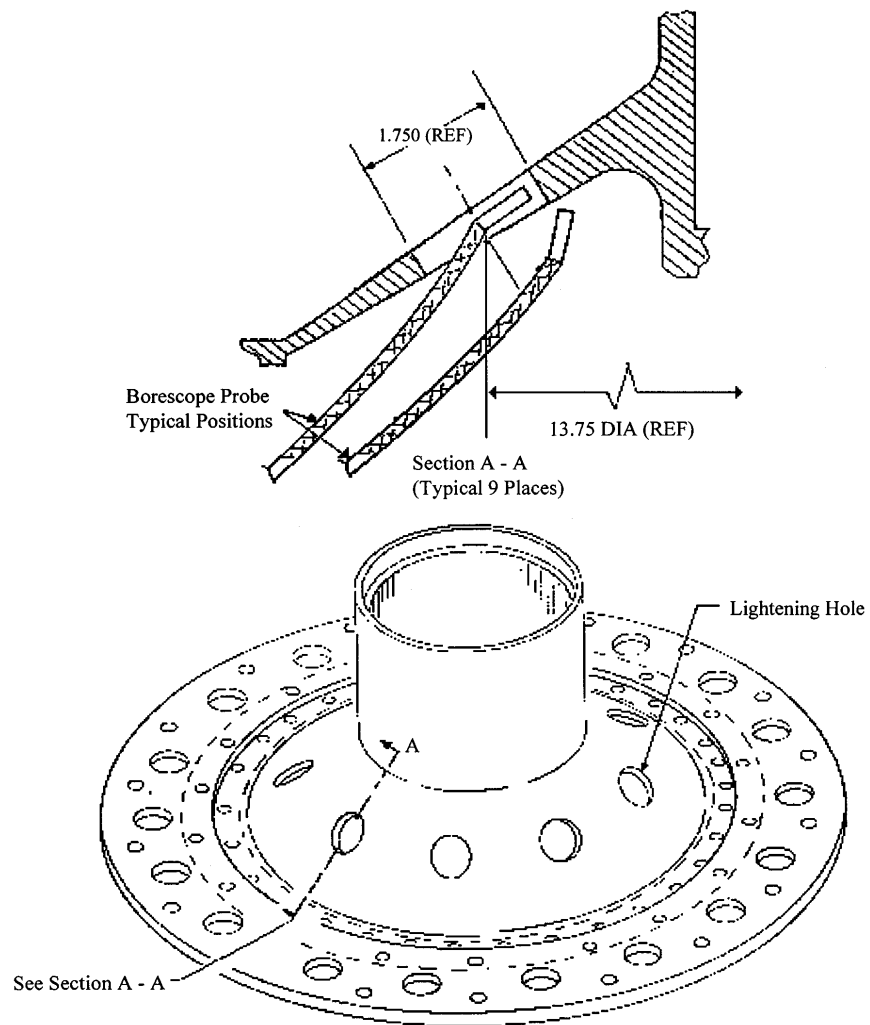
Borescope Inspection of Second Stage  
Lower Planetary Plate Lightening Holes  
Figure 1

manufactured Model CH-54B helicopters. This proposal would require initial and recurring inspections, and rework or replacement, if necessary, of the plate. Cracks on the plate initiate at and radiate from the lightening holes in the plate web due to fatigue. This condition, if not corrected, could result in failure of the plate due to fatigue cracking, which could lead to failure of the main gearbox and subsequent loss of control of the helicopter.

(2) Within the next 100 hours TIS after the effective date of this AD, and thereafter at intervals not to exceed 200 hours TIS, conduct a borescope inspection of the plate for cracks in the area of the nine lightening holes (see Figure 1). If a crack is found, replace the plate with an airworthy plate. The plate, P/N 6435-20516-101, is part of the main gearbox second stage planetary set (P/N 6435-20514-041), which is a serialized matched set, and must be replaced as a set.
