[Docket No. 98-NM-363-AD; Amendment 39-11363; AD 99-21-18]

Airworthiness Directives; Boeing Model 767 Series Airplanes Powered by Pratt & Whitney JT9D-7R4 Series Turbofan Engines or General Electric CF6-80A Series Turbofan Engines

ACTION: Final rule.

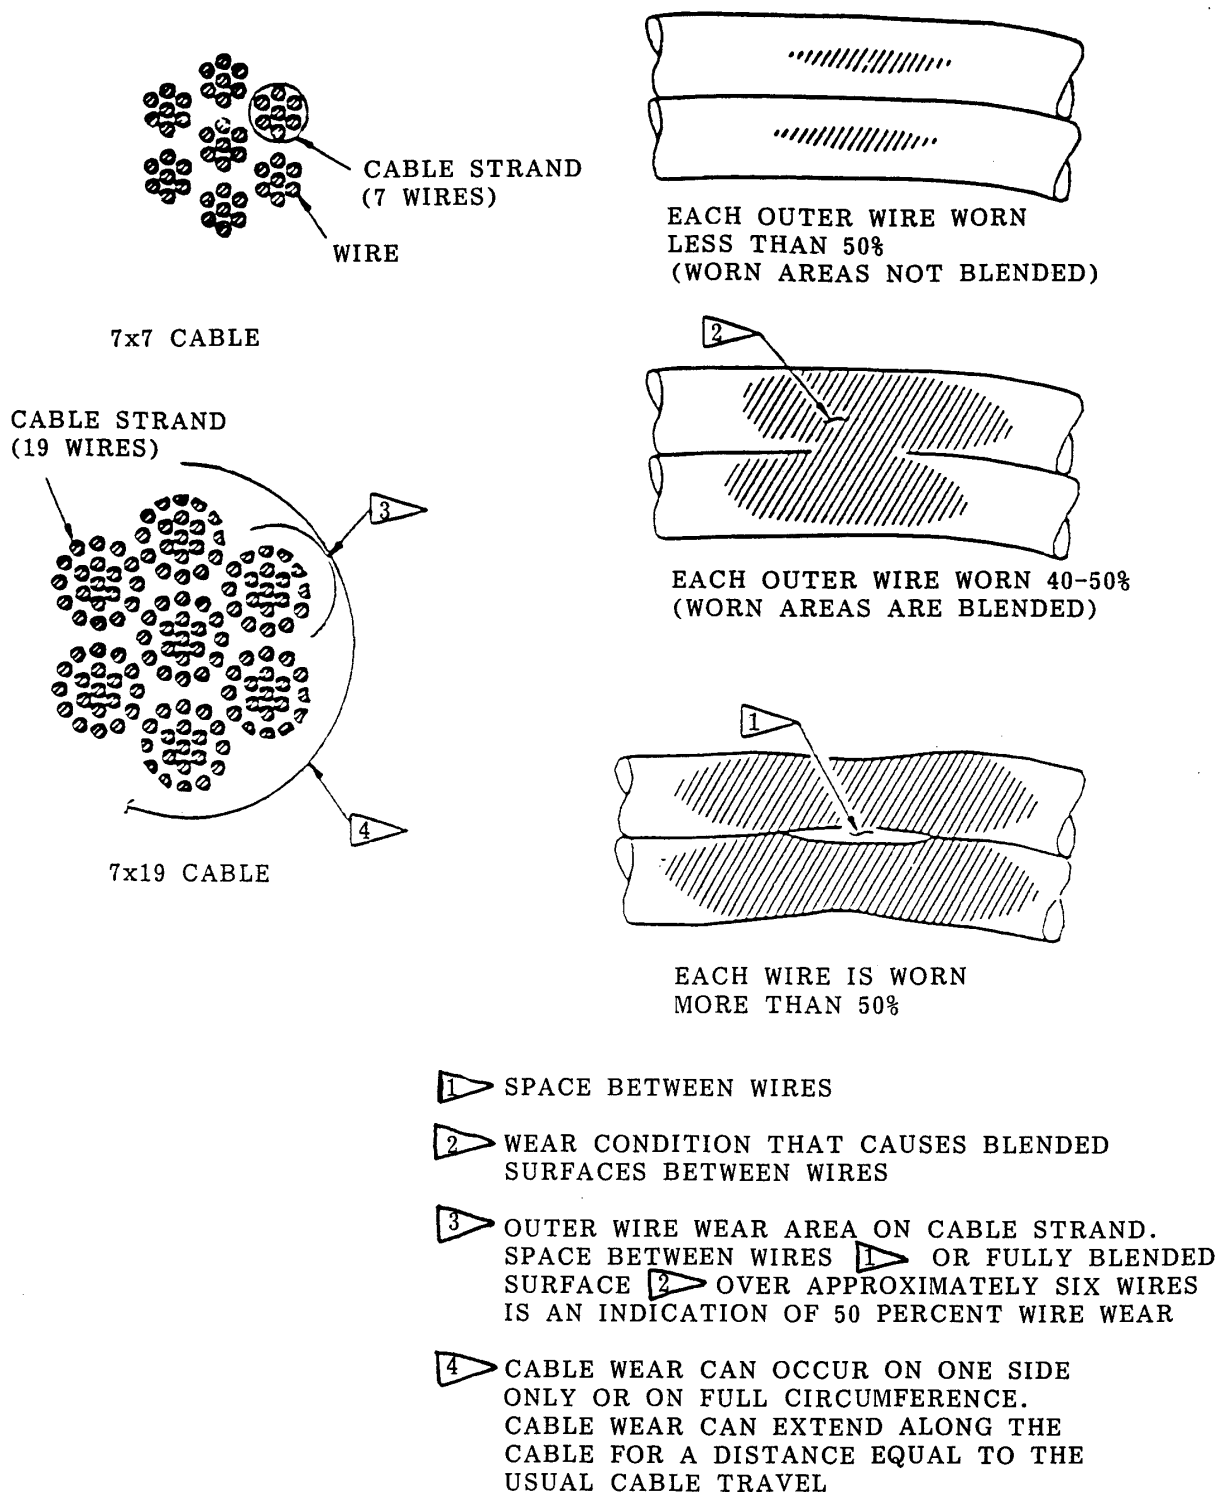
FIGURE 1

(1) One cable strand had worn wires where one wire cross section is decreased by more than 40 percent (see Figure 1),

B. Perform a detailed visual inspection of the cable runs to detect incorrect routing, kinks in the wire rope, or other damage. Replace the cable assembly if:
