**SUMMARY:** This amendment supersedes Airworthiness Directive (AD) 75-23-08 R5, which currently requires repetitively inspecting and replacing or repairing the exhaust system on certain Cessna Aircraft Company (Cessna) 300 and 400 series airplanes. The requirements of this AD replace the inspections and replacements that are required by AD 75-23-08 R5 with inspections and replacements containing new simplified procedures for all 300 and 400 series airplanes (models affected by the current AD plus additional models). This AD also revises the inspection intervals and requires replacing certain unserviceable parts and removing the exhaust system for a detailed inspection. This AD is the result of numerous incidents and accidents relating to the exhaust systems on Cessna 300 and 400 series airplanes dating from the middle 1970's to the present, including six incidents since issuance of AD 75-23-08 R5 where exhaust problems were cited. The actions specified by this AD are intended to detect and correct cracks and corrosion in the exhaust system, which could result in exhaust system failure and a possible uncontrollable in-flight fire with pilot and/or passenger injury.

Appendix to Doc

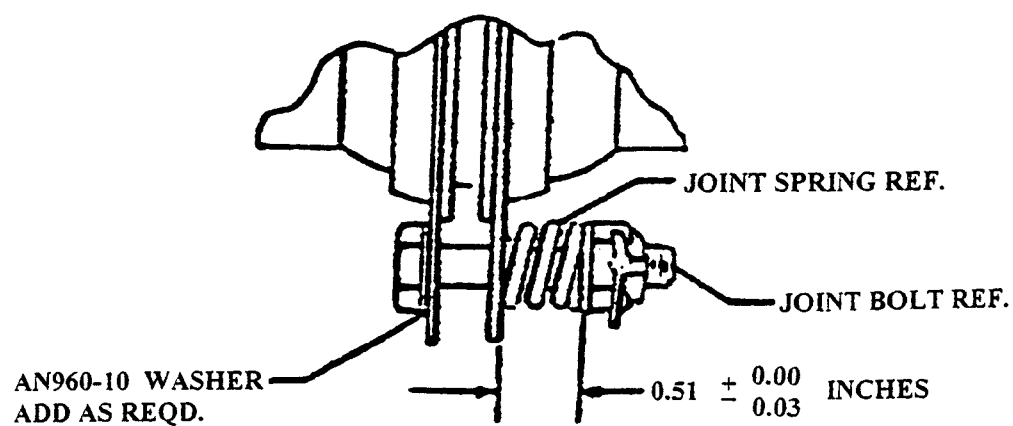
FIGURE 1 to the Appendix

(ii) Remove all the springs and measure the free length. Replace any spring having a free length of less than .57 inch.

Typical Exhaust Joint Spring Installation

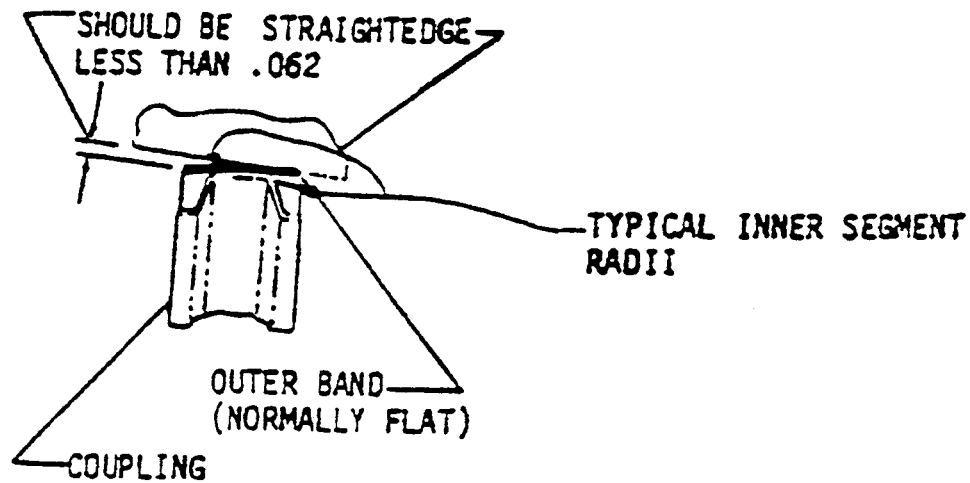
FIGURE 4 to the Appendix

Multi-Segment "V" Band Clamp Outer Band Flatness Check

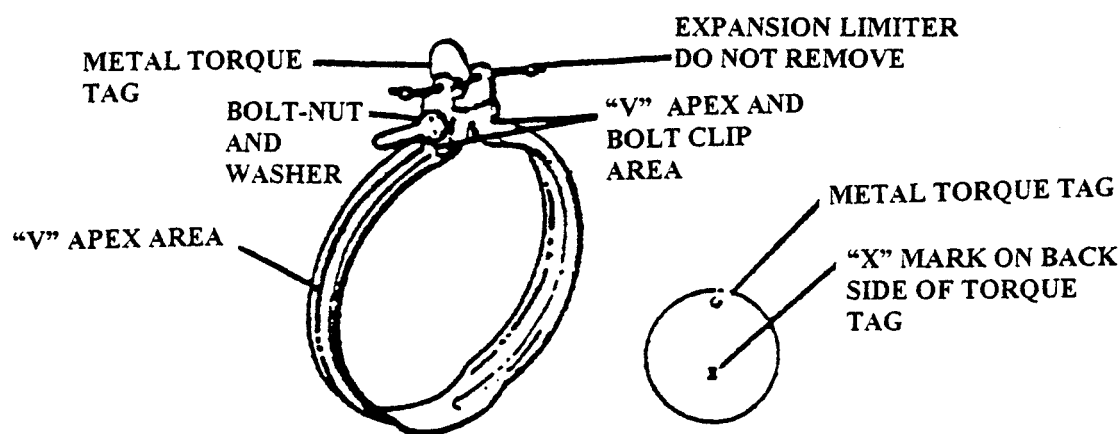
(iv) Visually inspect the one-piece "V" band clamp (overboard exhaust to turbocharger) with a light and mirror, in the area of the clamp surfaces adjacent to the intersection of the "V" apex and bolt clips, and the entire length of the "V" apex of the clamp for signs of cracks or fractures. If cracks or fractures are visible, replace the clamp (see Figure 5 of this Appendix). See Cessna service manual(s) and revisions for correct installation procedures

**One-Piece "V" Band Type Clamp****FIGURE 5 to the Appendix*****Inspection of the Exhaust System Aft of the Slip Joints***
