[Docket No. 2000-SW-65-AD; Amendment 39-12106; AD 2000-25-54]

#### Airworthiness Directives; Agusta S.p.A. Model A109E Helicopters

**2000-25-54 Agusta S.p.A.:** Amendment 39-12106. Docket No. 2000-SW-65-AD.

*Applicability:* Model A109E helicopters, with tail rotor blade (blade), part number 109-8132-01-109, installed, certificated in any category.

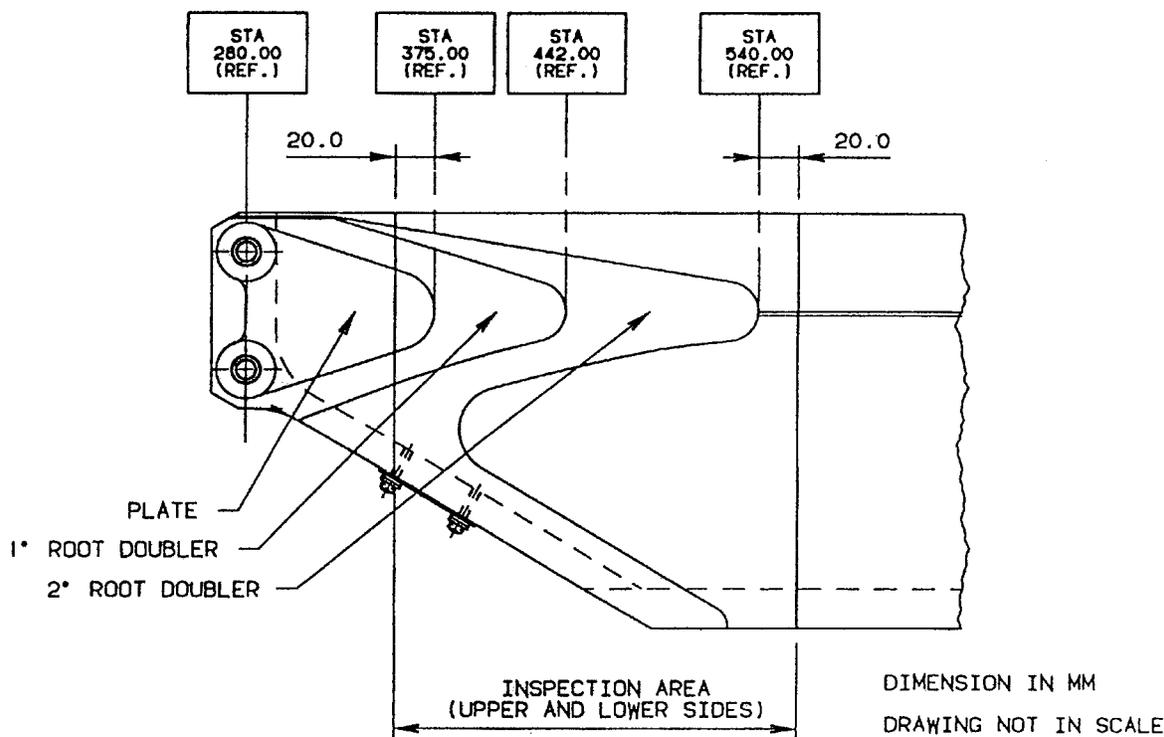
**FIGURE 1**

(a) Before each start of the engines, visually check both sides of each blade for a crack, in the area shown in Figure 1. An owner/operator (pilot), holding at least a private pilot certificate, may perform the visual check required by this paragraph and must enter compliance into the aircraft maintenance records in accordance with 14 CFR 43.11 and 91.417(a)(2)(v).

Note: Paint irregularities may be due to cracks.

(d) If a crack is found, replace the blade with an airworthy blade before further flight.
