(b) Within 10 hours time-in-service (TIS) and thereafter at intervals not to exceed 10 hours TIS or before the next flight after any abnormal tail rotor vibration, inspect each blade for a crack using a 5-power or higher magnifying glass in accordance with the Compliance Instructions, Part II, of Agusta S.p.A. Alert Bollettino Tecnico No. 109EP-14, dated October 11, 2000 (ABT).

[Docket No. 2000-NM-299-AD; Amendment 39-12107; AD 2001-03-04]

Airworthiness Directives; Bombardier Model CL-600-2B19 Series Airplanes

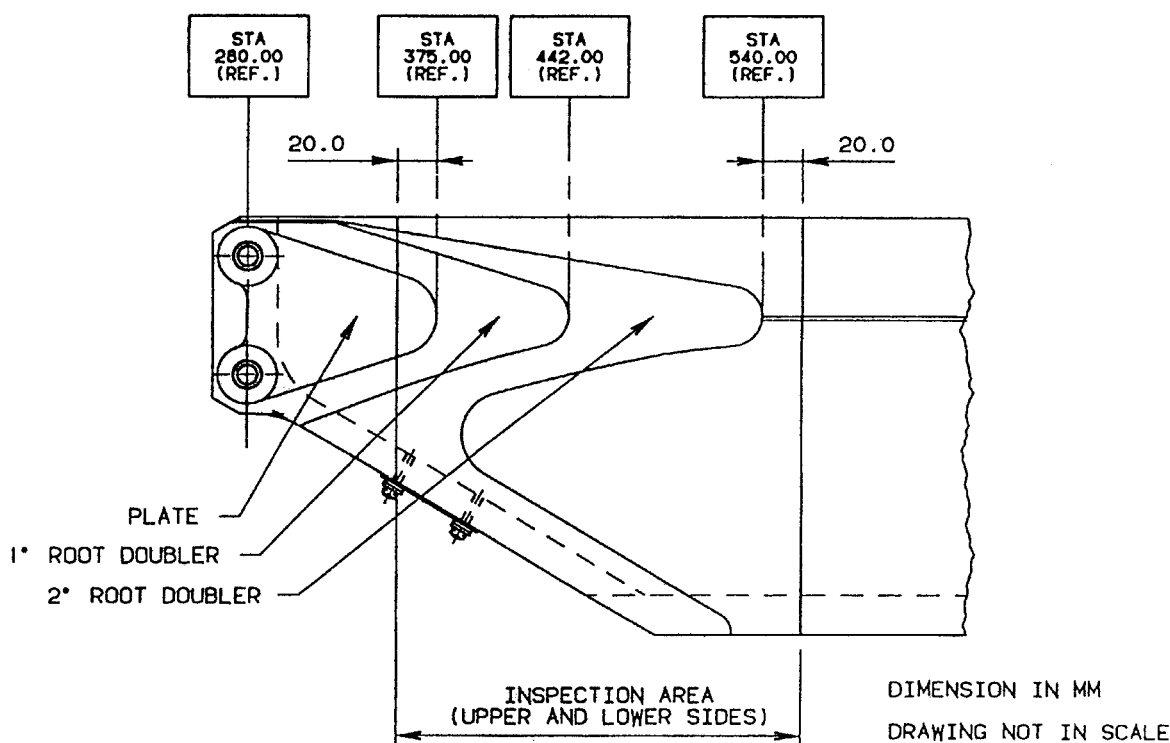
FIGURE 1

Note: Paint irregularities may be due to cracks.

(c) Within 25 hours TIS and thereafter at intervals not to exceed 25 hours TIS, dye-penetrant inspect each blade for a crack in accordance with the Compliance Instructions, Part III, of the ABT.

(d) If a crack is found, replace the blade with an airworthy blade before further flight.
