[Docket No. 2001-SW-13-AD]

Airworthiness Directives; Bell Helicopter Textron, Inc. Model 47B, 47B-3, 47D, 47D-1, 47G, 47G-2, 47G2A, 47G-2A-1, 47G-3, 47G-3B, 47G-3B-1, 47G-3B-2, 47G-3B-2A, 47G-4, 47G-4A, 47G-5, 47G-5A, 47H-1, 47J, 47J-2, 47J-2A, and 47K Helicopters

ACTION: Notice of proposed rulemaking.

Appendix 1—Nondestructive Inspection Procedure

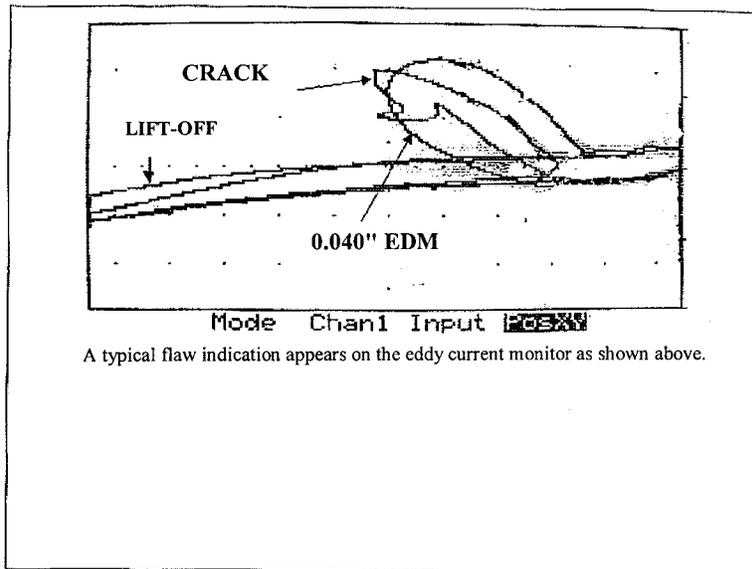
Figure 2, Appendix 1

6.1 Place the probe into the threaded area and slide it in the same direction as was done on the standard while monitoring the screen for root cracks. Moving the probe in the same direction produces a repeatable display that allows for more accurate flaw size determination. Scan the probe along each individual thread until all the threads are inspected. (See Figures 2 and 3.)
