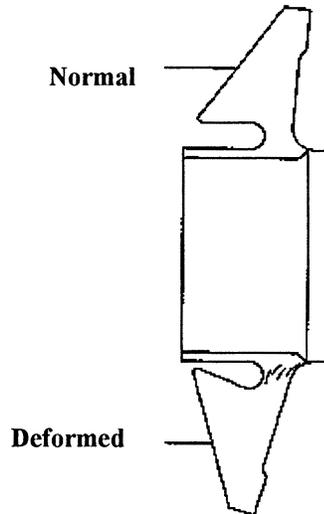
(b) Before each engine start, check the indicator for damage in accordance with Figure 1 of this AD. If damage is found, before further flight, replace the damaged indicator with an airworthy indicator, and replace the tail rotor yoke, P/N 406-012-102-107, with an airworthy tail rotor yoke.

Normal and Deformed (damaged) Indications of the High Altitude Tail Rotor Static Stop Yield Indicator (P/N 206-011-752-101)
