Federal Register

[Docket No. 2001-SW-24-AD; Amendment 39-12407; AD 2001-17-16]

Airworthiness Directives; Agusta S.p.A. Model A109E Helicopters

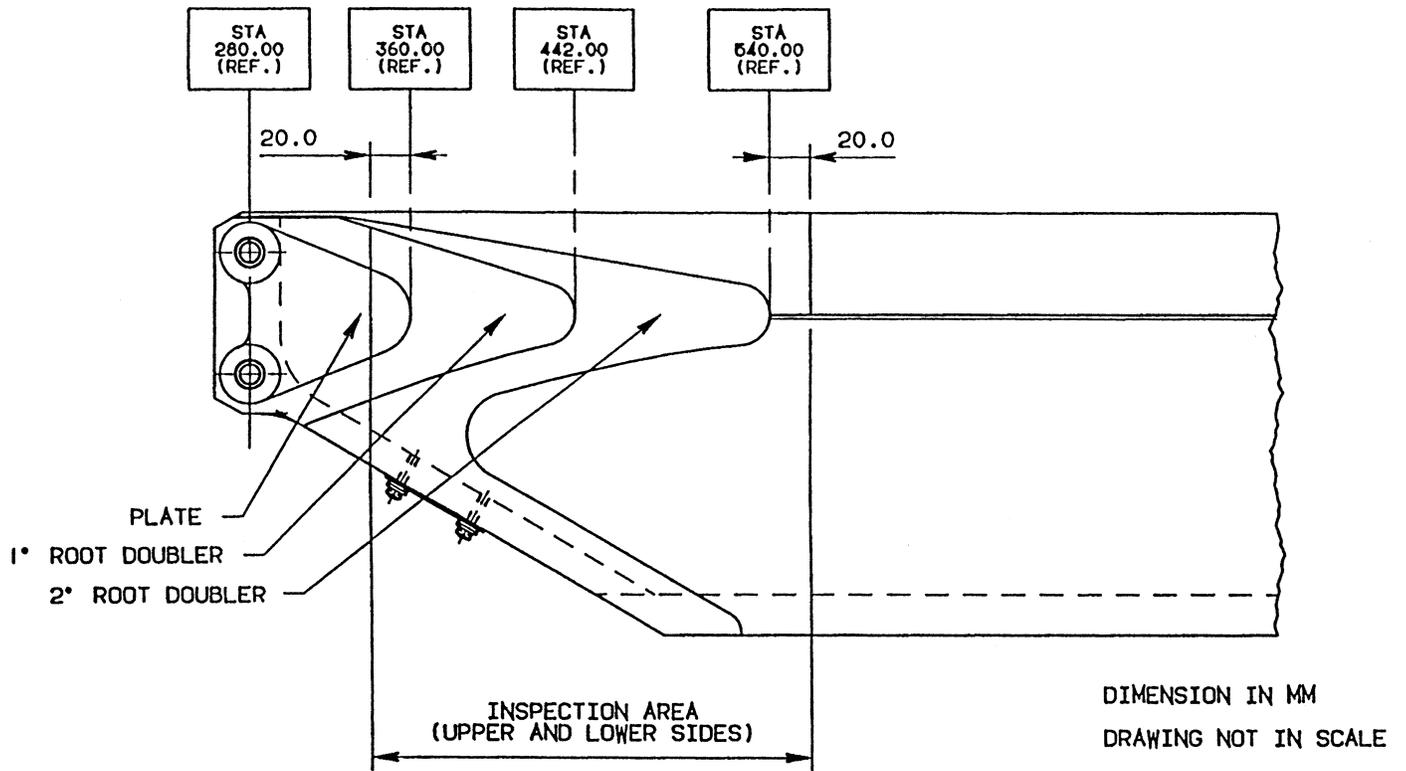
FIGURE 1

(a) Before each start of the engines, visually check both sides of each blade for a crack in accordance with Figure 1 of this AD for blade, P/N 109-8132-01-107, or Figure 2 of this AD for blade, P/N 109-8132-01-109. An owner/operator (pilot), holding at least a private pilot certificate, may perform the visual check required by this paragraph and must record compliance with paragraph (a) of this AD in the aircraft maintenance records in accordance with 14 CFR 43.11 and 91.417(a)(2)(v).

P/N 109-8132-01-107 T/R BLADE

(d) If a crack is found, replace the blade with an airworthy blade before further flight.
