[Docket No. 2001-SW-17-AD]

#### Airworthiness Directives; Bell Helicopter Textron, Inc.—Manufactured Model OH-13E, OH-13H, and OH-13S Helicopters

**ACTION:** Notice of proposed rulemaking (NPRM).

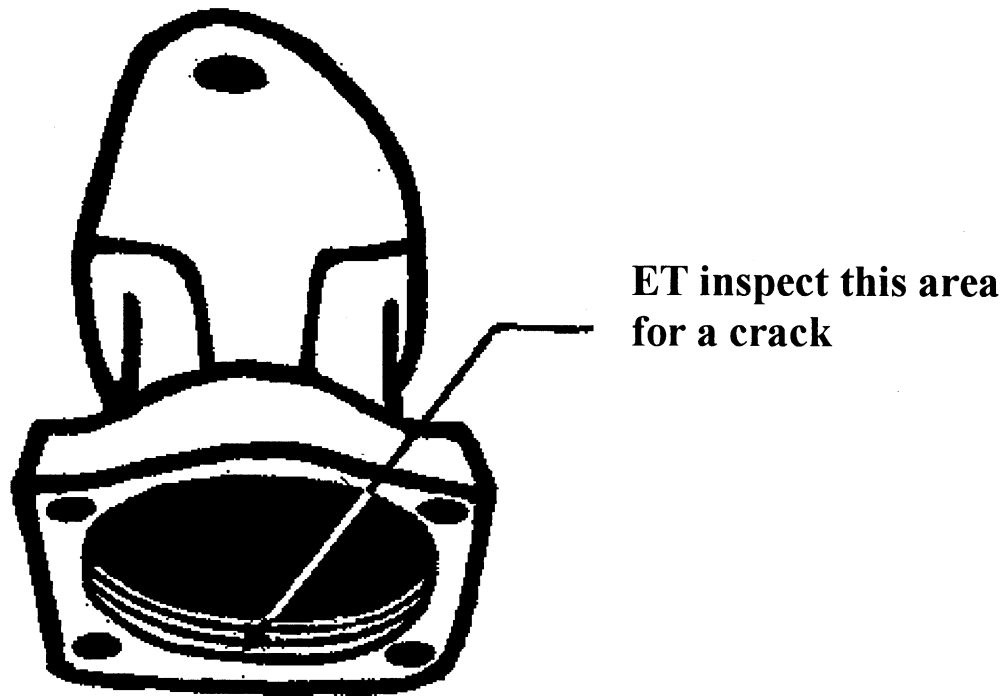
**Figure 1, Appendix 1**

- 1.1 The inboard inside diameter machined threads (reference Figure 1).

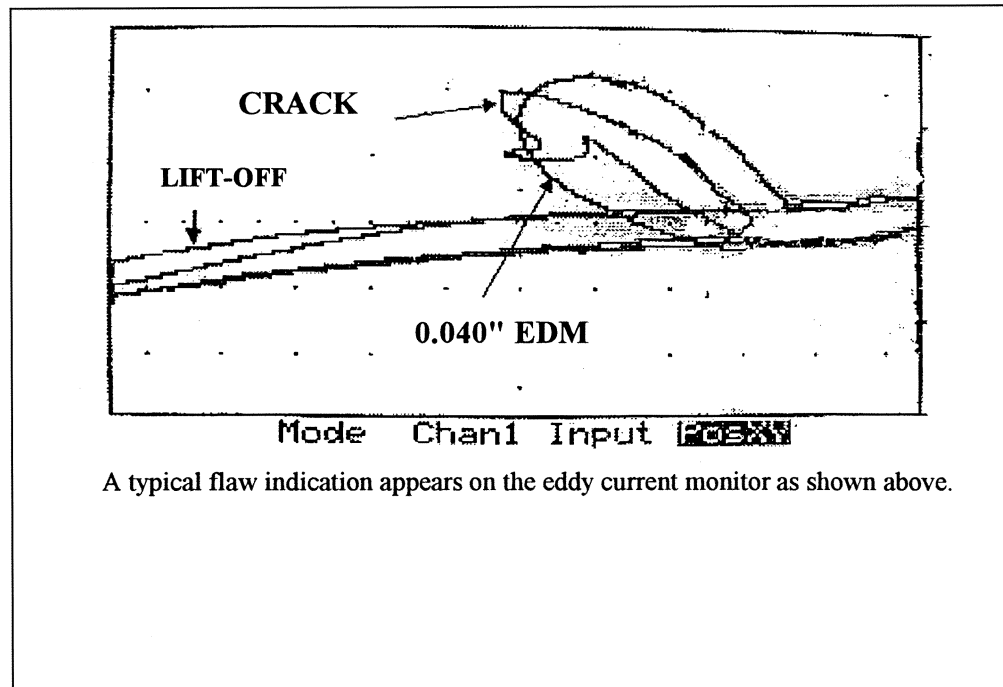
**Figure 2, Appendix 1**

- 6.1 Place the probe into the threaded area and slide it in the same direction as was done on the standard while monitoring the screen for root cracks. Moving the probe in the same direction produces a repeatable display that allows for more accurate flaw size determination. Scan the probe along each individual thread until all the threads are inspected. (See Figures 2 and 3.)

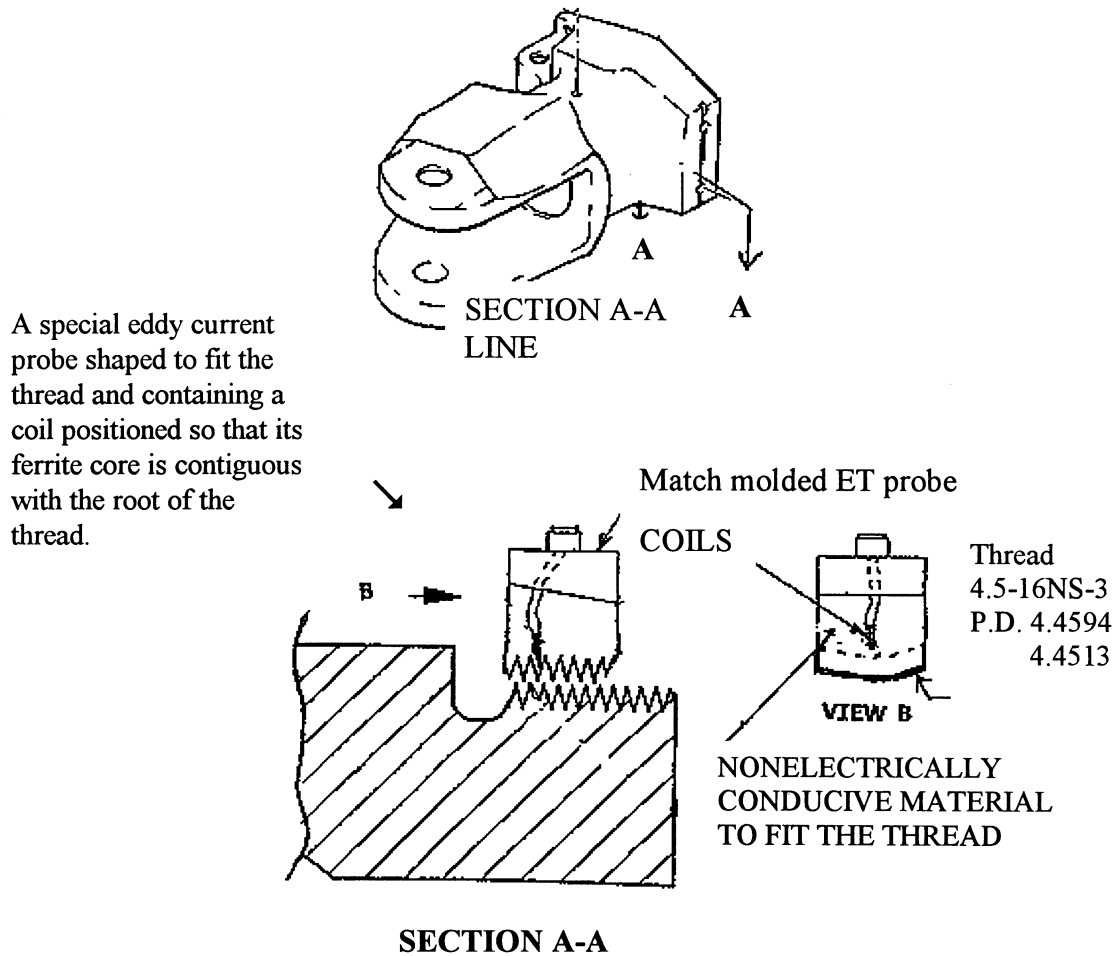
**Figure 3, Appendix 1**

- 2.1 Zetec Miz-20/22, Phasec 2200 or equivalent piece of equipment.  
2.2 Match molded ET probe SPC-193 (100kHz) or equivalent. (See Figure 3.)  
2.3 Reference standard EC-010-021, or equivalent. (See Figures 4 and 5.)  
2.4 Light oil.

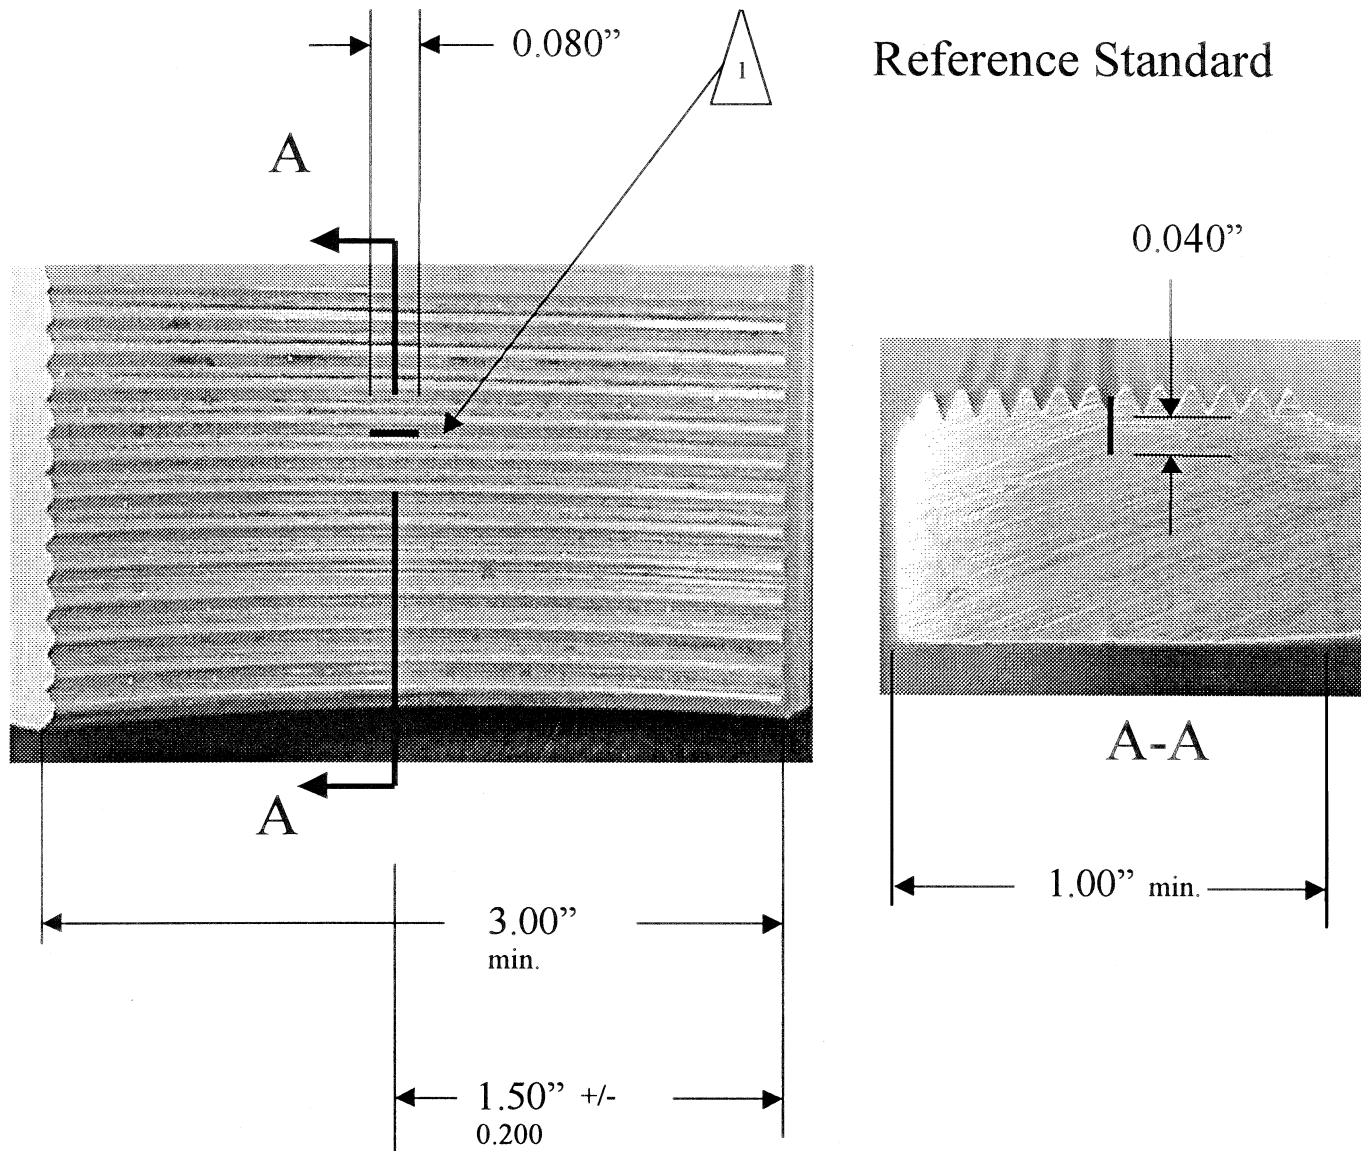
Figure 4, Appendix 1

EDM 1 place only in thread root.  
Notch width shall be 0.004 max.  
All other dimensions to be +/- 0.004 from indicated.

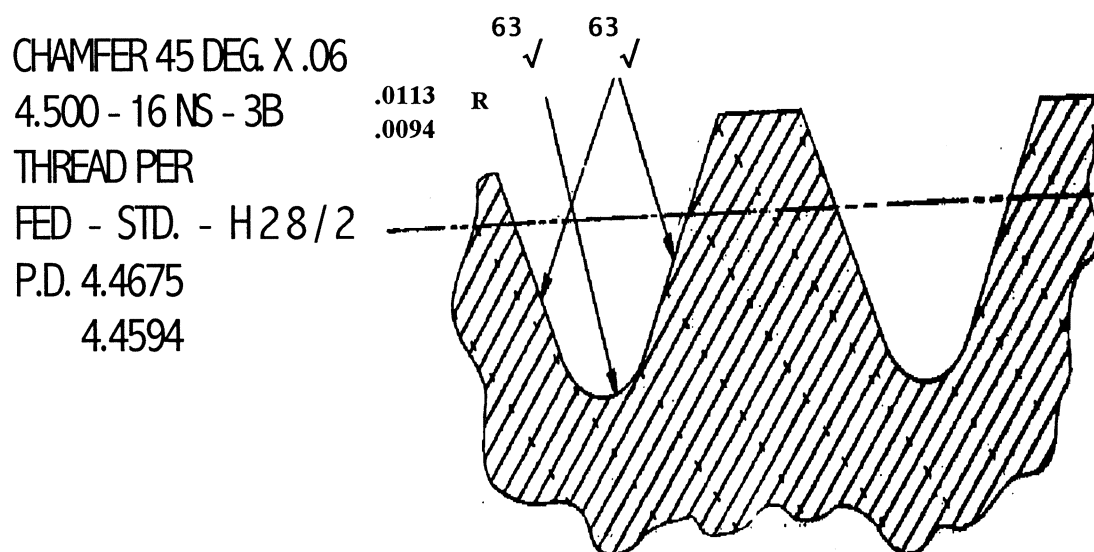
**Figure 5, Appendix 1**

1. Standard may be machined from aluminum tube stock.
2. The standard shall contain a minimum of four teeth per the tooth dimensions specified.
3. The EDM notch shall be placed in the center most tooth root as measured across the width of the standards. There shall be no less than two teeth and one root on either side of the EDM notch.
