[Docket No. 2001-SW-39-AD]

#### Airworthiness Directives; MD Helicopters Inc. Model MD-900 Helicopters

**ACTION:** Notice of proposed rulemaking (NPRM).

**SUMMARY:** This document proposes superseding an existing airworthiness directive (AD) for MD Helicopters Inc. Model MD-900 helicopters. That AD currently requires inspecting the main rotor upper hub assembly drive plate attachment flange (flange), determining the torque of each flange nut (nut), and if a crack is found, before further flight, replacing the hub assembly. In addition to the current requirements, this action would require visually inspecting the

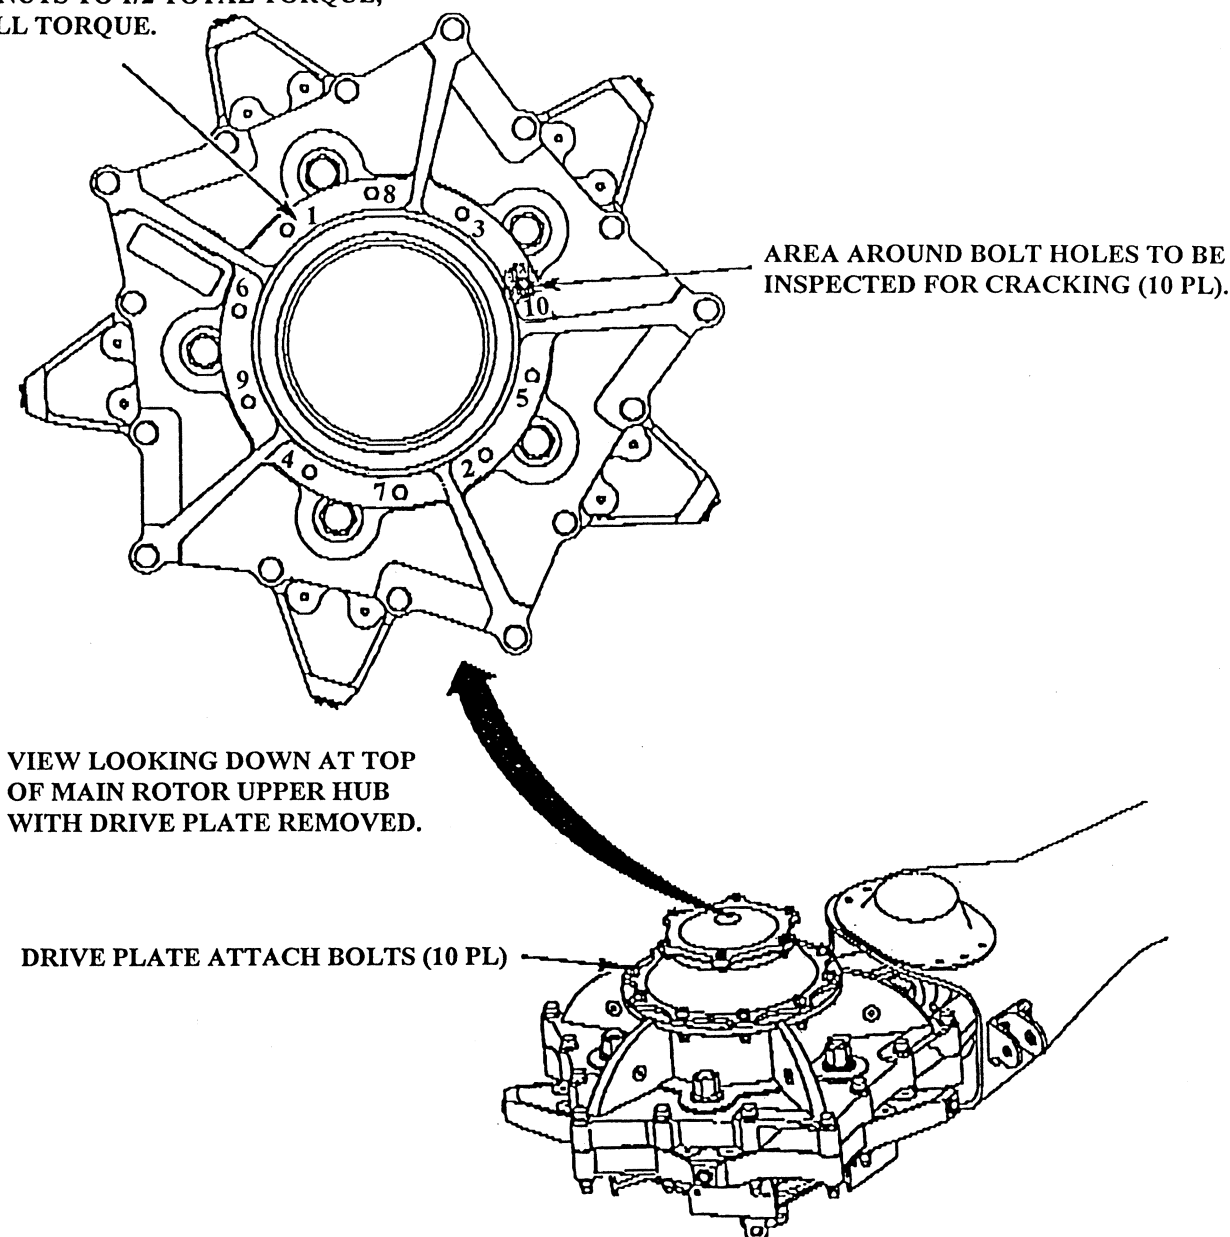
**Figure 1. Main Rotor Upper Hub Assembly Inspection.**

(v) Using paint stripper (Consumable Item List C313 or equivalent) and cleaning solvent (C420 or equivalent), remove the paint from the upper mating surface of the hub assembly to enable an accurate visual inspection of each drive plate attachment bolt hole (bolt hole) area for cracking (Figure 1). Ensure the paint stripper and solvent DO NOT contaminate the upper bearing and upper grease seal areas.

(vi) Using a 10× or higher magnifying glass and light, inspect the mating surface area and the area around and inside the 10 boltholes of the hub assembly for a crack. If a crack is found, prior to further flight, replace the hub assembly with an airworthy hub assembly.

(viii) Reinstall the main rotor drive plate using 10 new sets of replacement attachment hardware. Torque the nuts to 160 inch pounds above locknut locking/run-on torque in the sequence shown (Figure 1). Record in the rotorcraft logbook, or equivalent record, the locknut locking/run-on torque for each nut.
