[Docket No. 2001-SW-50-AD; Amendment 39-12838; AD 2002-15-08]

**Airworthiness Directives; Eurocopter France Model EC120B, EC 155B, SA330F, SA330G, SA330J, AS332C, AS332L, AS332L1, AS332L2, AS350B, AS350BA, AS350B1, AS350B2, AS350B3, AS350D, AS355E, AS355F, AS355F1, AS355F2, AS355N, AS365N2, AS 365 N3, SA-365N, and SA-365N1 Helicopters**

**ACTION:** Final rule.

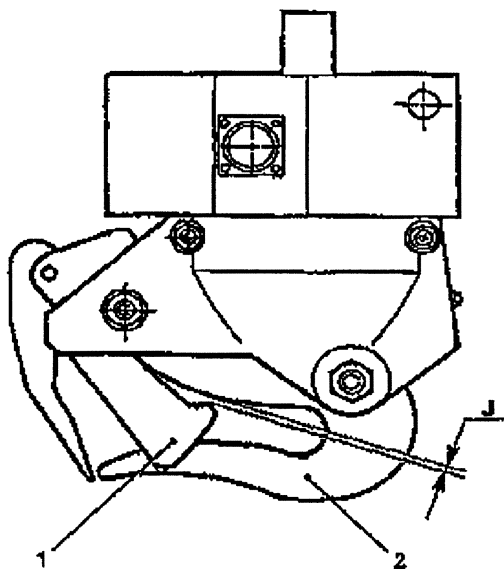
**Figure 1**

The Direction Generale De L'Aviation Civile (DGAC), the airworthiness authority for France, notified the FAA that an unsafe condition may exist on various ECF model helicopters. The DGAC advises of the discovery of an anomaly on the locking catch of certain cargo hooks that could jam the ring on the cargo hook and jeopardize the release of an underslung load.

**Clearance "J" must be less than 14 mm (0.55 inches)**

(a) With the cargo hook in the no-load position, measure the clearance "J" in accordance with Figure 1 of this AD. Remove any cargo hook if clearance "J" is equal to or greater than 14 millimeters (0.55 inches). See Figure 1:
