[Docket No. 2002–NE–08–AD; Amendment 39–12865; AD 2002–16–26]

#### Airworthiness Directives; Bombardier-Rotax GmbH Type 912 F and 914 F Series Reciprocating Engines

**2002-16-26 Bombardier-Rotax GmbH:**  
Amendment 39-12865. Docket No. 2002-NE-08-AD.

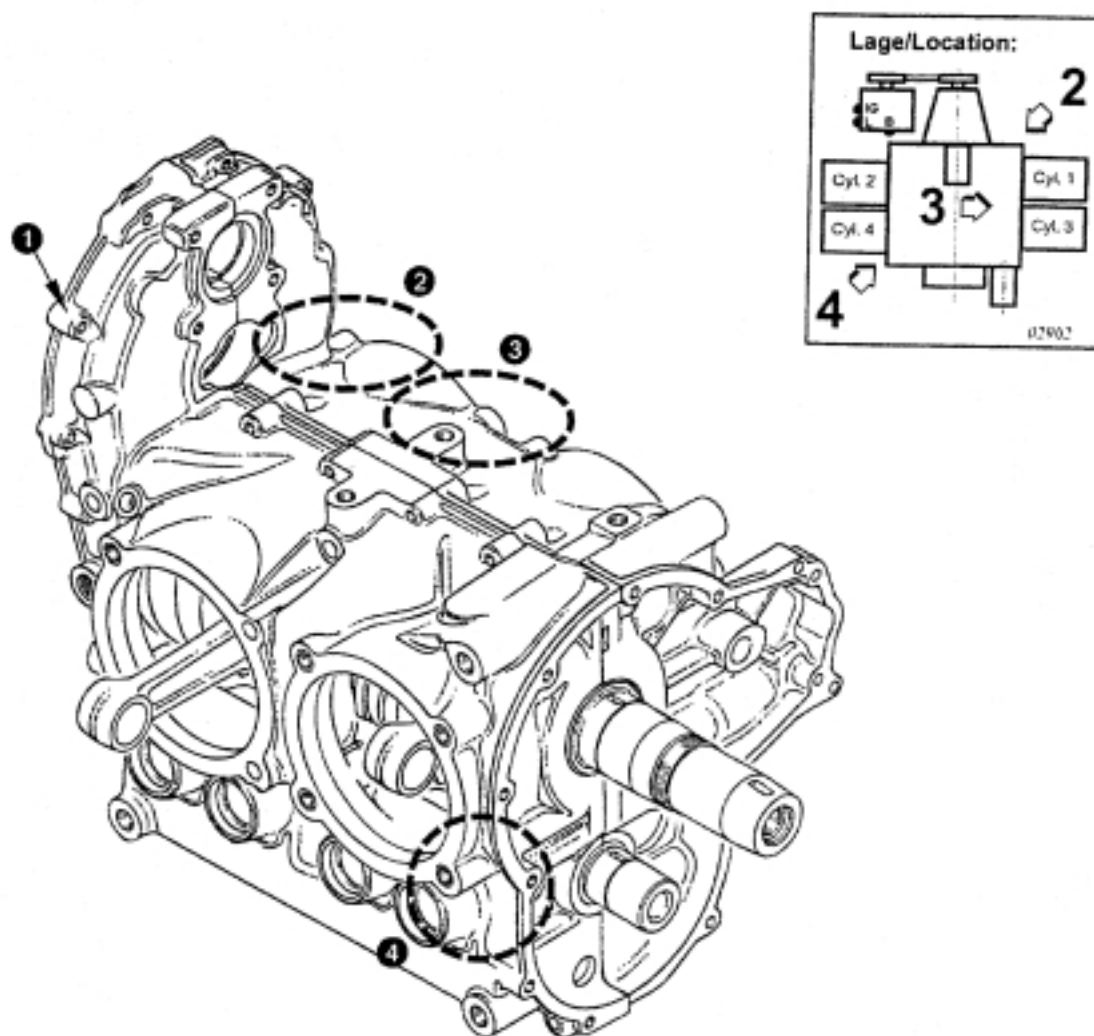
**Figure 1. Engine Crankcase Inspection Areas**

**SUMMARY:** This amendment adopts a new airworthiness directive (AD) that is applicable to certain serial numbers (SN's) of Bombardier-Rotax GmbH type 912 F and 914 F series reciprocating engines. This action requires initial and repetitive visual inspections of the engine crankcase for cracks. This amendment is prompted by reports of several instances of engine crankcases found cracked in service. The actions specified in this AD are intended to prevent oil loss caused by cracks in the engine crankcase, which could lead to in-flight failure of the engine and forced landing.

(1) Inspect the engine crankcase (item 1, Figure 1 of this AD) for cracks especially in the area of cylinder 1 upper side (item 2), between cylinder 1 and 3 upper side (item 3), and cylinder 4 lower side (item 4).

1. Engine Crankcase
2. Cylinder 1 Upper Side
3. Cylinder 3 Upper Side
4. Cylinder 4 Lower Side

(2) Cracks in crankcases of engines with a ROTAX cooling air baffle may not be easily visible, and oil leaks may be an indication of cracks. Visually inspect for oil leaks in areas of (item 2) and (item 3).

(3) If oil leaks are found, determine the source by either using a borescope or removing the object blocking the view such as the air baffle or accessory, and perform the inspection.

(4) If the engine crankcase is cracked, replace engine before further flight. Repair oil leaks from any other cause.

(b) Visually inspect the engine crankcase (item 1, Figure 1 of this AD) for cracks at each 100-hour, annual, or progressive inspection, or within 110 hours TIS since last inspection, whichever occurs first, in accordance with paragraph (a) of this AD.
