[Docket No. 2004-SW-09-AD; Amendment 39-13651; AD 2004-06-51]

#### Airworthiness Directives; Boeing Defense and Space Group Model 234 Helicopters

**2004-06-51 Boeing Defense and Space Group:** Amendment 39-13651. Docket No. 2004-SW-09-AD.

**Applicability:** Model 234 helicopters, with aft vertical shaft assembly, part number (P/N) 234D3300, serial number-181 or lower with a prefix of A, installed, certificated in any category.

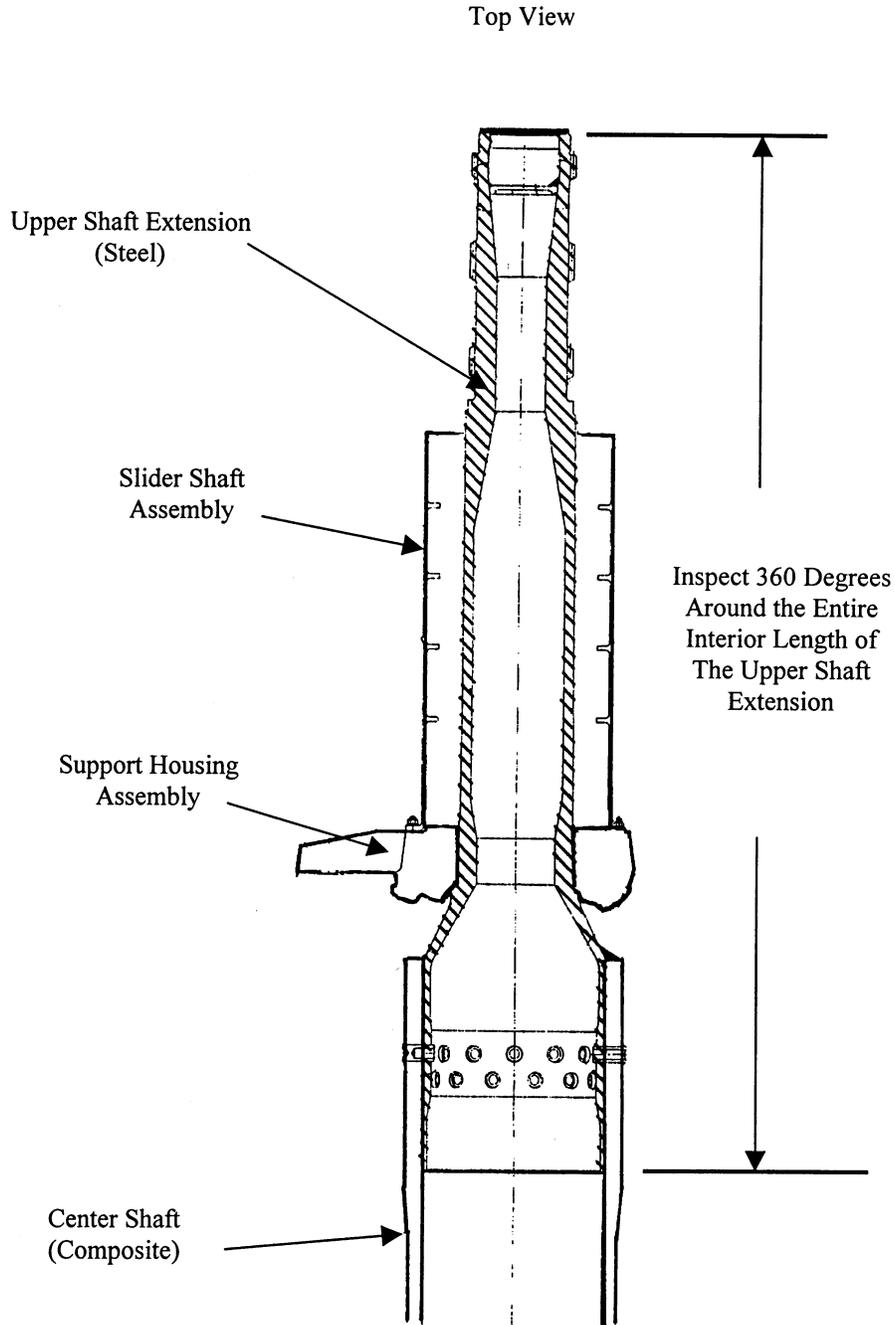
Aft Vertical Shaft  
Assembly Inspection Area  
Figure 1

To detect a crack in the upper shaft extension, which could result in catastrophic failure of the aft vertical shaft assembly and subsequent loss of control of the helicopter, accomplish the following:

(5) Inspect the upper shaft extension, P/N 114D3248, using a borescope or other lighted device that provides direct visual observation of the interior of the aft rotor shaft. Inspect 360 degrees around the entire interior length of the upper shaft extension. If any crack is found, replace the aft vertical shaft assembly, P/N 234D3300, with an airworthy assembly before further flight. See the following Figure 1 of this AD for the area to inspect:

(3) Inspect the upper shaft extension, P/N 114D3248, using a borescope or other lighted device that provides direct visual observation of the interior of the aft rotor shaft. Inspect 360 degrees around the entire interior length of the upper shaft extension (see Figure 1 of this AD). If any crack is found, replace the aft vertical shaft assembly, P/N 234D3300,
