[Docket No. FAA-2005-21680; Directorate Identifier 2004-SW-48-AD; Amendment 39-14341; AD 2005-21-03]

#### Airworthiness Directives; Bell Helicopter Textron Canada Model 206A, A-1, B, B-1, L, L-1, L-3, L-4 Helicopters

**ACTION:** Final rule.

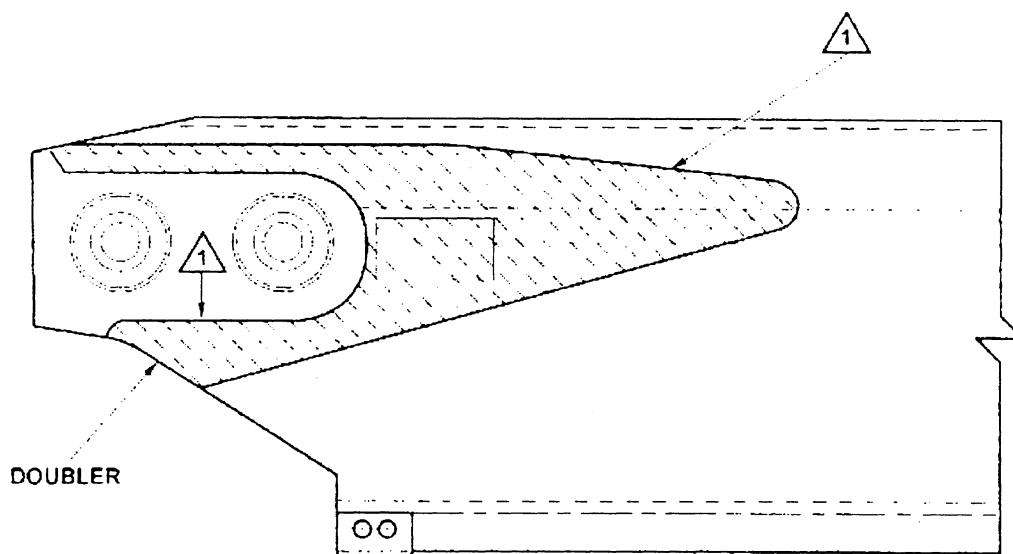
Transport Canada, the airworthiness authority for Canada, notified the FAA that an unsafe condition may exist on Model 206A, B, and L series helicopters. Transport Canada advises that an inadequate surface preparation on a limited number of blades resulted in two reported instances of blade root doubler de-bond. They also advise that to ensure blade integrity all suspected blades are to be checked daily until removed from service.

Inspect the doubler for an edge void or de-bond on both sides of each blade.

(a) Before the first flight of each day, clean each blade and visually check the blade root doublers for an edge void or de-bond on both sides of each blade as depicted in Figure 1 of this AD. An owner/operator (pilot), holding at least a private pilot certificate, may perform this visual check and must enter compliance with this paragraph into the helicopter maintenance records by following 14 CFR sections 43.11 and 91.417(a)(2)(v).

(b) If an edge void or a de-bond is found, before further flight, replace the blade with an airworthy blade with a serial number other than those to which this AD applies.
