## DEPARTMENT OF TRANSPORTATION

### Federal Aviation Administration

[Docket No. FAA-2004-19969; Directorate Identifier 2004-SW-43-AD; Amendment 39-13923; AD 2004-26-11]

#### **Airworthiness Directives; Bell Helicopter Textron Canada Model 222, 222B, 222U, 230, and 430 Helicopters**

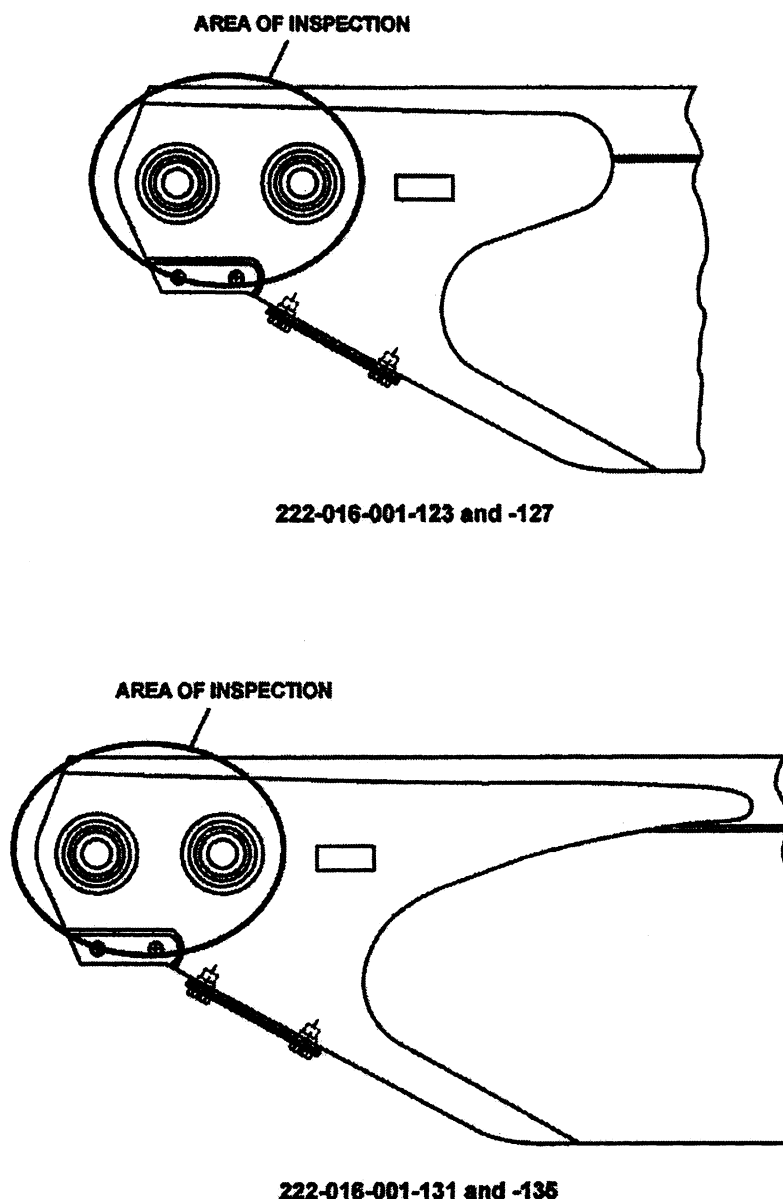
**Figure 1. Blade inspection area**

Transport Canada, the airworthiness authority for Canada, notified the FAA that an unsafe condition may exist on the specified BHTC model helicopters. Transport Canada advises of the discovery of cracked blades during scheduled inspections on three occasions. Two cracks originated from the outboard feathering bearing bore underneath the flanged sleeves. The third crack started from the inboard feathering bearing bore. Investigation found that the cracks originated from either a machining burr or a corrosion site in the bearing bore underneath the flanged sleeves.

- (a) Within 3 hours time-in-service (TIS) and at intervals not to exceed 3 hours TIS, clean and visually check both sides of each blade for a crack in the paint in the areas shown in Figure 1 of this AD. An owner/operator (pilot), holding at least a private

wiping down both surfaces of each blade in the inspection area depicted in Figure 1 of this AD using aliphatic naptha (C-305) or detergent (C-318) or equivalents. Using a 10X or higher power magnifying glass, visually inspect both sides of the blade in the areas depicted in Figure 1 of this AD.

(b) If a crack is found in the paint while complying with paragraph (a) of this AD, before further flight, inspect the blade by removing the blade and by abrading the area and following the other requirements in paragraph (c) of this AD.

(1) If even a crack is found in the paint, before further flight, remove the blade.

(2) Remove the paint to the bare metal in the area of the suspected crack by using Plastic Metal Blasting (PMB) or a nylon web abrasive pad. Abrade the blade surface in a span-wise direction only.

(3) Using a 10X or higher power magnifying glass, inspect the blade for a crack.

(i) If a crack is found, before further flight, replace the blade with an airworthy blade.

(ii) If no crack is found in the blade surface, refinish the blade by applying one coat of MIL-P-23377 or MIL-P-85582 Epoxy Polyamide Primer so that the primer overlaps

the existing coats just beyond the abraded area. Let the area dry for 30 minutes to 1 hour. Then, apply one sealer coat of Polyurethane MILC85285 TYI CL2, color Number 27925 (semi-gloss white) per Fed. Std. 595. Reinstall the blade.
