Federal Register

Thursday, February 17, 2005

[Docket No. FAA-2005-20107; Directorate Identifier 2005-SW-02-AD; Amendment 39-13981; AD 2005-04-09]

Airworthiness Directives; Bell Helicopter Textron Canada Model 222, 222B, 222U, 230, and 430 Helicopters

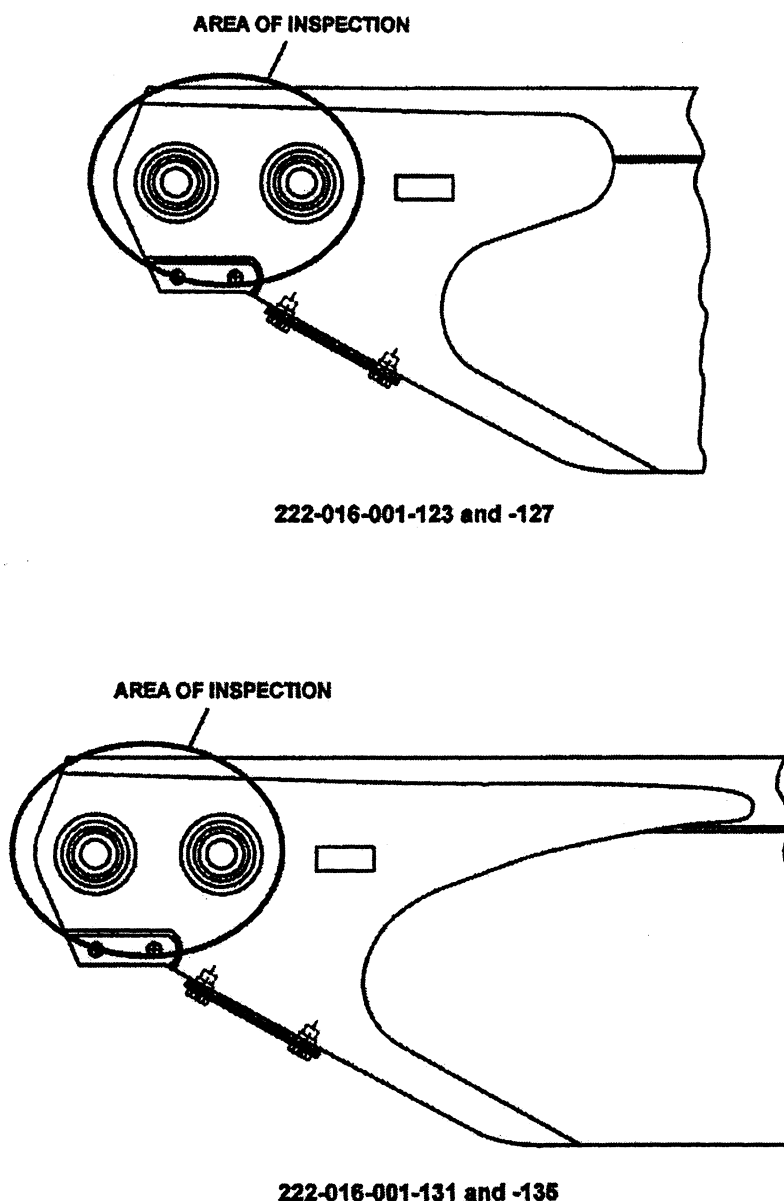
Figure 1. Blade inspection area

Transport Canada, the airworthiness authority for Canada, notified the FAA that an unsafe condition may exist on the specified BHTC model helicopters. Transport Canada advises of the discovery of cracked blades during scheduled inspections on three occasions. Two cracks originated from the outboard feathering bearing bore underneath the flanged sleeves. The third crack started from the inboard feathering bearing bore. Investigation found that the cracks originated from either a machining burr or a corrosion site in the bearing bore underneath the flanged sleeves.

(a) Within 3 hours time-in-service (TIS), and thereafter at intervals not to exceed 3 hours TIS, clean and visually check both sides of each blade for a crack in the paint in the areas shown in Figure 1 of this AD. An owner/operator (pilot), holding at least a

intervals not to exceed 50 hours TIS, clean the blade by wiping down both surfaces of each blade in the inspection area depicted in Figure 1 of this AD using aliphatic naphtha (C-305) or detergent (C-318) or an equivalent. Using a 10X or higher power magnifying glass, visually inspect both sides of the blade in the areas depicted in Figure 1 of this AD.

(1) If a crack is found, even if only in the paint, before further flight, remove the blade from the helicopter and proceed with the following:

(2) Remove the paint on the blade down to the bare metal in the area of the suspected crack by using plastic metal blasting (PMB) or a nylon web abrasive pad. Abrade the blade surface in a span-wise direction only.

(3) Using a 10X or higher power magnifying glass, inspect the blade for a crack.

(i) If a crack is found, replace the blade with an airworthy blade before further flight.

(ii) If no crack is found in the blade surface, refinish the blade by applying one coat of epoxy polyamide primer, MIL-P-23377 or MIL-P-85582, so that the primer overlaps the existing coats just beyond the abraded area. Let the area dry for 30 minutes to 1 hour. Then, apply one sealer coat of polyurethane, MILC85285 TYI CL2, color number 27925 (semi-gloss white), per Fed. Std. 595. Reinstall the blade.
