### Airworthiness Directives; Bell Helicopter Textron Model 204B, 205A, 205A-1, 205B, 210, 212, 412, 412CF, and 412EP Helicopters

**ACTION:** Notice of proposed rulemaking (NPRM).

**Bell Helicopter Textron:** Docket No. FAA-2006-26219; Directorate Identifier 2004-SW-49-AD.

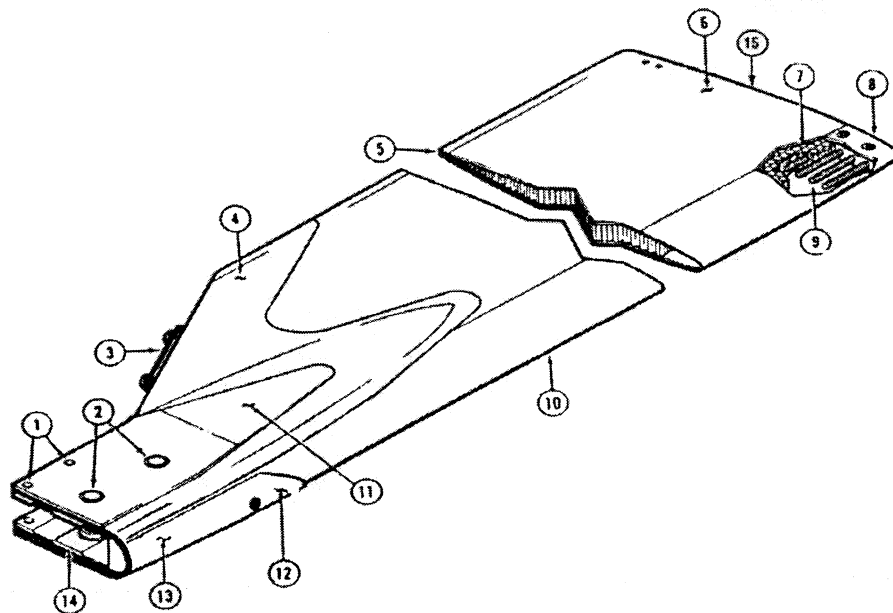
(2) Using a 3-power or higher magnifying glass and a bright light, visually inspect the T/R blade skins, leading edge spar, doublers, grip plates, and trailing edge for a crack, corrosion (may be indicated by blistering, peeling, flaking, bubbling, or cracked paint) and any other damage (including a nick, scratch, or dent). See Figure 1 of this AD. Pay particular attention to both sides of the T/R

blade in the area located 10 to 25 inches from the T/R blade tip (blade station 26 to 41—the T/R blade tip is located at blade station 51). Also pay particular attention to any blade surface that was snagged by the cloth, as that may be an indication of a crack or paint chip that could lead to corrosion.

(3) If any blistering, peeling, flaking, bubbling, or cracked paint is detected, remove the paint from the affected area and visually inspect the affected area for corrosion or a crack using a 10-power or higher magnifying glass. If any corrosion is found, measure the depth of the corrosion (a digital optical micrometer is one tool that can be used for this measurement).

(4) If a nick, scratch, or dent is found, visually inspect for a crack using 10-power or higher magnifying glass and measure the depth of the damage (a digital optical micrometer is one tool that can be used for this measurement).

(1) Replace any T/R blade that has a crack with an airworthy blade.

(2) Replace any T/R blade that has any corrosion, nick, scratch, dent, or other damage that exceeds any maximum repair limit with an airworthy blade.

(3) Repair or replace with an airworthy blade any T/R blade that has any corrosion, nick, scratch, dent or other damage that is within the maximum repair limits.
