DEPARTMENT OF TRANSPORTATION**Federal Aviation Administration****14 CFR Part 39**

[Docket No. FAA-2007-27229; Directorate Identifier 2007-NE-03-AD]

Airworthiness Directives; CFM International, S.A. CFM56-7B Series Turbofan Engines

ACTION: Notice of proposed rulemaking (NPRM).

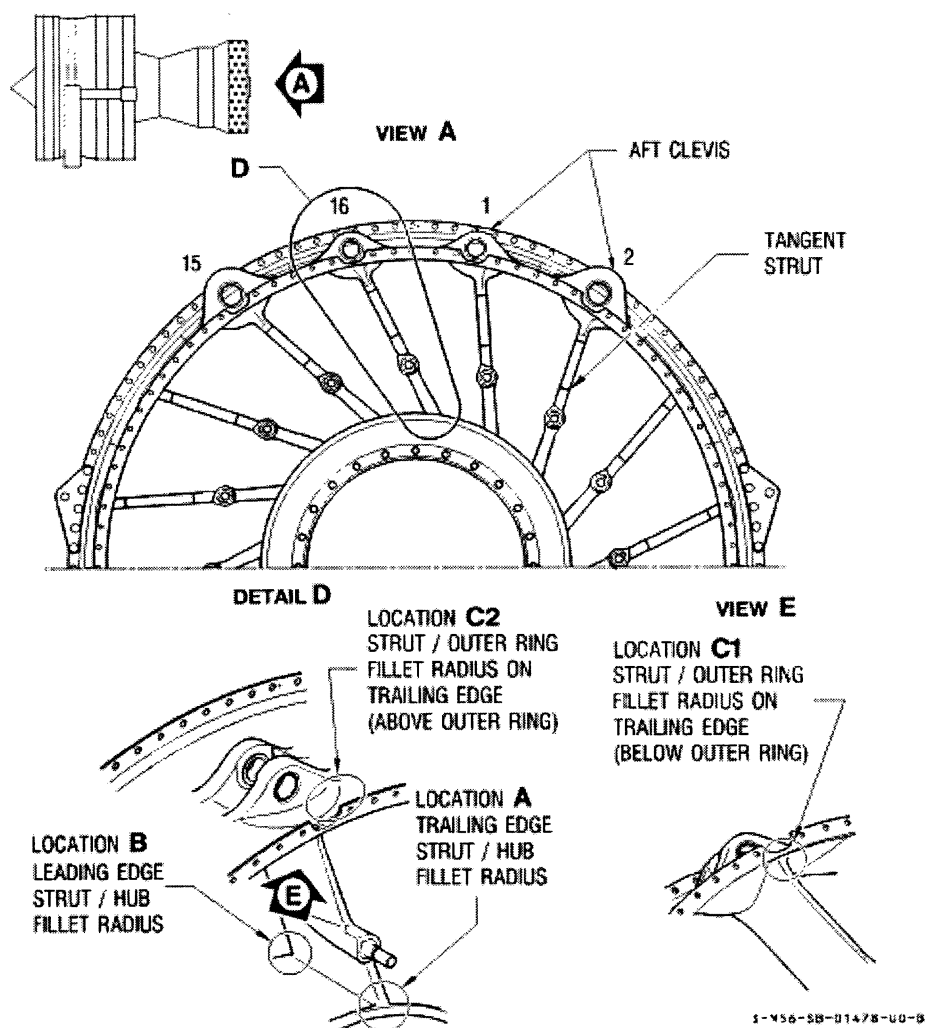
Figure 805,

- (d) This proposed AD results from a refined lifing analysis by the engine

manufacturer that shows the need to identify an initial threshold for inspecting certain TRFs. We are proposing this AD to prevent failure of the TRF from low-cycle fatigue cracks. Failure of the TRF could result in engine separation from the airplane, which could lead to loss of control of the airplane.

2. *Mandatory Inspection Intervals for the Critical Areas of the Turbine Rear Frame with Tangential Struts (4 Mount Struts, No. 1, 2, 15, and 16).*

Figure index No.	Inspection location	Inspection threshold (cycles since new)	Inspection intervals (cycles)	Inspection reference
805	Strut/outer ring fillet radius on trailing edge (A).	25,000* for -7B SAC (except business jet) engine models.	Refer to Figure 806* for -7B SAC commercial applications.	Refer to SB 72-0579*.
	Strut/outer ring fillet radius on leading edge (B).	19,000* for -7B SAC business jet engine models.	Refer to Figure 807* for -7B SAC business jet applications.	
	Strut/outer ring fillet radius on trailing edge (C1 below outer ring).			
	Strut/outer ring fillet radius on trailing edge (C2 above outer ring).

Turbine Rear Frame with Tangential struts P/ N 340-166-205-0, 340-166-206-0, 340-166-207-0, 340-166-208-0, 340-166-209-0, 340-166-210-0—Areas to Be Inspected

IF NO CRACK IS FOUND ON ANY OF THE FOUR MOUNT STRUTS, THE

TURBINE REAR FRAME IS SERVICEABLE AND MUST BE RE-INSPECTED AT 4,700 CYCLE REPETITIVE INTERVALS. IF CRACKS ARE FOUND ON THE MOUNT STRUTS, THE TRF MUST BE RE-INSPECTED ACCORDING TO THE FOLLOWING REPETITIVE INTERVALS

Total cumulated crack length at each location	Re-inspect within
$L < 0.20$ (5)	4,700.
$0.20 (5) \leq L < 0.28$ (7)	3,300.
$0.28 (7) \leq L < 0.39$ (10)	1,300.
$0.39 (10) \leq L < 0.59$ (15)	700.
$0.59 (15) \leq L < 0.79$ (20)	120.
$L \geq 0.79$ (20)	IMMEDIATELY REMOVE THE TURBINE FRAME.

DURING EACH INSPECTION, ALL THE LOCATIONS MUST BE INSPECTED. IF CRACKS ARE FOUND AT DIFFERENT LOCATIONS, THE REPETITIVE INSPECTION INTERVAL IS THE MINIMUM INTERVAL CORRESPONDING TO THE MAX. CUMULATED CRACK LENGTHS.
