### Airworthiness Directives; Eurocopter France Model AS355E, F, F1, F2, and N Helicopters

**ACTION:** Notice of proposed rulemaking (NPRM).

**Eurocopter France:** Docket No. FAA–2007–28691; Directorate Identifier 2006–SW–22–AD. Supersedes AD 2003–21–09 R1, Amendment 39–14621, Docket No. 2003–SW–10–AD.

**Applicability:** Model AS355E, F, F1, F2, and N helicopters, with a main gear box (MGB) lubrication pump (pump), part number (P/N) 355A32-0700-01, 355A32-0700-02, or 355A32-0701-00, any serial number (S/N), certificated in any category.

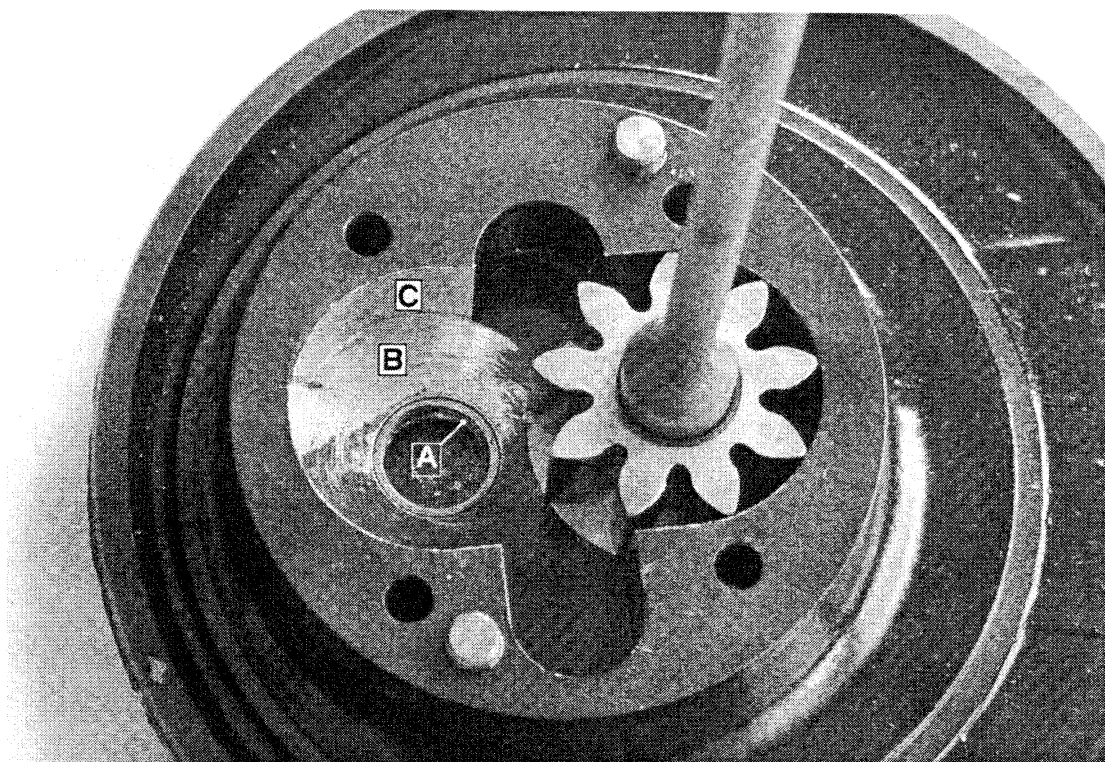
- (1) Crank pin play,
- (2) Out of round bronze bushing in area "A" of Figure 1 of this AD,
- (3) Offset of the driven gear pinion,
- (4) Metal chips, or
- (5) Wear in area "C" of Figure 1 of this AD.

**Note 2:** If wear is present in the B area only, as depicted in Figure 1, replacing the MGB and the pump is not required.

(d) While inspecting the pump, if you find any of the following, replace the MGB and the pump with an airworthy MGB and pump before further flight:
