[Docket No. FAA-2007-28828; Directorate Identifier 2007-NM-010-AD]

Airworthiness Directives; Boeing Model 707 Airplanes and Model 720 and 720B Series Airplanes

ACTION: Notice of proposed rulemaking (NPRM).

Appendix 1. 707 SFAR 88 Survey Areas

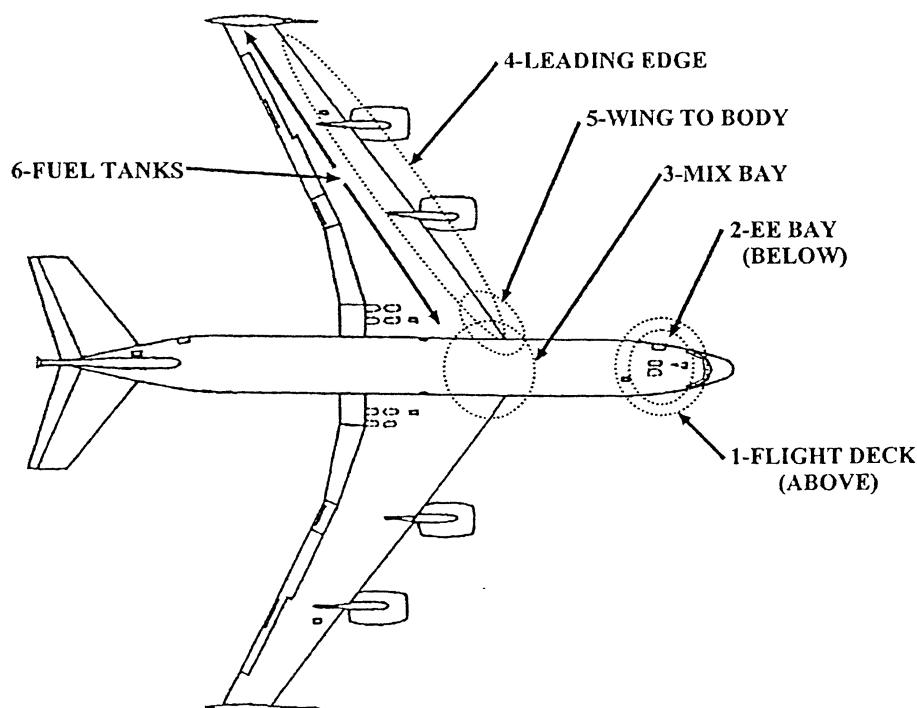
707 SFAR 88 SURVEY AREAS

1) Flight Deck

New circuit breakers will be installed on the P1, P2, P3, P4 and/or P5 panels. Two new indication lights are installed in the lower P11 panel. Provide photographs of these panels.

2) E/E-Bay

3) Mix Bay

4) Leading Edge

5) Wing to Body (Un-pressurized wire penetrations)

6) Fuel Tanks
