[Docket No. FAA–2007–29089; Directorate Identifier 2007–NM–215–AD; Amendment 39–15197; AD 2007–18–52]

### Airworthiness Directives; Boeing Model 737–600, –700, –700C, –800, –900, and –900ER Series Airplanes

**2007-18-52 Boeing:** Amendment 39-15197. Docket No. FAA-2007-29089; Directorate Identifier 2007-NM-215-AD.

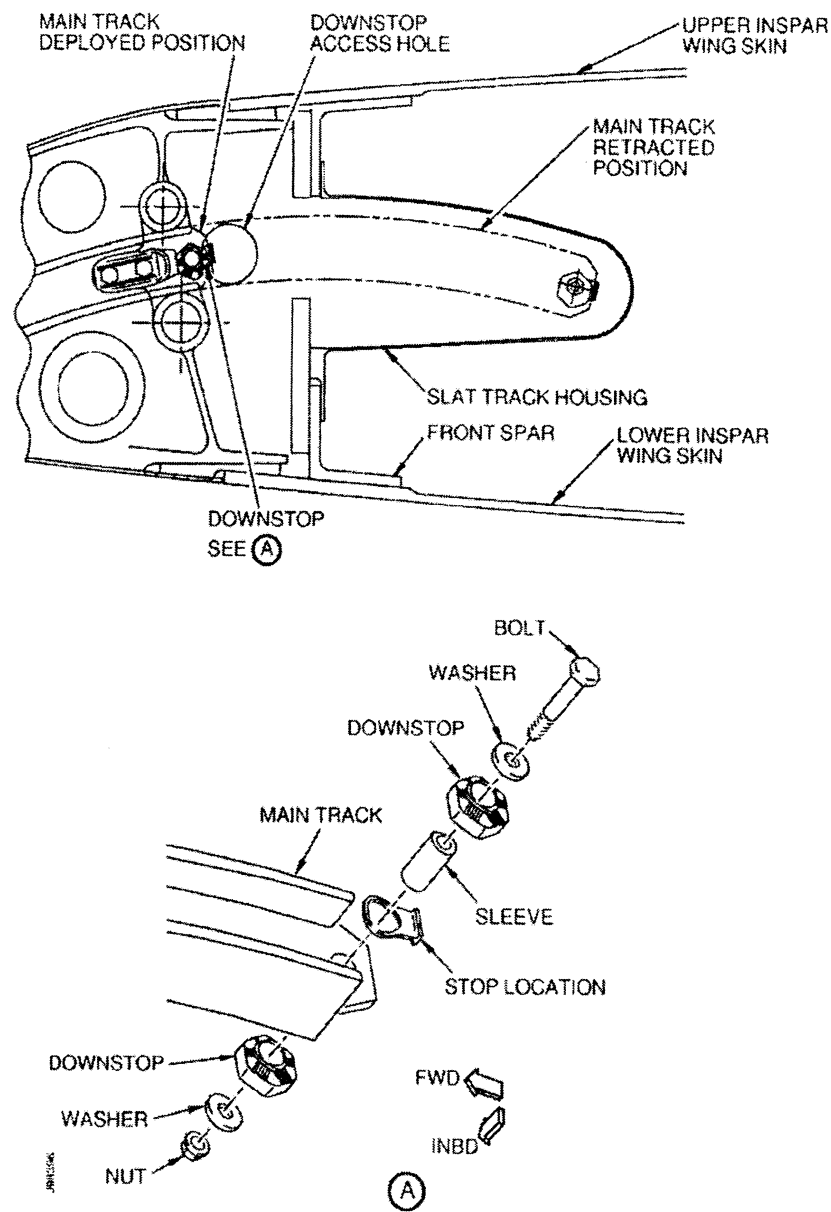
(d) This AD results from additional reports of parts coming off the main slat track downstop assemblies. We are issuing this AD to detect and correct loose or missing parts from the main slat track downstop assemblies, which could result in a fuel leak and consequent fire.

Slat Track Downstop Assembly

(f) Within 10 days after the effective date of this AD: Do a detailed inspection or a borescope inspection of each main slat track downstop assembly to verify proper installation of the slat track hardware (i.e., the bolt, washers, downstops, stop location, and nut shown in Figure 1 of Boeing Service Letter 737-SL-57-084-B, dated July 10, 2007, and in this AD). Proper installation of the sleeve need not be confirmed, and the stop location part may be installed on either the inboard or the outboard side of the slat track. If any part is missing or is installed improperly, before further flight, install a new or serviceable part using a method approved in accordance with the procedures specified in paragraph (h) of this AD; and do a detailed inspection of the inside of the slat can for foreign object debris (FOD) and

(g) Within 24 days after receipt of AD 2007-18-51: Apply a torque between 50 to 80 inch-pounds to the nut. The bolt head must be held with the torque applied to the nut.
