[Docket No. FAA-2009-0484; Directorate Identifier 2008-SW-44-AD; Amendment 39-15924; AD 2009-12-01]

**Airworthiness Directives; Bell Helicopter Textron, Inc. Model 47, 47B, 47B3, 47D, 47D1, 47E, 47G, 47G-2, 47G-2A, 47G-2A-1, 47G-3, 47G-3B, 47G-3B-1, 47G-3B-2, 47G-3B-2A, 47G-4, 47G-4A, 47G-5, 47G-5A, 47H-1, 47J, 47J-2, 47J-2A, and 47K Helicopters**

**ACTION:** Final rule; request for comments.

#### 2009–12–01 Bell Helicopter Textron, Inc.:

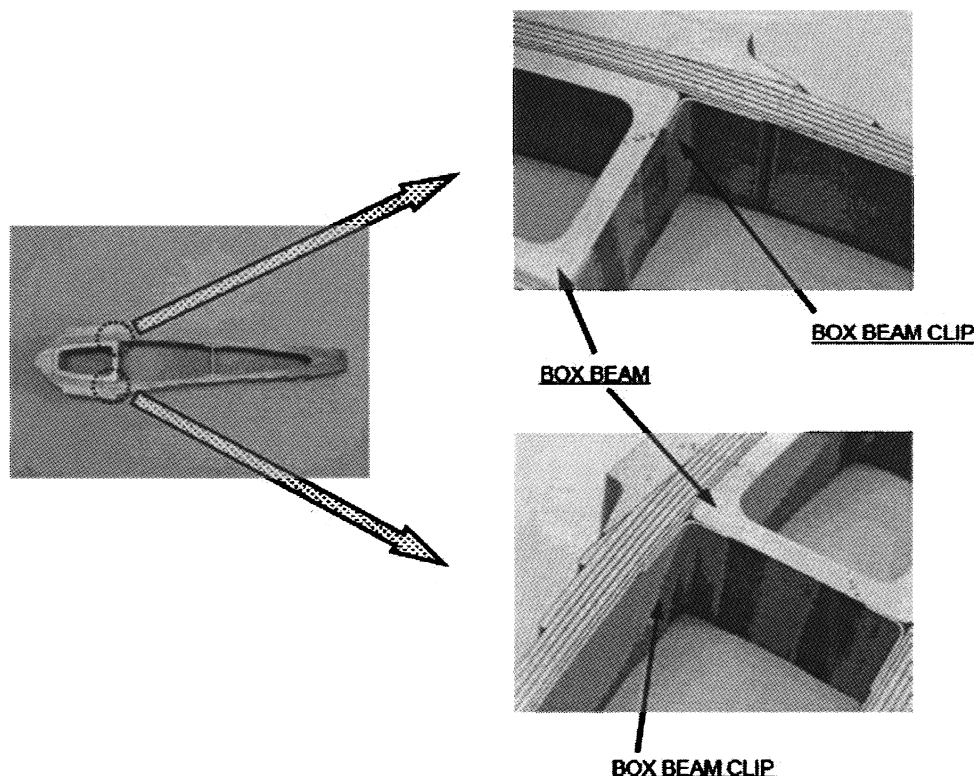
Figure 1 - Correct Installation of Clip for Box Beam

To prevent a main rotor blade spar crack as a result of an incorrectly installed main rotor blade box beam clip (clip), loss of a main rotor blade, and subsequent loss of control of the helicopter, do the following:

(a) Within 10 hours time-in-service (TIS), visually inspect the entire length of each upper and lower clip of each main rotor blade from the main rotor blade tip to the root by following Part II of the Accomplishment Instructions, paragraphs 1. through 8., of Bell Helicopter Textron, Inc. Alert Service Bulletin No. 47–08–25, dated May 26, 2008 (ASB) and referring to the depictions in Figures 1 and 2 of the ASB and Figure 1 of this AD for correct installation.

(b) Before further flight, if you find a main rotor blade with an incorrectly installed clip, replace that unairworthy main rotor blade with an airworthy main rotor blade that has a clip that is installed correctly.
