**Federal Aviation Administration**

[Docket No. FAA-2010-1101; Directorate Identifier 2009-CE-013-AD]

**Airworthiness Directives; Cessna Aircraft Company Models 150, 152, 170, 172, 175, 177, 180, 182, 185, 188, 190, 195, 206, 207, 210, T303, 336, and 337 Airplanes**

**ACTION:** Notice of proposed rulemaking (NPRM).

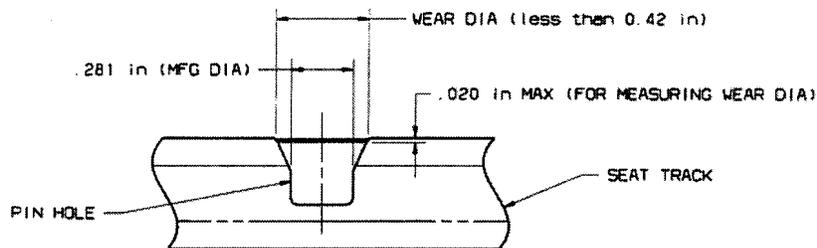
Figure 1. Diameter of seat pin locking engagement hole

(4) Inspect the diameter of each seat locking pin engagement hole in the pilot and copilot seat rails for excessive wear. Due to wear on the rail surface at the hole opening, we allow this measurement 0.020 of an inch

below the surface of the rail. You must take this measurement somewhere between the surface of the rail or no more than 0.020 of an inch below the surface of the rail.

(i) If the diameter of any of the holes is 0.42 of an inch or more (see figure 1), before further flight, replace the rail.

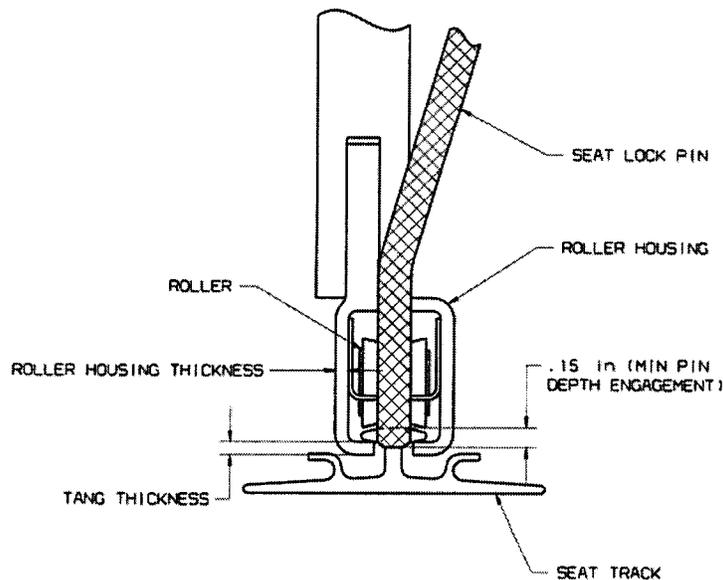
Figure 2. Seat locking pin depth engagement

(2) Lift up the forward edge of each seat to eliminate vertical play of the seat locking pin

in the engagement hole, and from this position, inspect the depth of engagement of each seat locking pin (see figure 2). If the rail is worn, this depth is measured from the worn surface, not the manufactured surface.

(i) If engagement of any of the seat locking pins measures less than 0.15 of an inch, before further flight, replace or repair any seat components necessary to achieve a seat pin engagement of a minimum of 0.15 of an inch.

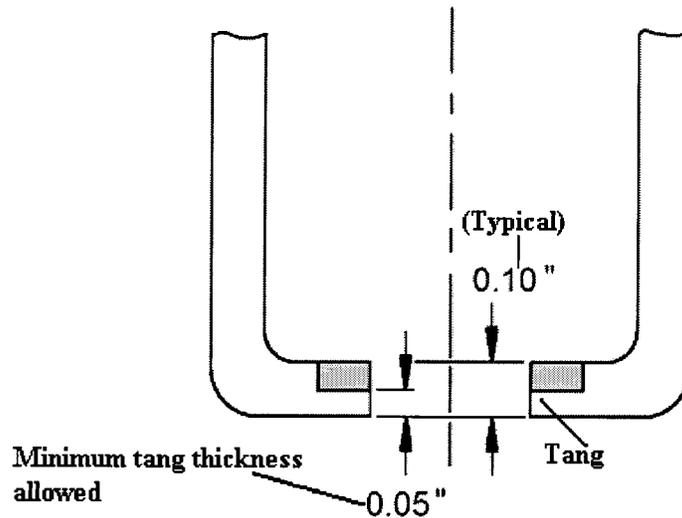
**Figure 3. Closeup of seat roller housing and tang thickness**

(6) Inspect the thickness of the tang (see figure 2 and figure 3). Due to wear of the tang chafing against the seat rail, measure the tang thickness where the tang inner edges contact the seat rail.

(i) If the tang thickness measures less than 0.05 of an inch, before further flight replace the roller housing.

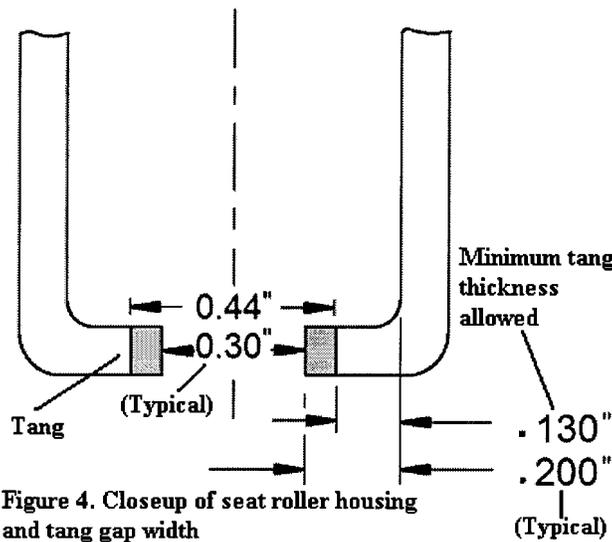
**Figure 4. Closeup of seat roller housing and tang gap width**

(7) Inspect the inner edges of the tangs. Due to wear or deformation of the tangs, measure the distance from one tang inner

edge to the other tang inner edge (see figure 4).

(i) The maximum distance allowed between tang edges is 0.44 inches. If the

distance between tang inner edges measures 0.44 of an inch or more, before further flight, replace the roller housing.

(ii) The minimum measurement allowed for the remaining tang is 0.130 inches remaining on either of the tangs, from the inner edge of the tang to the bend of the roller housing. If the measurement is less than 0.130 inches on either of the tangs, before further flight, replace the roller housing.

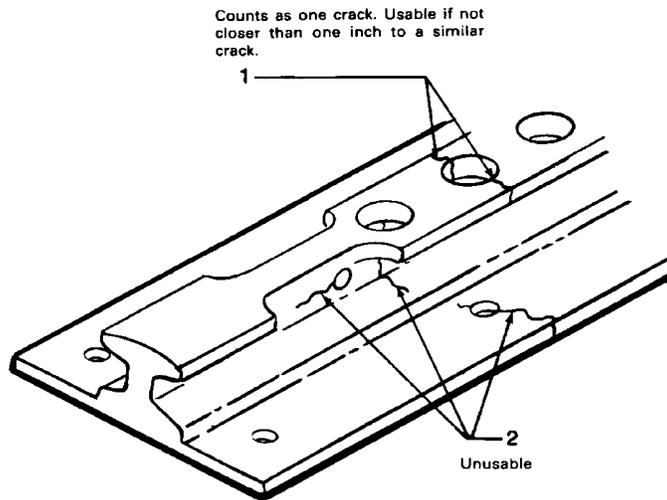
**Figure 5. Seat rail**

(9) Visually inspect the seat rails for cracks.

- (1) Any portion of web or lower flange is cracked (index 2).
- (2) Any crack in crown of rail is in any direction other than right angle to length of rail.
- (3) Number of cracks on any one rail exceeds four, or any two cracks (index 1) are closer than one inch.

(i) If there are seat rail cracks that exceed the crack criteria in figure 5, before further flight, replace the seat rail.

**REPLACE SEAT RAIL WHEN:**
