Airworthiness Directives; Cessna Aircraft Company (Cessna) Models 337, 337A (USAF 02B), 337B, 337C, 337D, 337E, T337E, 337F, T337F, 337G, T337G, M337B, F 337E, FT337E, F 337F, FT337F, F 337G, and FT337GP Airplanes

ACTION: Notice of proposed rulemaking (NPRM).

Cessna Aircraft Company: Docket No. FAA-2011-0450; Directorate Identifier 2011-CE-010-AD.

Appendix 1 to Docket No. FAA–2011–0450**General and Focused Inspection Procedures**

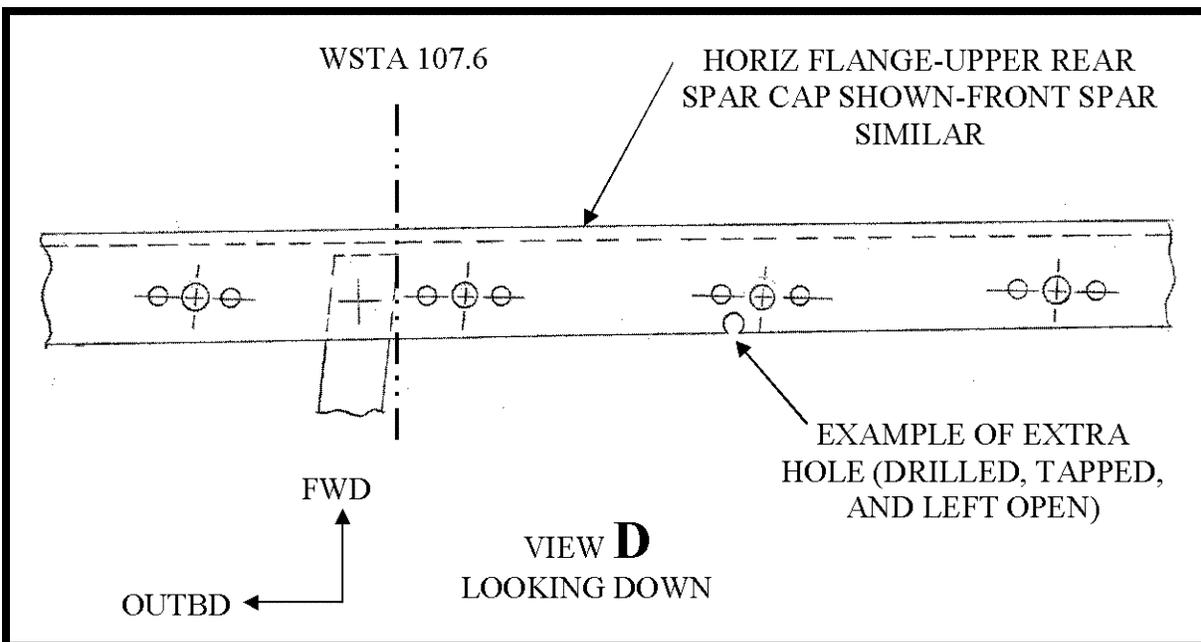
Figure 5

(14) Inspect the upper spar cap horizontal flanges for open holes (See View D, Figure 5).

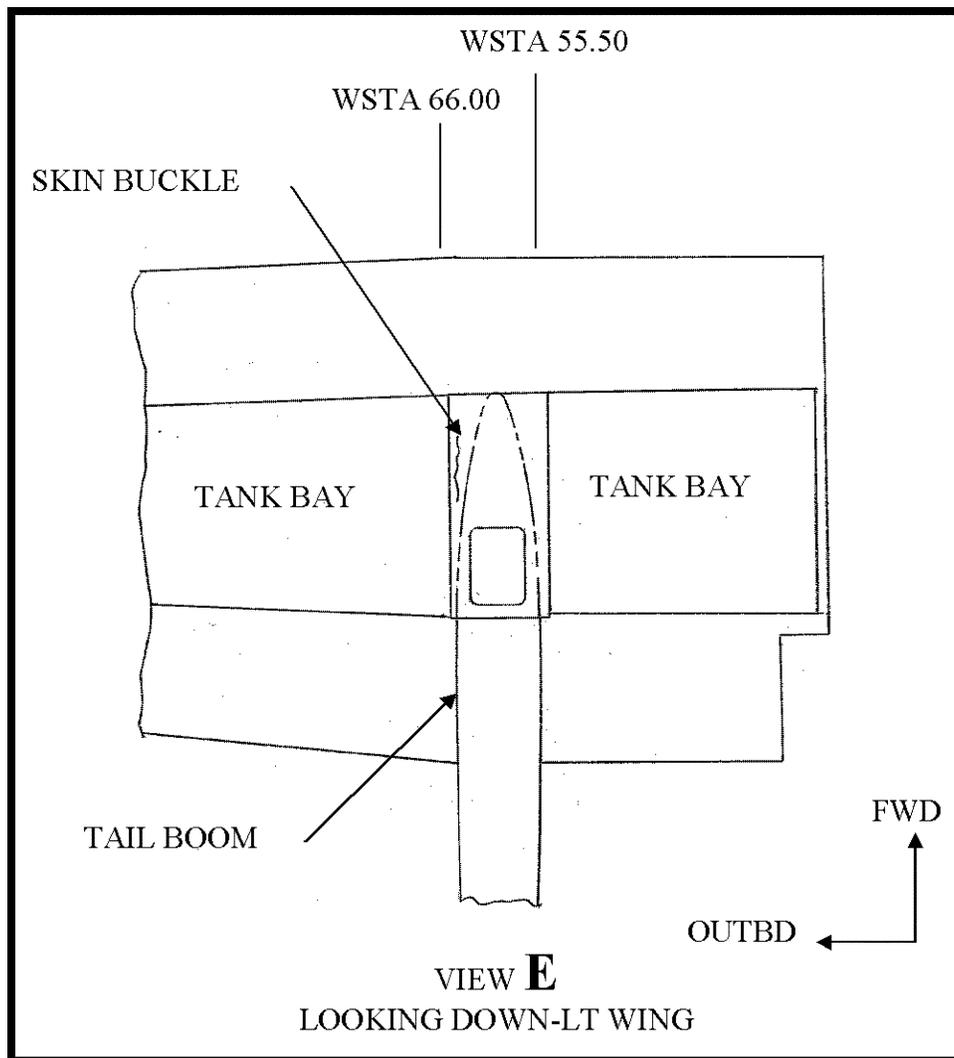
Figure 6

(2) Wrinkles in the upper wing skins from WSTA 55 to 66, adjacent to the booms (See View E, Figure 6).

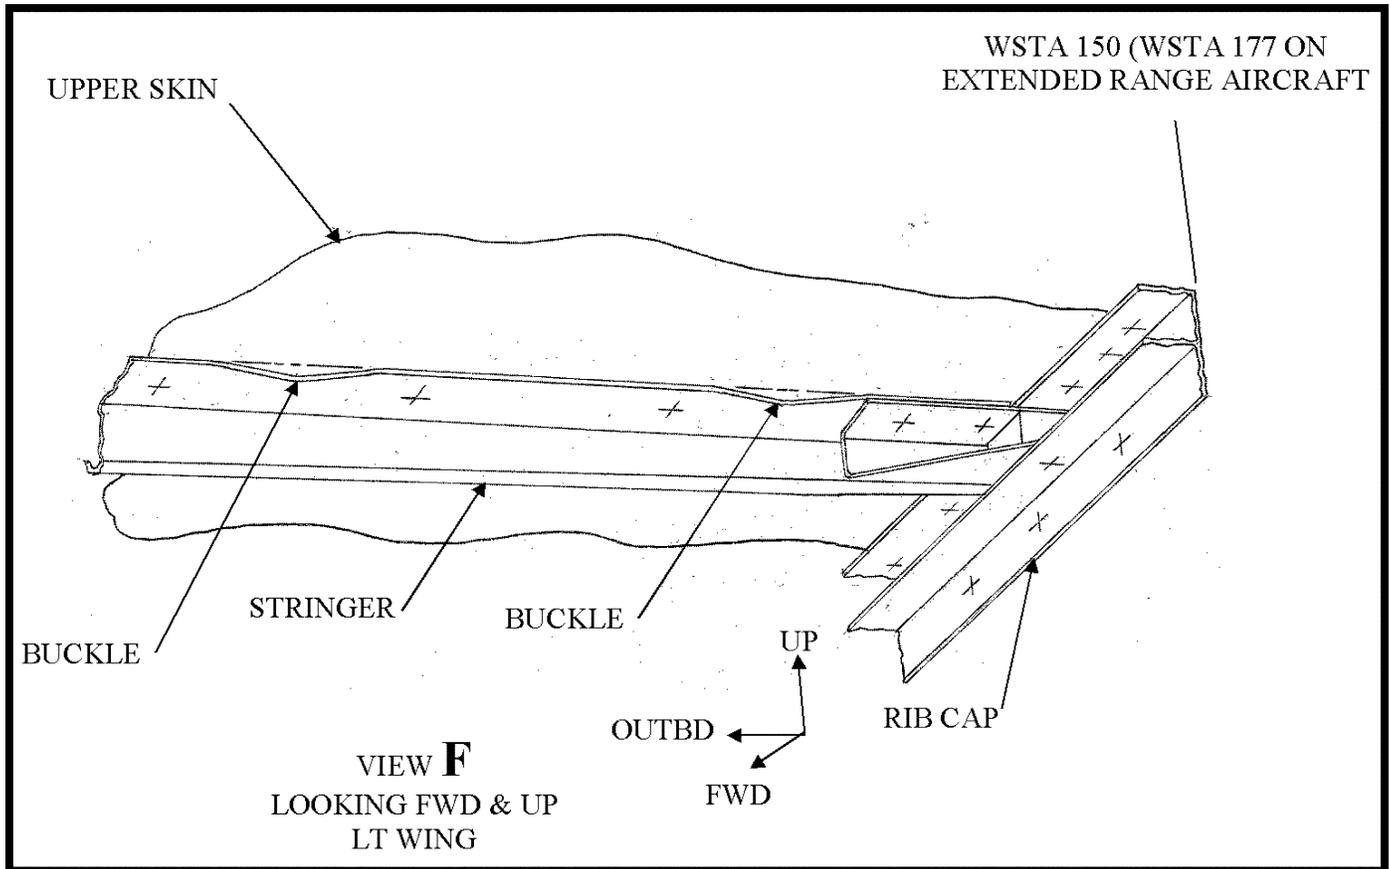
Figure 7

(10) Inter-rivet buckling of the stringers attached to the upper surface skin, outboard of the fuel tank access covers (See View F, Figure 7).
