[Docket No. FAA–2010–1101; Directorate Identifier 2009–CE–013–AD; Amendment 39–16690; AD 2011–10–09]

Airworthiness Directives; Cessna Aircraft Company Models 150, 152, 170, 172, 175, 177, 180, 182, 185, 188, 190, 195, 206, 207, 210, T303, 336, and 337 Airplanes

ACTION: Final rule.

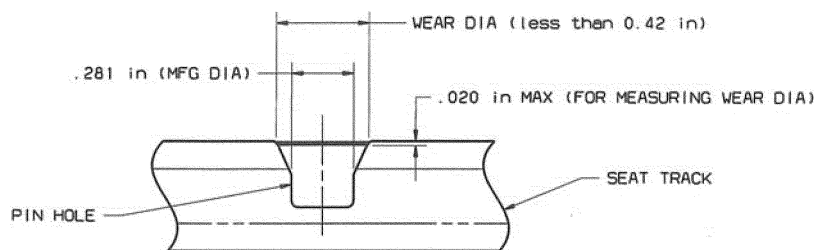
Figure 1. Diameter of seat pin locking engagement hole

(3) Inspect the diameter of each seat locking pin engagement hole in the pilot and copilot seat rails for excessive wear. Due to wear on the rail surface at the hole opening, we allow this measurement 0.020 of an inch below the surface of the rail. You must take this measurement somewhere between the surface of the rail or no more than 0.020 of an inch below the surface of the rail.

(i) If the diameter of any of the holes is 0.42 of an inch or more (see figure 1), before further flight, replace the rail.

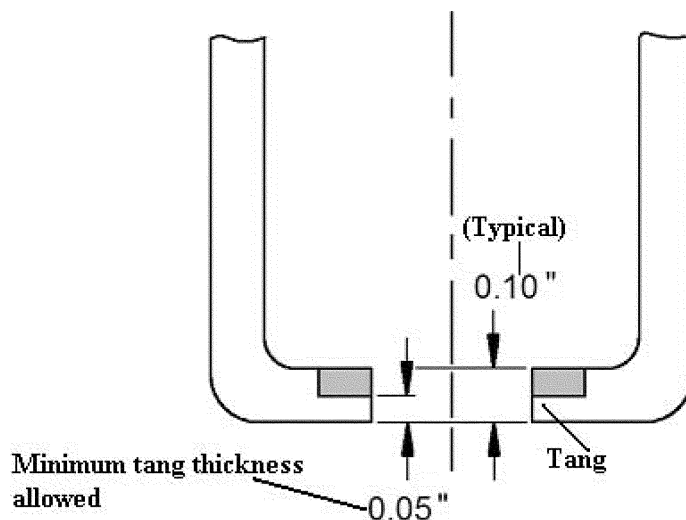
Figure 3. Closeup of seat roller housing and tang thickness

(5) Inspect the thickness of the tang (see figure 2 and figure 3). Due to wear of the tang chafing against the seat rail, measure the tang

(i) If the tang thickness measures less than 0.05 of an inch, before further flight replace the roller housing.

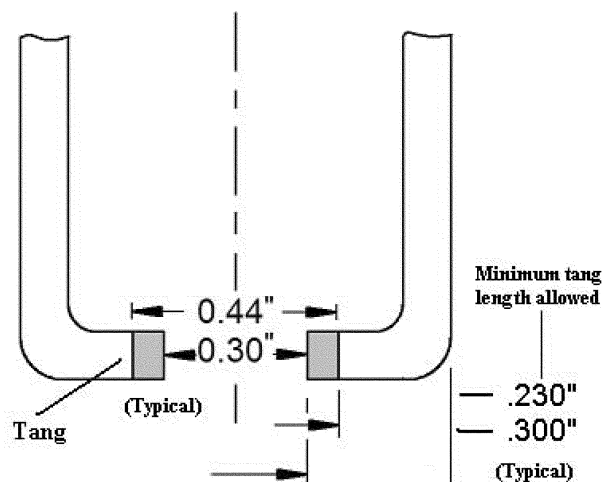
Figure 4. Closeup of seat roller housing and tang gap width

We have changed the callouts in figure 4 to measure the tang length from outside of the roller housing instead of from inside of the roller housing. We have also changed the description of the tang measurement in figure 4 to more accurately describe the measurement.

(6) Due to wear or deformation of the tangs, inspect the tang length from the inner edge of the tang to the outer edge (the bend area) of the roller housing (see figure 4).

(i) The minimum measurement allowed for the remaining tang length is 0.230 inches remaining on either of the tangs, from the inner edge of the tang to the outer edge (the bend area) of the roller housing. If the measurement is less than 0.230 inches on either of the tangs, before further flight, replace the roller housing.
