[Docket No. FAA–2012–0415; Directorate Identifier 2008–SW–065–AD]

#### Airworthiness Directives; Bell Helicopter Textron, Incorporated Helicopters

**SUMMARY:** We propose to supersede an existing airworthiness directive (AD) for Bell Helicopter Textron, Inc. (BHTI) Model 204B, 205A, 205A–1, 205B, and 212 helicopters. The existing AD currently requires conducting various inspections associated with the main rotor grip (grip). If a crack is found, that AD requires replacing the grip before further flight. If delamination of the buffer pad on the grip tang inner surface is found, that AD requires inspecting the grip surface for corrosion or other damage and repairing or replacing the grip if corrosion or other damage is found. That AD also requires determining and recording the hours time-in-service (TIS) and the engine start/stop cycles for each grip on a component history card or equivalent record. Additionally, that AD requires you to report certain inspection results to the FAA. Since we issued that AD, additional cracks in grips have been found. Analysis of these events has shown that a retirement life is needed for certain grips, and the AD

**Bell Helicopter Textron, Inc. (BH

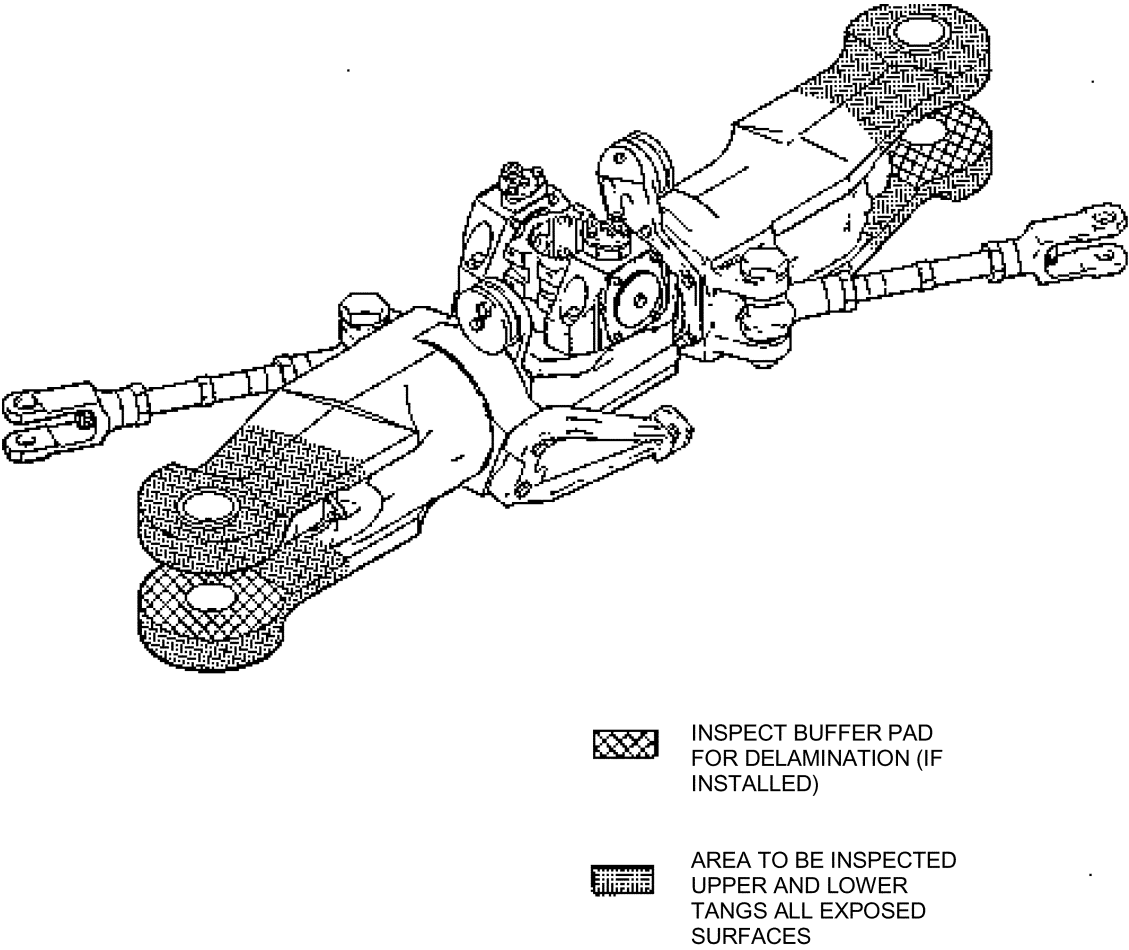
Figure 1. Inspection of Main Rotor Hub Grip Tangs

- (i) Clean the exposed surfaces of the upper and lower tangs of each grip with denatured alcohol, and wipe dry.
- (ii) Using a 10-power or higher magnifying glass, visually inspect the exposed surfaces of the upper and lower tangs of each grip for a crack. Pay particular attention to the lower surface of each lower grip tang from the main rotor blade bolt-bushing flange to the leading and trailing edge of each grip tang. See Figure 1 of this AD.

- (i) Remove each main rotor blade, and
- (ii) Inspect each grip buffer pad on the inner surfaces of each grip tang for delamination (see Figure 1 of this AD). If there is any delamination, remove the buffer pad and inspect the grip surface for corrosion or other damage.

- (i) Replace any cracked grip with an airworthy grip.
- (ii) Replace any grip with any corrosion or other damage with an airworthy grip, or repair the grip if the corrosion or other damage is within the maximum repair damage limitations found in the applicable Component and Repair Overhaul Manual.
- (iii) Replace any grip, P/N 204-011-121-009 or ASI-4011-121-9, which has been in service for 15,000 or more hours TIS.
- (iv) Replace any grip, P/N 204-011-121-121, which has been in service for 25,000 or more hours TIS.
