**[Docket No. FAA-2012-1135; Directorate Identifier 2012-SW-097-AD; Amendment 39-17281; AD 2012-21-52]**

#### **Airworthiness Directives; Agusta S.p.A. (Type Certificate Currently Held by AgustaWestland S.p.A.) (Agusta) Helicopters**

**ACTION:** Final rule; request for comments.

**SUMMARY:** We are publishing a new airworthiness directive (AD) for Agusta Model AW139 helicopters, which was sent previously to all known U.S. owners and operators of these

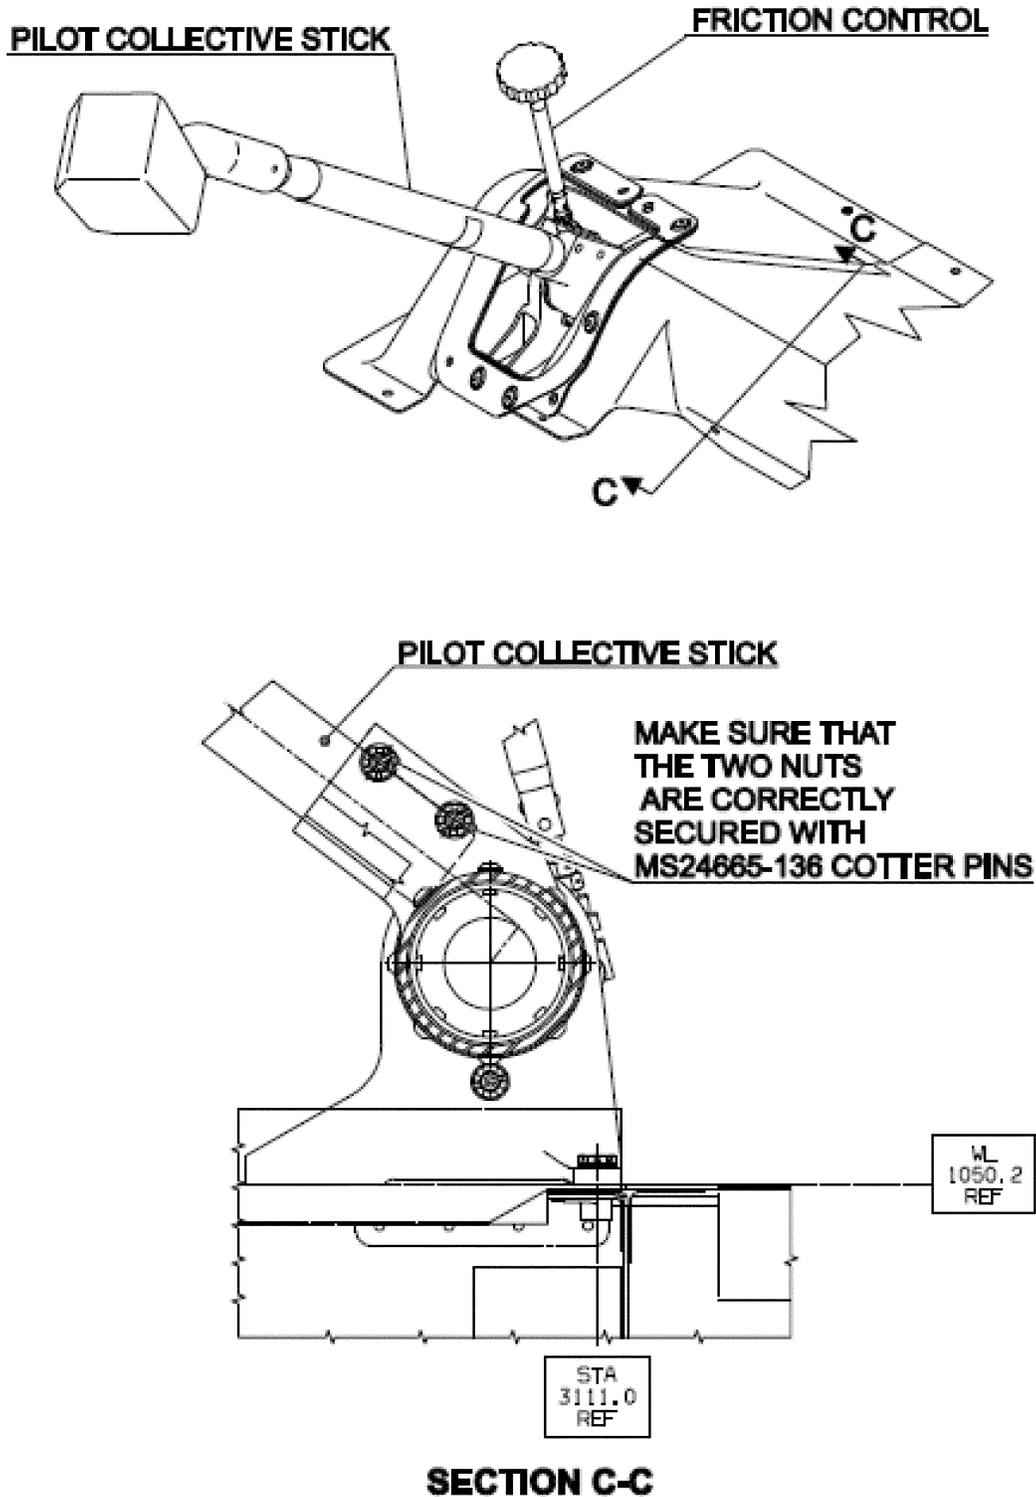
(1) Inspect the pilot collective stick installation to determine whether the self-locking nuts, part-number (P/N) MS17825–4, are secured with cotter pins, P/N MS24665–136, as depicted in Figure 1 to paragraph (e) of this AD. If the self-locking nuts are not secured with cotter pins, before further flight, reinstall the pilot collective stick.

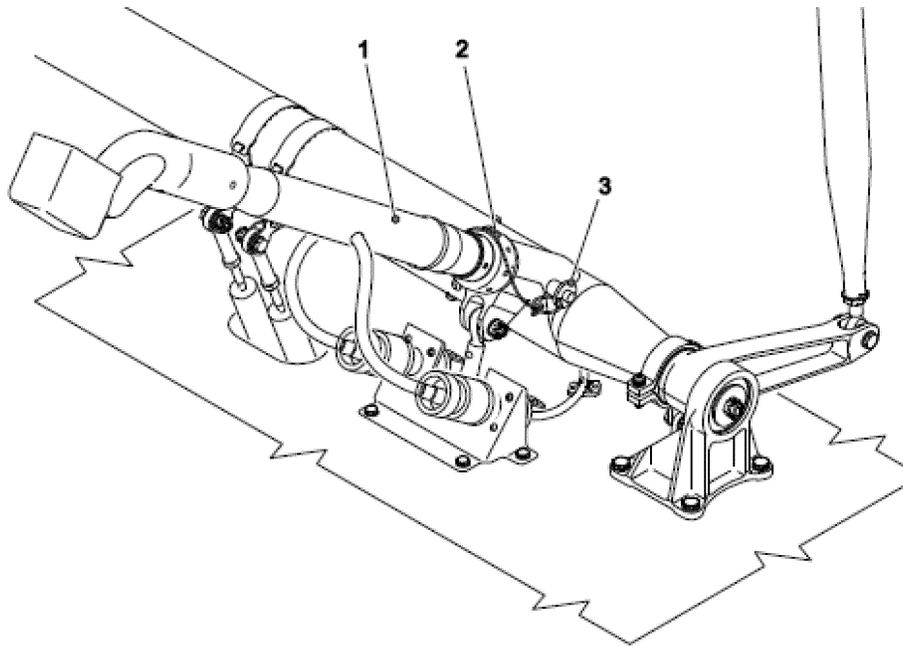
(2) Inspect the co-pilot collective stick installation to determine whether the ring nut (item 2) is loose and the quick-release pin

(item 3) is installed as depicted in Figure 2 to paragraph (e) of this AD. If the ring nut is loose or the quick-release pin is not installed,

before further flight, reinstall the co-pilot collective stick.

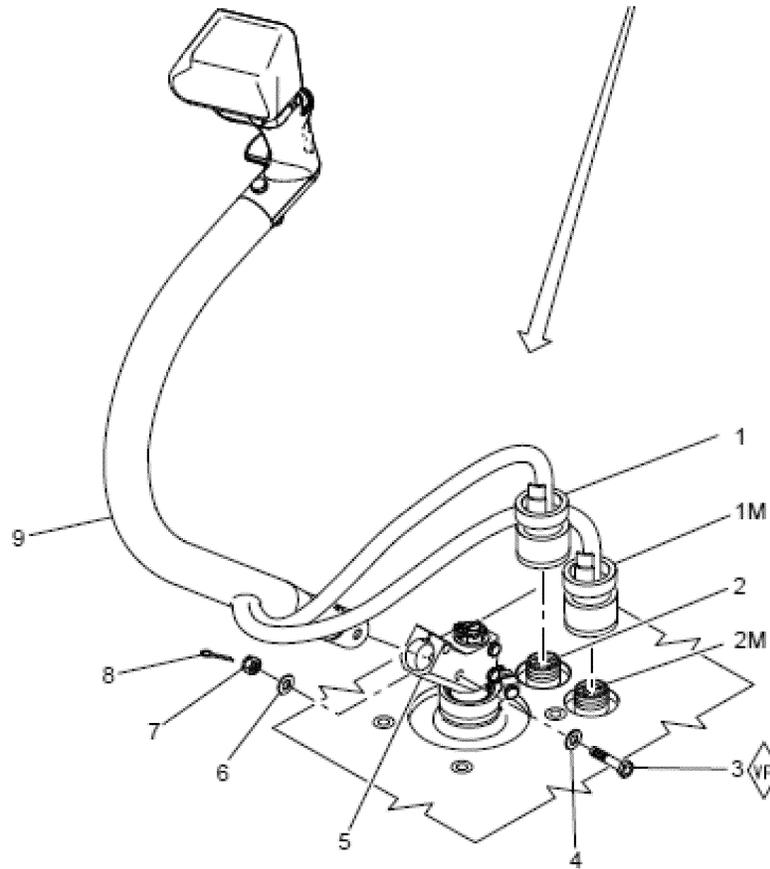
(3) Inspect the pilot cyclic stick installation for proper installation of the bolt (item 3), washer (item 4), self-locking nut (item 7),

washer (item 6), and the cotter pin (item 8), as depicted in Figure 3 to paragraph (e) of this AD. If the pilot cyclic stick is not

installed as depicted, before further flight, reinstall the pilot cyclic stick.

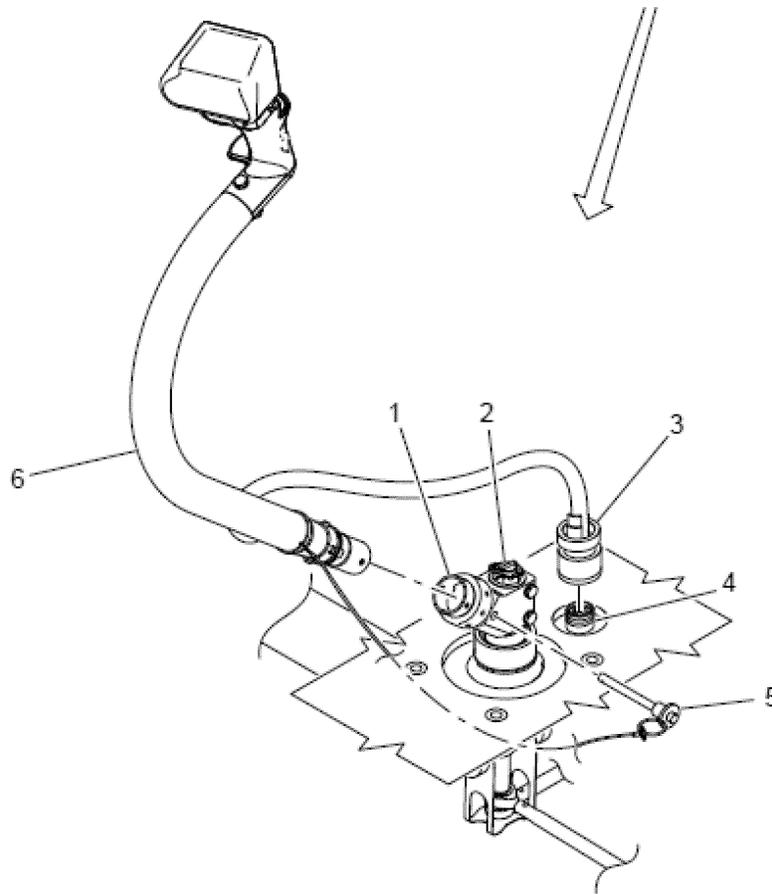
(4) Inspect the co-pilot cyclic stick installation to determine whether the ring nut (item 1) is loose and the quick-release pin

(item 5) is installed as depicted in Figure 4 to paragraph (e) of this AD. If the ring nut is loose or the quick-release pin is not installed

as depicted, before further flight, reinstall the co-pilot cyclic stick.
