Federal Register

[Docket No. FAA-2011-1231; Directorate Identifier 2011-NM-088-AD; Amendment 39-17418; AD 2013-08-01]

Airworthiness Directives; The Boeing Company Airplanes

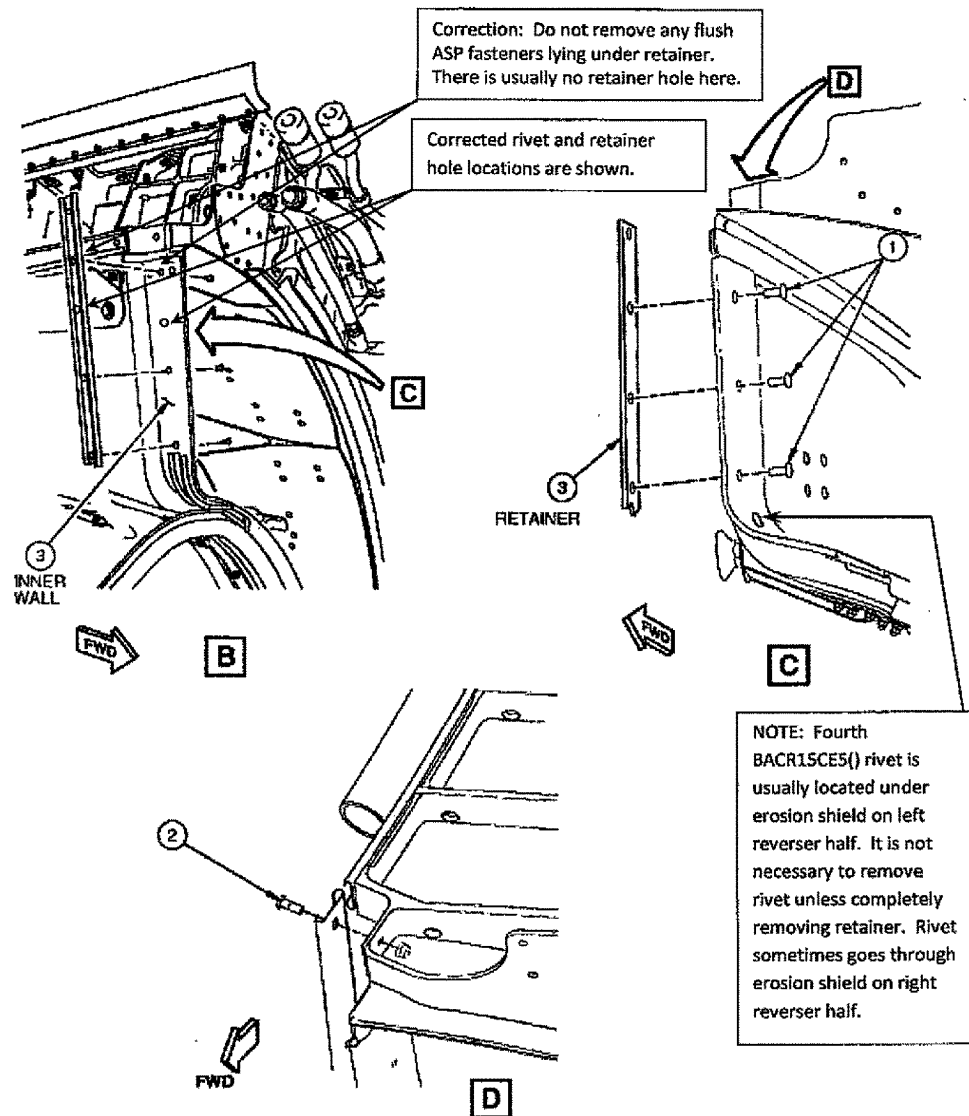
Figure 1, Fastener Removal of the Retainer Support on the Left Thrust Reverser Half

(2) Figures 1 and 3 of this AD, titled “Fastener Removal of the Retainer Support on the Left (Right) Thrust Reverser Half,” have View B showing the top fastener in the center of three adjustable sustained preload (ASP) fasteners. That top fastener does not require removal in order to remove the retainer. The figures in this AD point to the correct information for those fasteners.

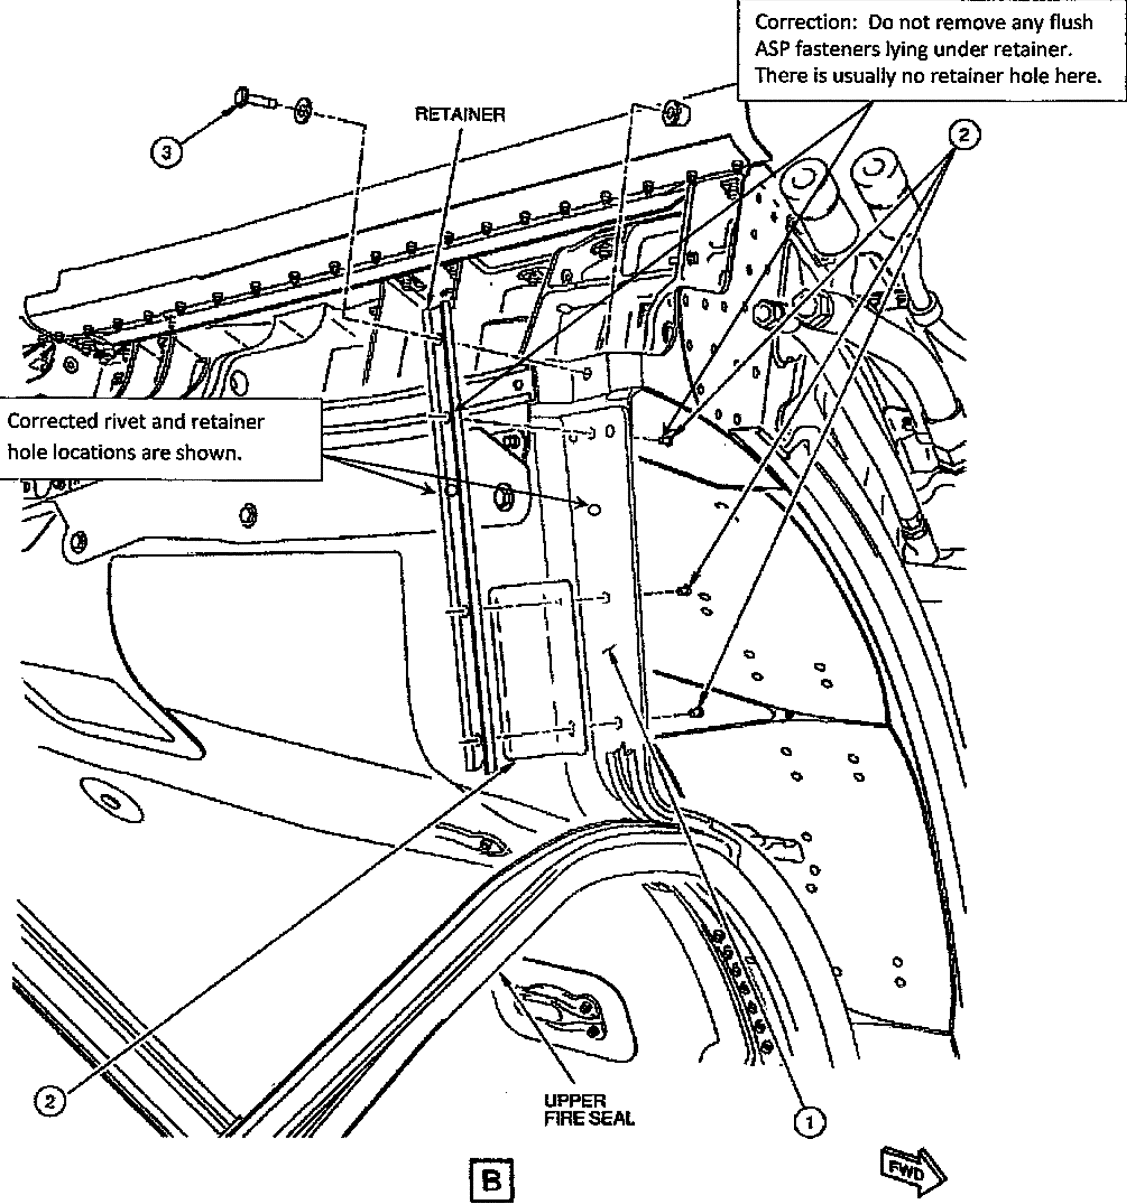
Figure 2, Installation of the New Bracket behind the Retainer Support on the Left Thrust Reverser Half

(3) Figures 2 and 4 of this AD, titled “Installation of the New Bracket behind the Retainer Support on the Left (Right) Thrust Reverser Half,” have View B showing the top rivet hole. That rivet hole is actually below the row of three ASP fasteners. The figures in this AD point to the correct information for those rivet holes.
