[Docket No. FAA-2013-0486; Directorate Identifier 2010-SW-031-AD]

#### Airworthiness Directives; MD Helicopters, Inc. (MDHI), Helicopters

**ACTION:** Notice of proposed rulemaking (NPRM).

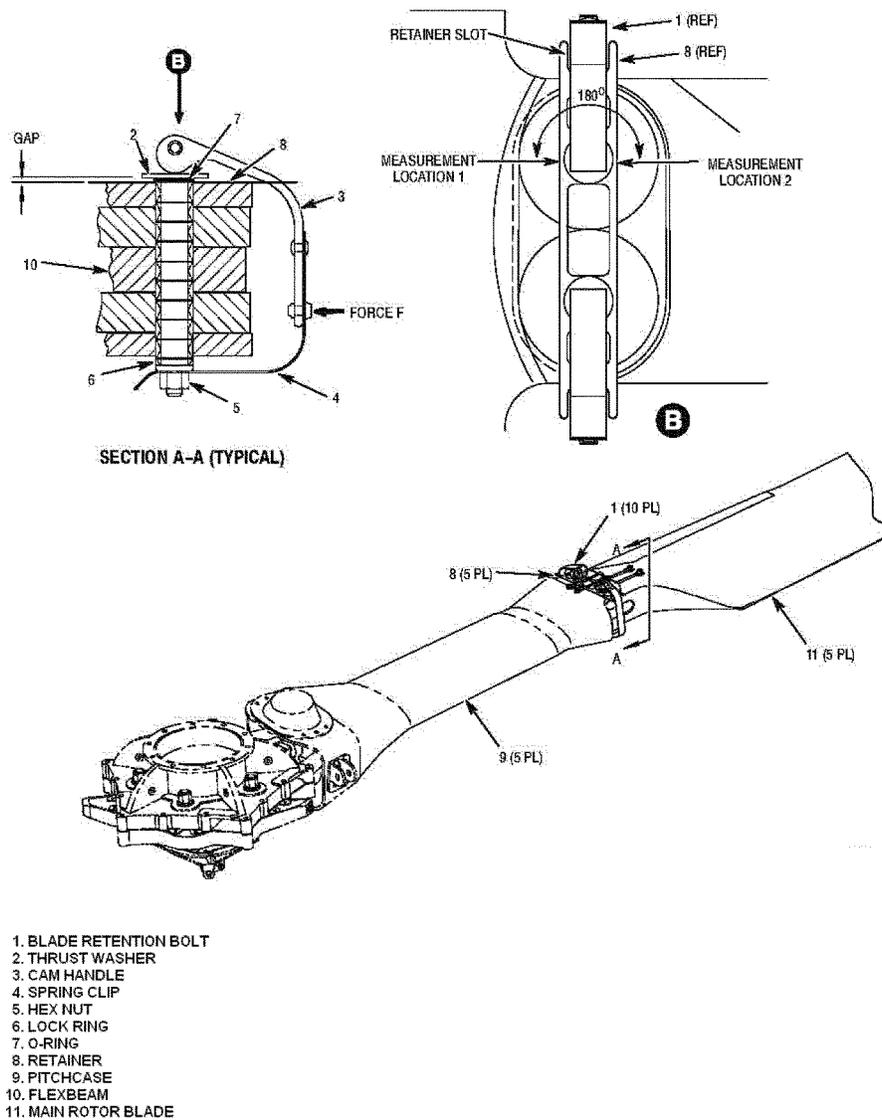
Figure 1 to paragraph (e) of this AD

- (1) Before the first flight of each day:
  - (i) Visually check each bolt for failure. Failure of a bolt may be indicated by movement of the bolt out of the bolt hole or by inconsistent extension of the bolt above or below the other bolts being inspected (a failed bolt migrates out of the bolt hole).
  - (ii) Visually check for a gap between the thrust washer and the retainer, P/N 900R2100009–101 or –103. The thrust washer is depicted as item 2 and the retainer is depicted as item 8 in Figure 1 to paragraph (e) of this AD.

(iv) If there is any indication of bolt failure or if there is no gap between the thrust washer and retainer, before further flight, remove and inspect the bolt for a crack.

Replace any cracked bolt with an airworthy bolt.

(iii) If there is a gap between the thrust washer and retainer, measure the gap in two locations, 180 degrees apart, with a feeler gage. If the gap is more than 0.100 inch (2.54 mm) at either location, before further flight, remove and inspect the bolt for a crack. Replace any cracked bolt with an airworthy bolt.
