[Docket No. FAA-2013-0822; Directorate Identifier 2013-SW-004-AD]

Airworthiness Directives; Eurocopter France Helicopters

ACTION: Notice of proposed rulemaking (NPRM).

Eurocopter France: Docket No. FAA–2013–0822; Directorate Identifier 2013–SW–004–AD.

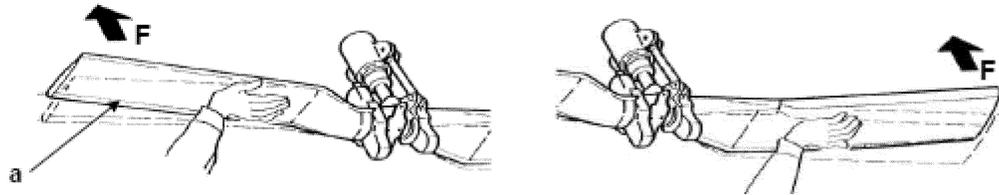
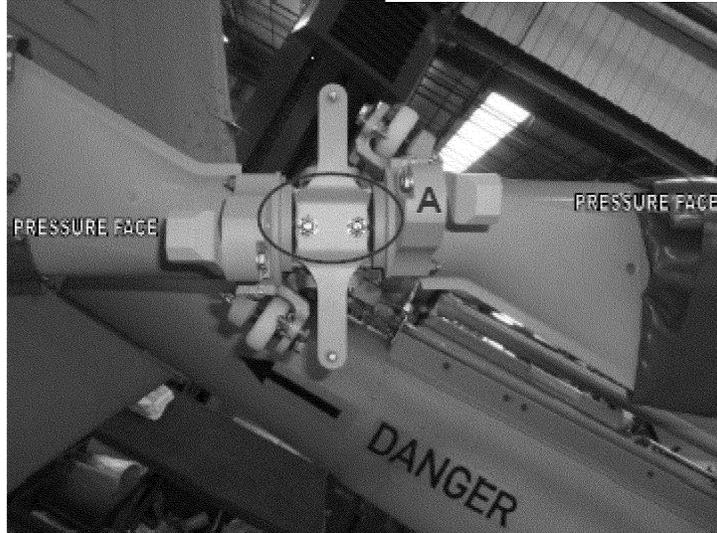
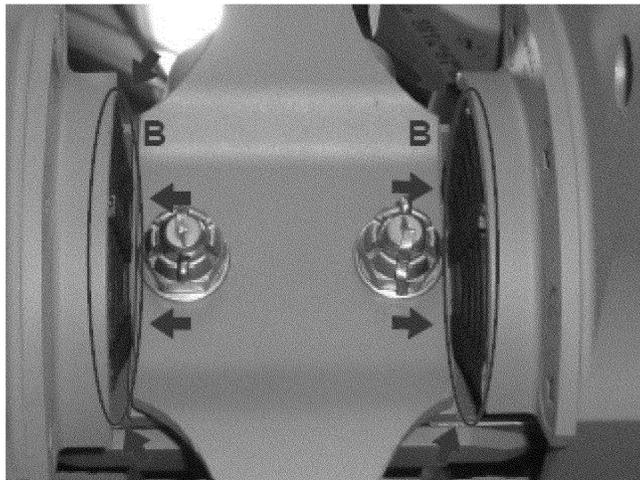
(B) Apply load (F) by hand, perpendicular to the pressure face of one tail rotor blade (a), as shown in Figure 1 to paragraph (f) of this AD, taking care not to reach the extreme position against the tail rotor hub. The load will deflect the tail rotor blade towards the tail boom.

(C) While maintaining the load, check all the visible faces of the bearings (front and side faces) in area B of DETAIL A of Figure 1 to paragraph (f) of this AD for separation between the elastomer and metal parts, a crack in the elastomer, or an extrusion (see example in Figure 2 to paragraph (f) of this AD). A flashlight may be used to enhance the check.

(v) If there is an extrusion on any bearing, before further flight, replace the four bearings with airworthy bearings.

(vi) If there is a separation or a crack on the pressure side bearing, measure the separation or the crack. If the separation or crack is greater than 5 millimeters (.196 inches) as indicated by dimension “L” in Figure 4 to paragraph (f) of this AD, before further flight, replace the four bearings with airworthy bearings.

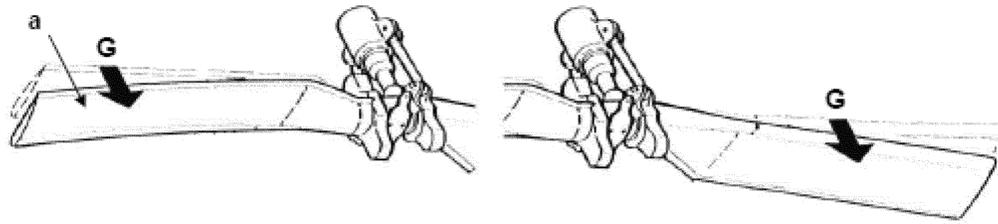
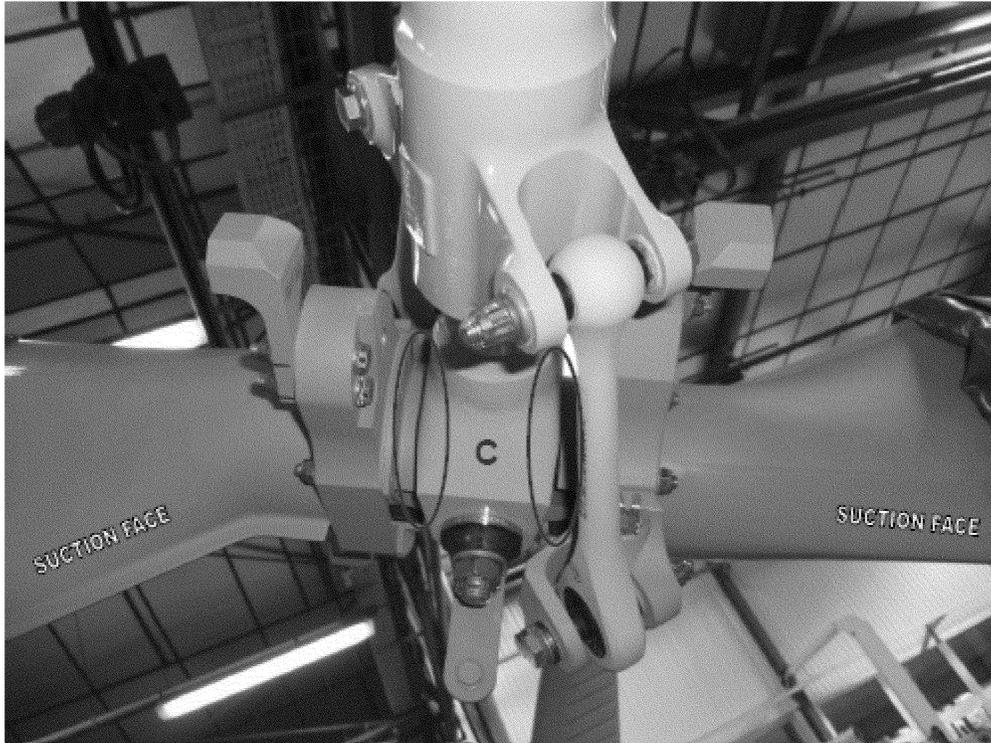
(E) Apply load (G) by hand perpendicular to the suction face of one tail rotor blade as shown in Figure 3 to paragraph (f) of this AD.

(F) While maintaining the load, check visible faces of Area C as shown in Figure 3 to paragraph (f) of this AD for any extrusion. A flashlight may be used to enhance the check.

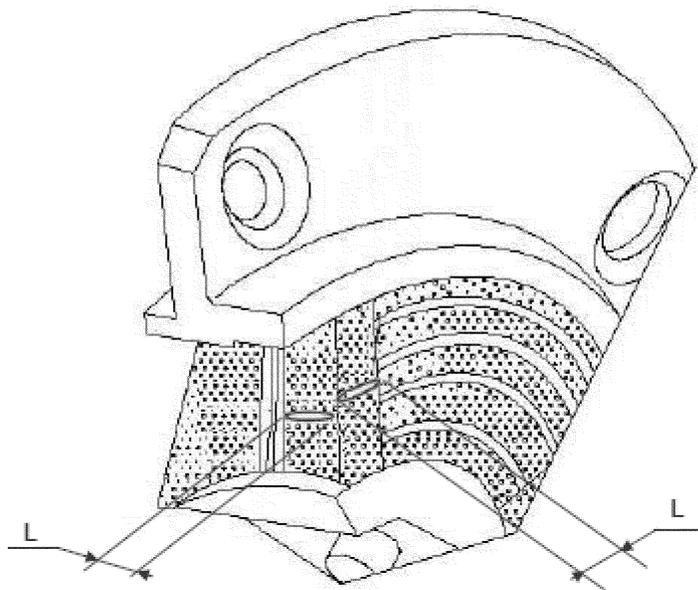
Figure 4 to paragraph (f)

(iii) If there is a separation or a crack on the bearing, measure the separation or the crack. If the separation or crack is greater than 5 mm (.196 inches) as indicated by dimension "L" and greater than 2 mm (.078 inches) as indicated by dimension "P" in Figure 3 of Eurocopter Emergency Alert Service Bulletin (EASB) No. 05.00.71 or No. 05.00.63, both Revision 2 and both dated December 19, 2012, as required for your model helicopter, before further flight, replace the bearing.
