[Docket No. FAA-2013-0486; Directorate Identifier 2010-SW-031-AD; Amendment 39-17622; AD 2013-20-16]

#### Airworthiness Directives; MD Helicopters, Inc. (MDHI) Helicopters

**2013–20–16 MD Helicopters, Inc. (MDHI):**  
Amendment 39–17622; Docket No.  
FAA–2013–0486; Directorate Identifier  
2010–SW–031–AD.

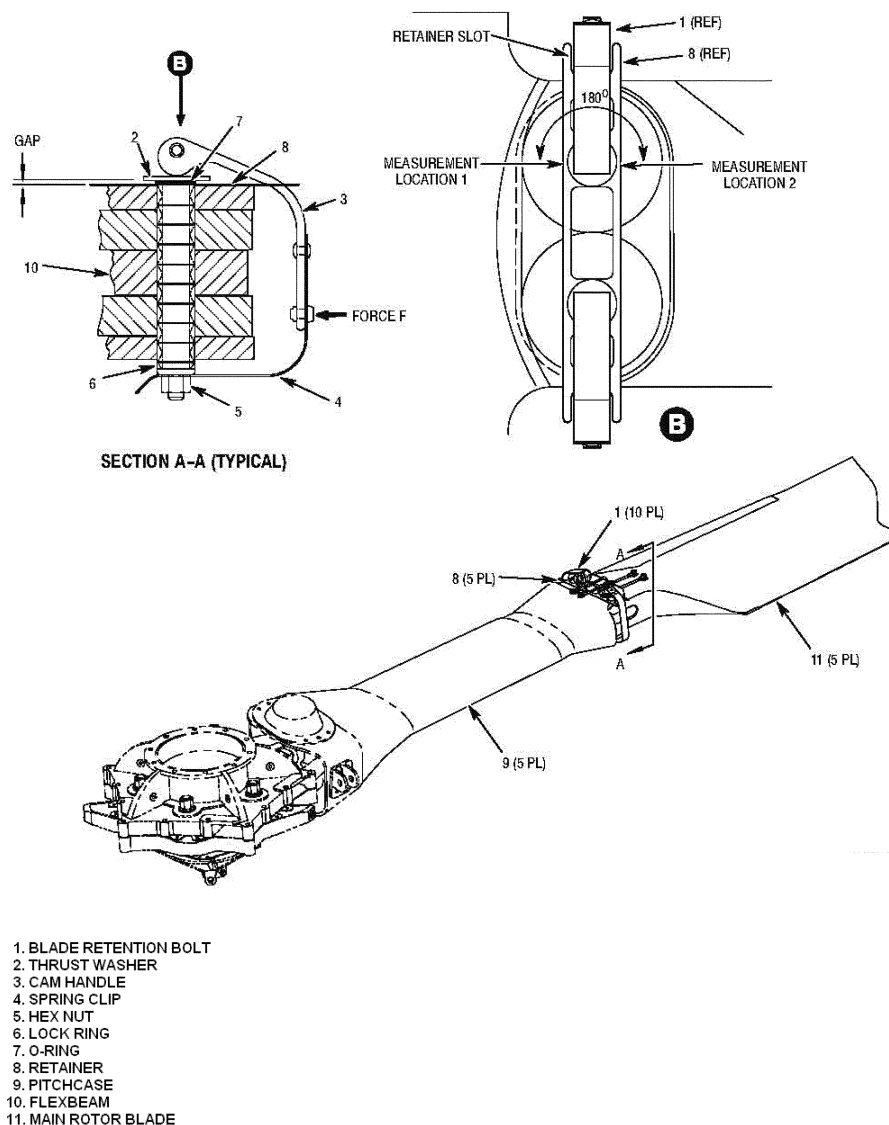
Figure 1 to Paragraph (e)  
Gap and Force Check of the Blade Retention Bolts

This AD defines the unsafe condition as bolt failure. This condition could result in loss of main rotor blade structural integrity and subsequent loss of control of the helicopter.

- (1) Before the first flight of each day:
  - (i) Visually check each bolt for failure. Failure of a bolt may be indicated by movement of the bolt out of the bolt hole or by inconsistent extension of the bolt above or below the other bolts being inspected (a failed bolt migrates out of the bolt hole).
  - (ii) Visually check for a gap between the thrust washer and the retainer, P/N 900R2100009–101 or –103. The thrust washer is depicted as item 2 and the retainer is depicted as item 8 in Figure 1 to paragraph (e) of this AD.

(iv) If there is any indication of bolt failure or if there is no gap between the thrust washer and retainer, before further flight, remove and inspect the bolt for a crack. Replace any cracked bolt with an airworthy bolt.

(iii) If there is a gap between the thrust washer and retainer, measure the gap in two locations, 180 degrees apart, with a feeler gage. If the gap is more than 0.100 inch (2.54 mm) at either location, before further flight,

remove and inspect the bolt for a crack. Replace any cracked bolt with an airworthy bolt.
