Federal Register

Wednesday, March 9, 2016

[Docket No. FAA-2015-3149; Directorate Identifier 2015-NM-014-AD; Amendment 39-18394; AD 2016-03-07]

#### Airworthiness Directives; Airbus Airplanes

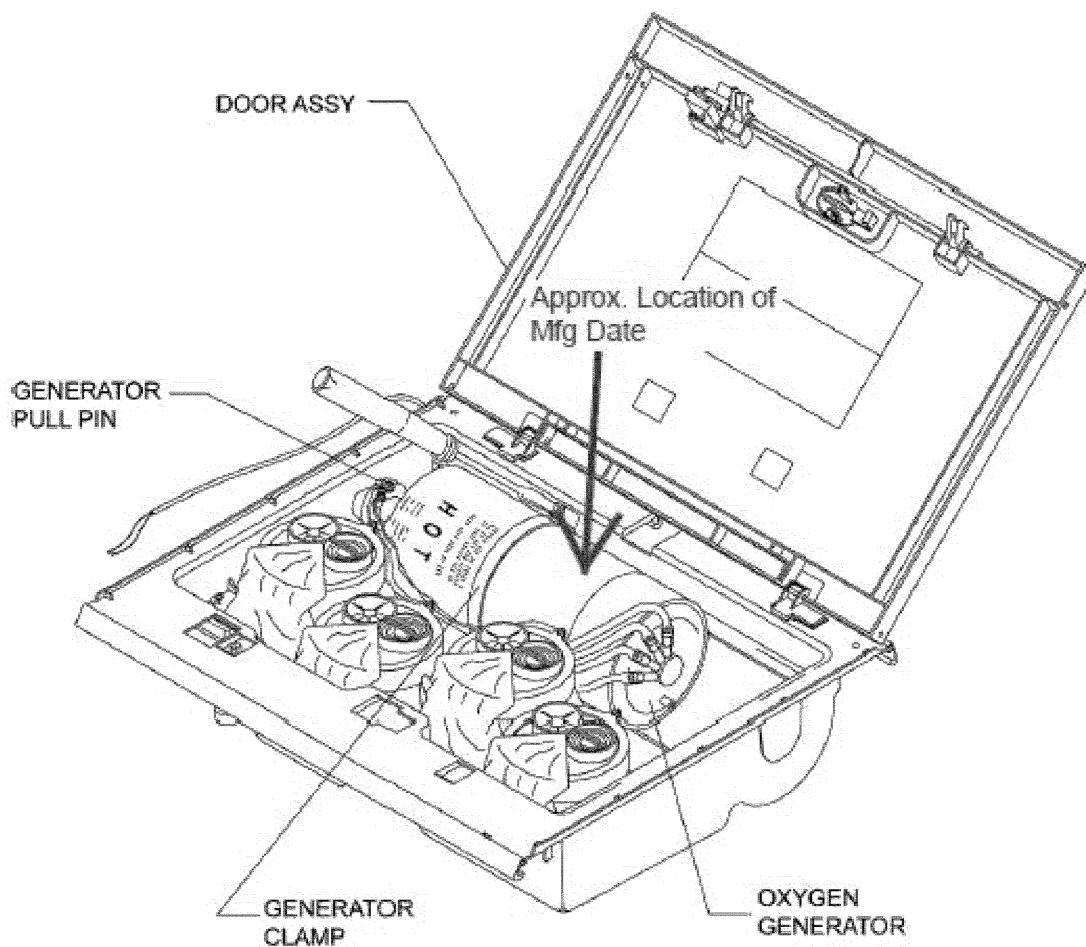
**Figure 1 to paragraph (g) of this AD - Location of date (MM-YY)**

Within 30 days after the effective date of this AD: Inspect each passenger chemical oxygen generator to identify the date of manufacture (refer to figures 1 and 2 to paragraph (g) of this AD for the location of the date) of each passenger chemical oxygen generator having any part number (P/N) listed in paragraphs (g)(1) through (g)(6) of this AD, in accordance with the Instructions of Airbus Alert Operators Transmission (AOT) A35L007-14, Revision 01, June 17, 2015, including Appendix A, Revision 01,

If, during any inspection required by paragraph (g) of this AD, any passenger chemical oxygen generator having a date of manufacture of 1999, 2000, or 2001 is found: At the time specified in paragraph (h)(1), (h)(2), or (h)(3) of this AD, as applicable, replace the affected passenger chemical oxygen generator, in accordance with the Instructions of Airbus AOT A35L007-14, Revision 01, June 17, 2015; including Appendix A, Revision 01, dated June 17, 2015 (for 15- and 22-minute passenger chemical oxygen generators); or in accordance with the Accomplishment Instructions of B/E Aerospace Service Bulletin 117042-35-001, dated December 10, 2014 (for 15-minute passenger chemical oxygen generators).

If, during any inspection required by paragraph (g) of this AD, any passenger chemical oxygen generator having a date of manufacture of 2002 or later is found: At the time specified in paragraph (i)(1), (i)(2), (i)(3), (i)(4), (i)(5), (i)(6), (i)(7), or (i)(8) of this AD, as applicable, replace the affected passenger chemical oxygen generator with a serviceable unit, in accordance with the Instructions of Airbus AOT A35L007-14, Revision 01, June 17, 2015; including Appendix A, Revision 01, dated June 17, 2015 (for 15- and 22-minute passenger chemical oxygen generators); or in accordance with the Accomplishment Instructions of B/E Aerospace Service Bulletin 117042-35-001, dated December 10, 2014 (for 15-minute passenger chemical oxygen generators).

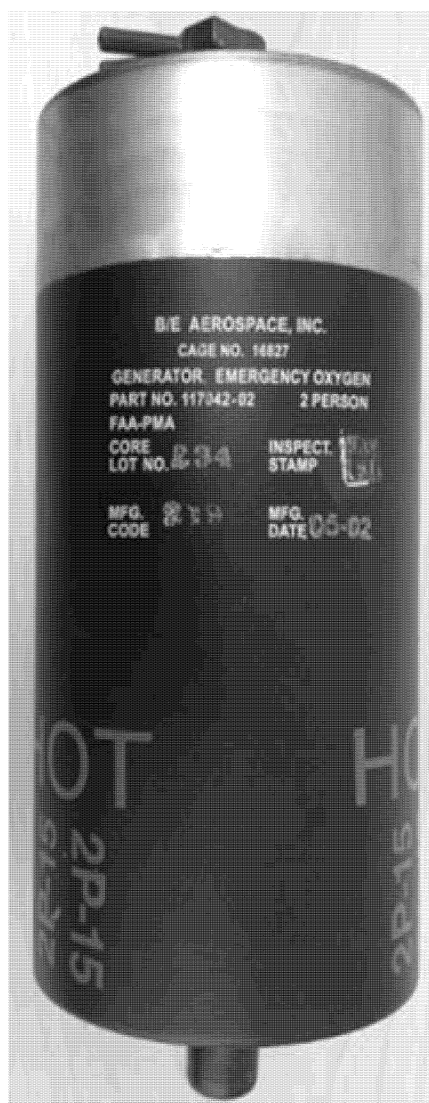
**Figure 2 to paragraph (g) of this AD – Manufacturing (MFG.) date (05-02 = May 2002) example**

Airbus asked that we remove the operator identification from the chemical oxygen generator pictured in Figure 2 to paragraph (g) of the proposed AD (80 FR 52419, August 31, 2015). Airbus stated that Figure 2 to paragraph (g) should replicate Figure 2

We agree with the commenter for the reason provided. We have changed the oxygen generator picture in Figure 2 to paragraph (g) of this AD accordingly.
