Airworthiness Directives; Bombardier Model CL-600-2C10 (Regional Jet Series 700, 701, & 702) Airplanes, Model CL-600-2D15 (Regional Jet Series 705) Airplanes, and Model CL-600-2D24 (Regional Jet Series 900) Airplanes

ACTION: Notice of proposed rulemaking (NPRM).

Docket No. FAA-2006-24074;
Directorate Identifier 2005-NM-213-AD.

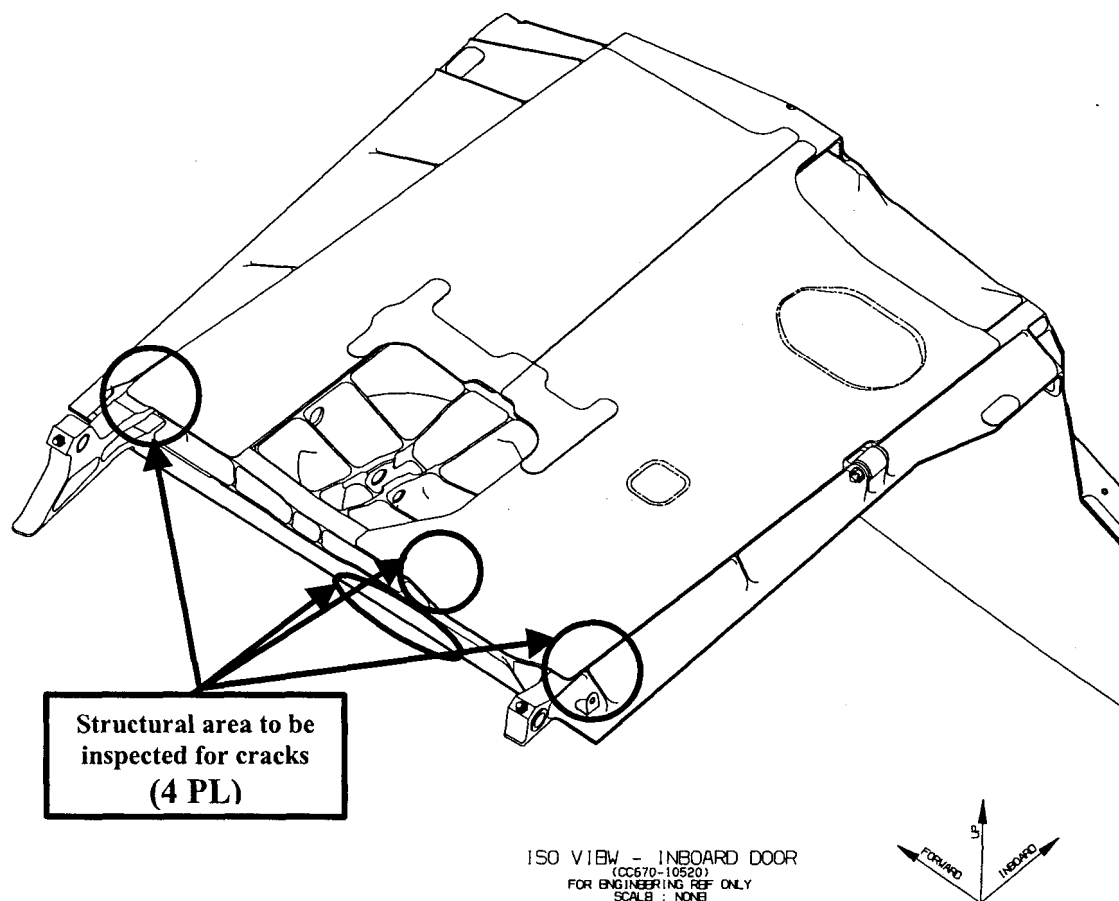
Figure 1
LH side shown
RH side opposite

(g) For Model CL-600-2C10 (Regional Jet series 700 & 701) series airplanes, S/Ns 10003 through 10999 inclusive; and Model CL-600-2D24 (Regional Jet series 900) series airplanes, S/Ns 15002 through 15990 inclusive: At the applicable time specified in paragraph (f) of this AD, perform detailed inspections of the lower panel, part number (P/N) CC670-10520, of the left- and right-hand MLG doors for the conditions and in the areas specified in paragraphs (g)(1), (g)(2), (g)(3), and (g)(4) of this AD; and Figures 1, 2, and 3 of this AD.

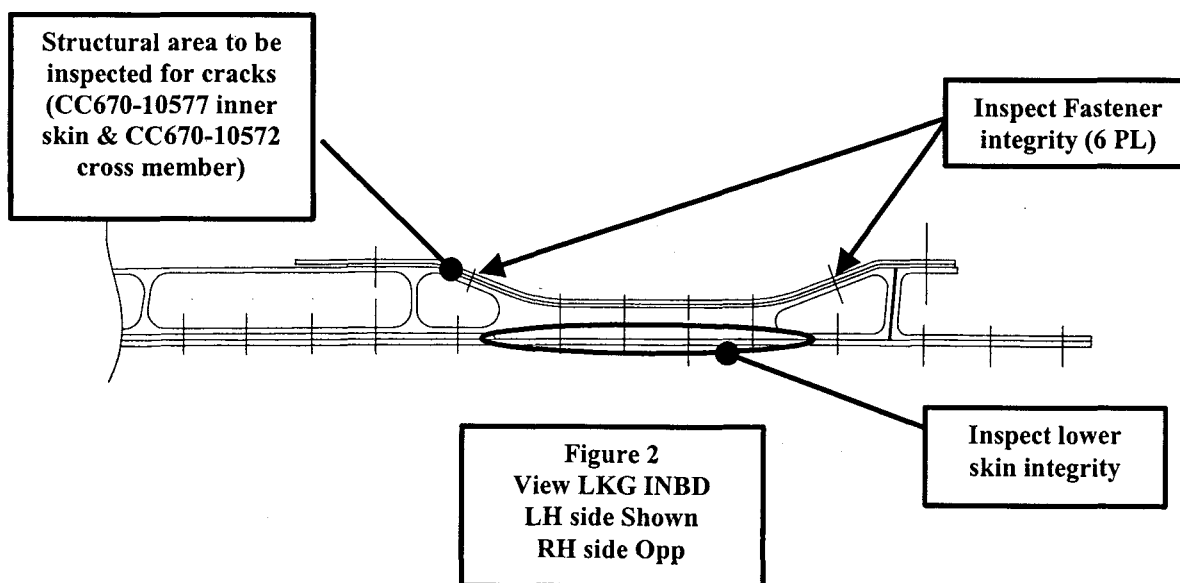
(1) Inspect the cross member, P/N CC670-10572, of the MLG door lower panel for cracking or deformation, in accordance with Figure 2 of this AD.

(2) Inspect the inner skin, P/N CC670-10577, of the MLG door lower panel at the

cross member (P/N CC670-10572) for cracking or deformation, or pulled or missing fasteners, in accordance with Figure 2 of this AD.

(3) Inspect the outer skin, P/N CC670-10574, of the MLG door lower panel at the cross member (P/N CC670-10572) for cracking or deformation, or pulled or missing

fasteners, in accordance with Figure 2 of this AD.

(i) If any cracking or deformation, or pulled or missing fastener, as applicable, is found during any inspection done in accordance with paragraph (g) or (h) of this AD: Before

(1) Repair the damage in accordance with a method approved by either the Manager, New York Aircraft Certification Office (ACO), FAA; or Transport Canada Civil Aviation (or its delegated agent); and accomplish repetitive inspections in accordance with a

(2) Replace the lower panel assembly, P/N CC670-10520, of the affected MLG door with a new or serviceable lower panel assembly having the same P/N, in accordance with Task Cards 32-12-01-000-801-A01 and 32-12-01-400-801-A01 of the CRJ 700/900 Series Regional Jet Aircraft Maintenance Manual; and repeat the inspections specified in paragraph (g) of this AD at intervals not to exceed 100 flight cycles.

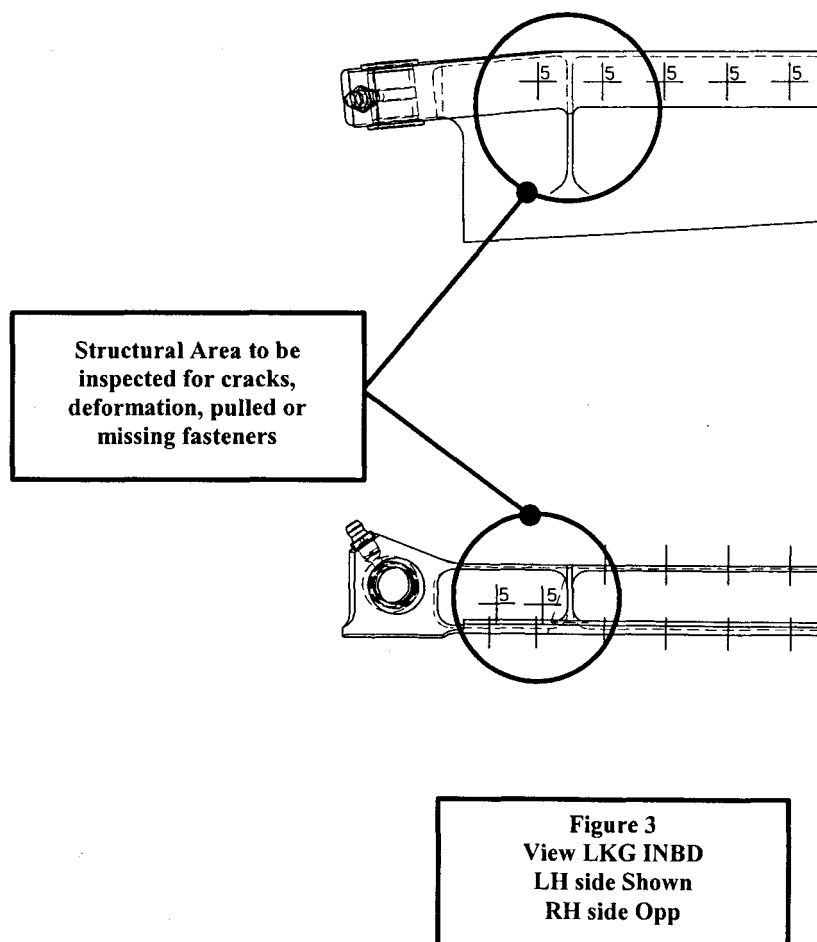
(4) Inspect the forward member, P/N CC670-10570, and aft member, P/N CC670-10571, of the MLG door lower panel, for cracking or deformation, or pulled or missing fasteners, in accordance with Figure 3 of this AD. Figures 1 through 3 of this AD follow.
