### Federal Railroad Administration

#### Notice of Safety Advisory 2006-02

**SUMMARY:** This safety advisory provides recommended practices for the testing, classification, and reuse of second-hand rail.<sup>1</sup> The purpose of this safety advisory is to reduce the number of rail defects that occur when second-hand rail is used.

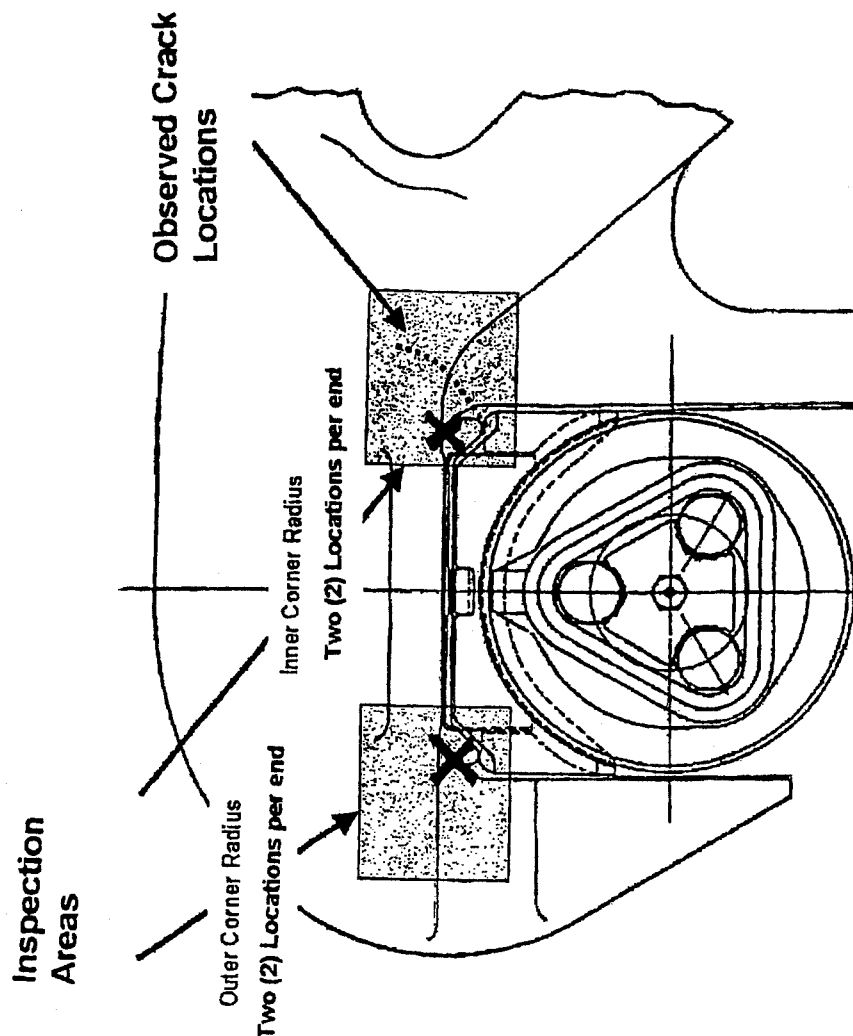
**Fig. 1 Showing Eight Inspection Locations Per Side Frame**
