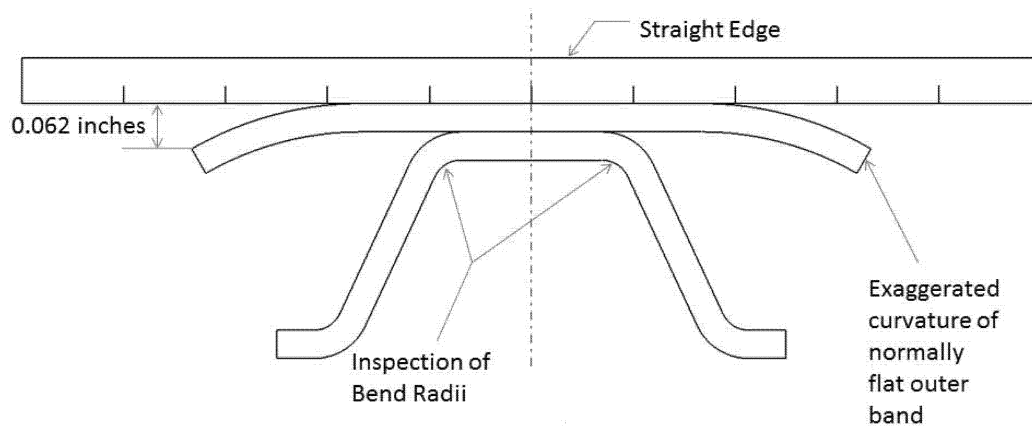
Figure 1 to paragraphs (k)(1)(iii) and (v) of this AD: Cross section of v-band coupling

(v) Visually inspect the bend radii of the coupling v-retainer coupling segments for cracks. Inspect the radii throughout the length of the segment. See figure 1 to paragraphs (k)(1)(iii) and (v) of this AD. If any cracks are found, do not re-install the v-band coupling. Before further flight, you must install a new v-band coupling and restart the hours TIS for the repetitive replacement of the v-band coupling.
