14 CFR Part 39

[Docket No. FAA-2006-25084; Directorate Identifier 2005-SW-38-AD]

Airworthiness Directives; Bell Helicopter Textron Canada Model 206L Series Helicopters

ACTION: Notice of proposed rulemaking (NPRM).

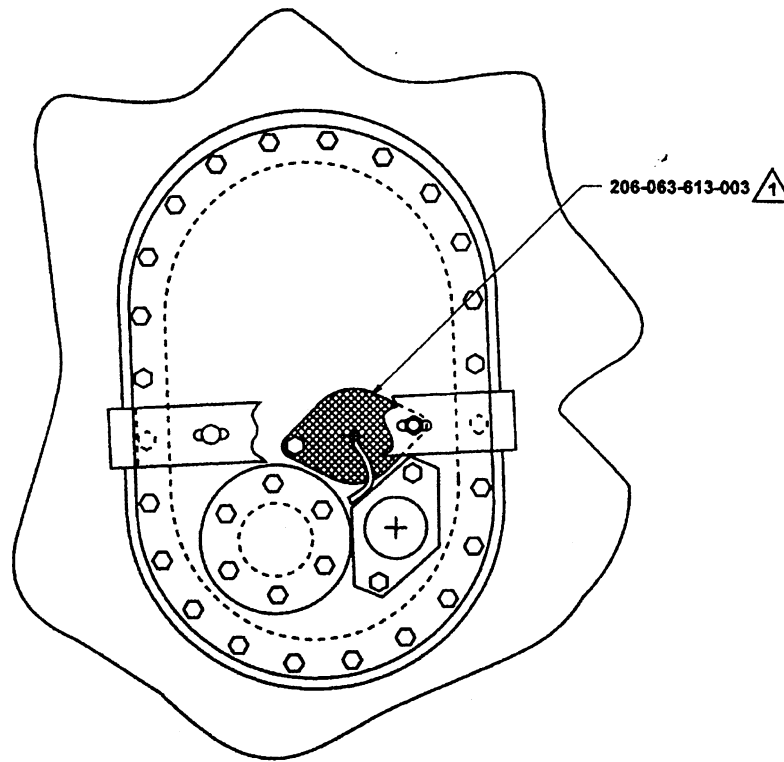
(a) On or before the next 100-hour time-in-service inspection, determine whether the installed switch unit has a serial number listed in the applicability section of this AD. If the installed switch unit is one of the listed switch units, before further flight, replace it with an airworthy switch unit that has a serial number other than those listed in the applicability section of this AD. See Figure 1 of this AD for the location of the serial number.

NOTE
1 Part number and serial number are located in the cross hatched area.
