**Airworthiness Directives; Bombardier Model CL-600-2C10 (Regional Jet Series 700, 701, and 702) Airplanes, Model CL-600-2D15 (Regional Jet Series 705) Airplanes, and Model CL-600-2D24 (Regional Jet Series 900) Airplanes**

**2006–14–05 Bombardier, Inc. (Formerly Canadair):** Amendment 39–14676. Docket No. FAA–2006–24074; Directorate Identifier 2005–NM–213–AD.

(d) This AD results from a report of a main landing gear (MLG) door departing from an airplane. We are issuing this AD to prevent failure of the lower panel of the MLG door, departure of the lower panel from the airplane, and consequent damage to airplane structure, which could adversely affect the airplane's continued safe flight and landing.

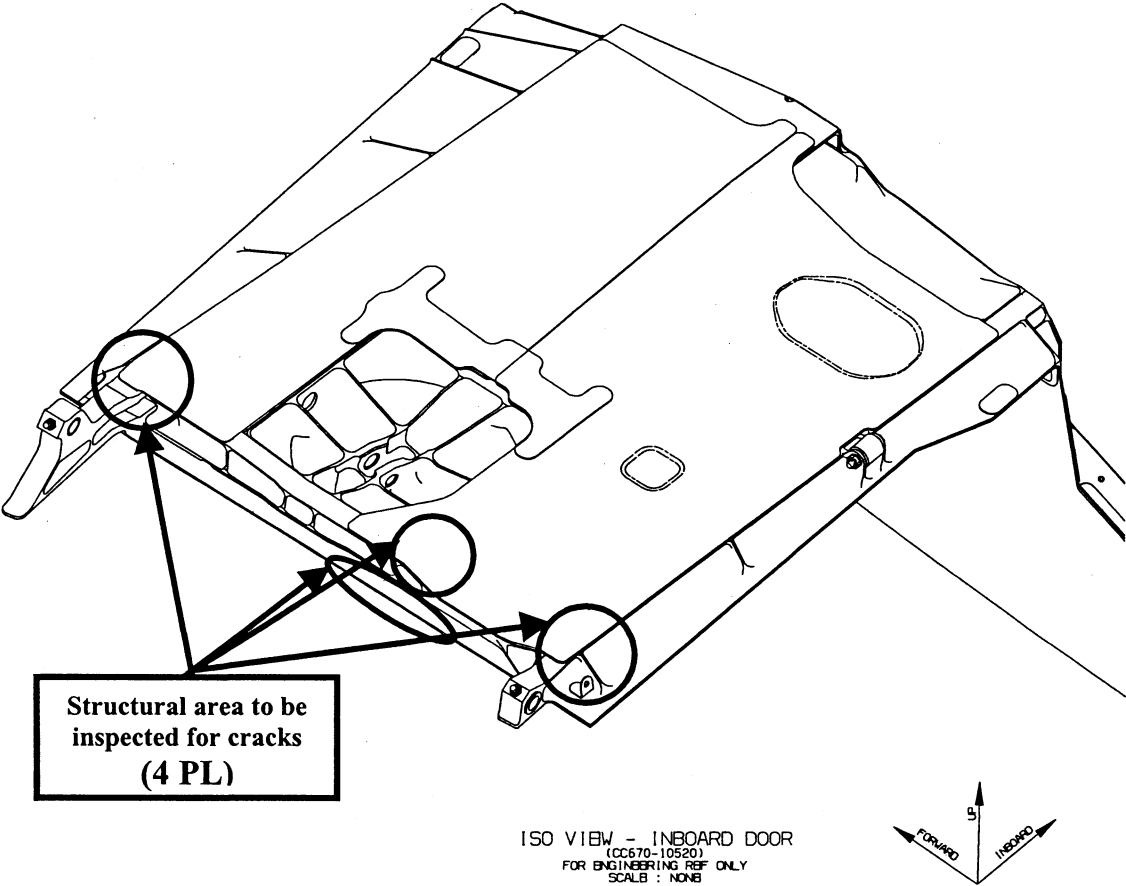
**Figure 1**  
LH side shown  
RH side opposite

2D24 (Regional Jet series 900) series airplanes, S/Ns 15002 through 15990 inclusive: At the applicable time specified in paragraph (f) of this AD, perform detailed inspections of the lower panel, part number (P/N) CC670–10520, of the left- and right-hand MLG doors for the conditions and in the areas specified in paragraphs (g)(1), (g)(2), (g)(3), and (g)(4) of this AD; and Figures 1, 2, and 3 of this AD.

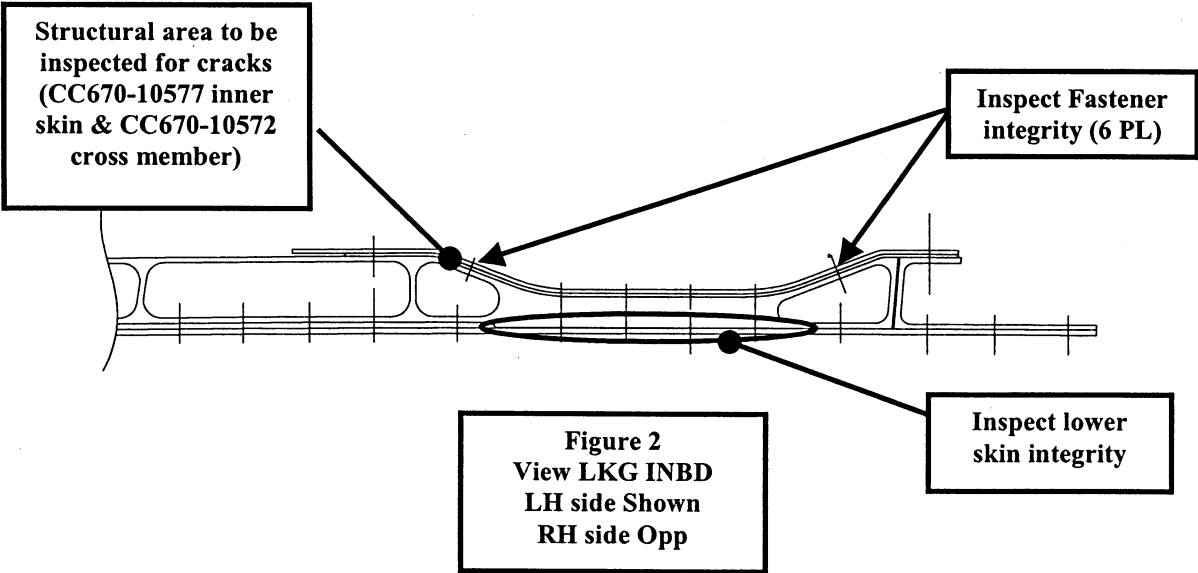
(1) Inspect the cross member, P/N CC670–10572, of the MLG door lower panel for cracking or deformation, in accordance with Figure 2 of this AD.

(2) Inspect the inner skin, P/N CC670–10577, of the MLG door lower panel at the cross member (P/N CC670–10572) for cracking or deformation, or pulled or missing fasteners, in accordance with Figure 2 of this AD.

(3) Inspect the outer skin, P/N CC670–10574, of the MLG door lower panel at the cross member (P/N CC670–10572) for cracking or deformation, or pulled or missing fasteners, in accordance with Figure 2 of this AD.

(i) If any cracking or deformation, or pulled or missing fastener, as applicable, is found during any inspection done in accordance with paragraph (g) or (h) of this AD: Before further flight, accomplish paragraph (i)(1), (i)(2), or (i)(3) of this AD.

(2) Replace the lower panel assembly, P/N CC670-10520, of the affected MLG door with a new or serviceable lower panel assembly having the same P/N, according to a method approved by either the Manager, New York ACO, FAA; or TCCA (or its delegated agent). Task Cards 32-12-01-000-801-A01 and 32-12-01-400-801-A01 of the CRJ 700/900

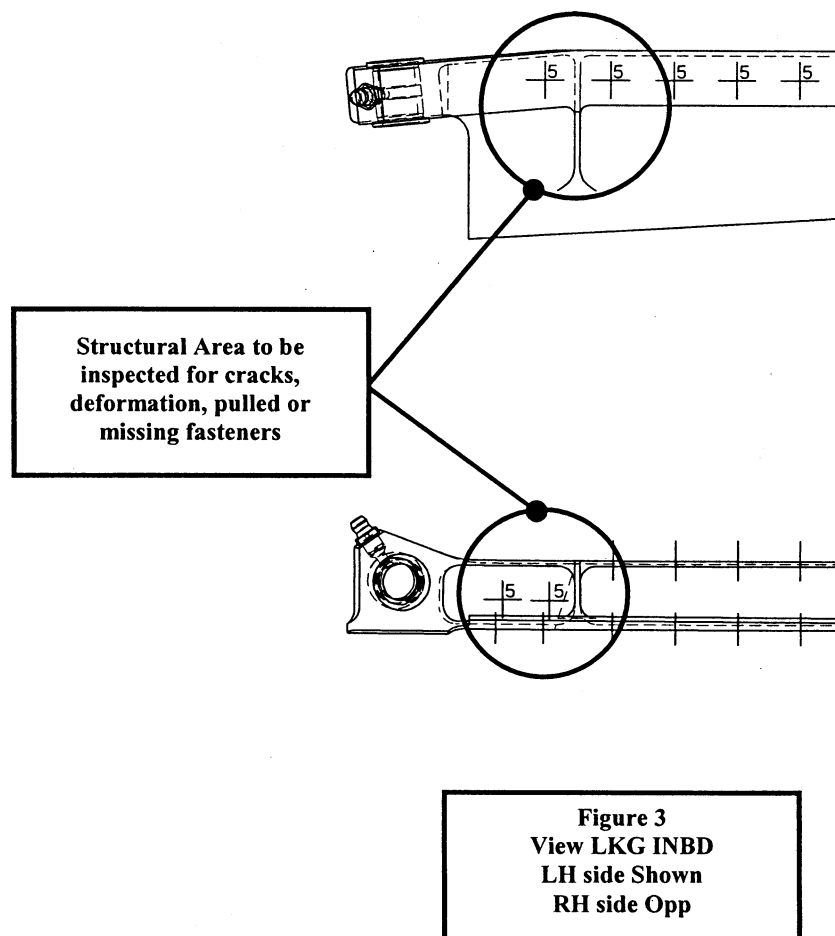
(4) Inspect the forward member, P/N CC670–10570, and aft member, P/N CC670–10571, of the MLG door lower panel for cracking or deformation, or pulled or missing fasteners, in accordance with Figure 3 of this AD. Figures 1 through 3 of this AD follow.
