[Docket No. FAA-2006-25703; Directorate Identifier 2006-SW-20-AD; Amendment 39-14747; AD 2006-17-51]

Airworthiness Directives; Agusta S.p.A. Model AB139 Helicopters

2006-17-51 Agusta S.p.A.: Amendment 39-14747. Docket No. FAA-2006-25703; Directorate Identifier 2006-SW-20-AD.

Applicability: Model AB139 helicopters, with tailpipe assembly left hand, part number (P/N) 3G7800L00131 and right hand, P/N 3G7800L00231, installed, certificated in any category.

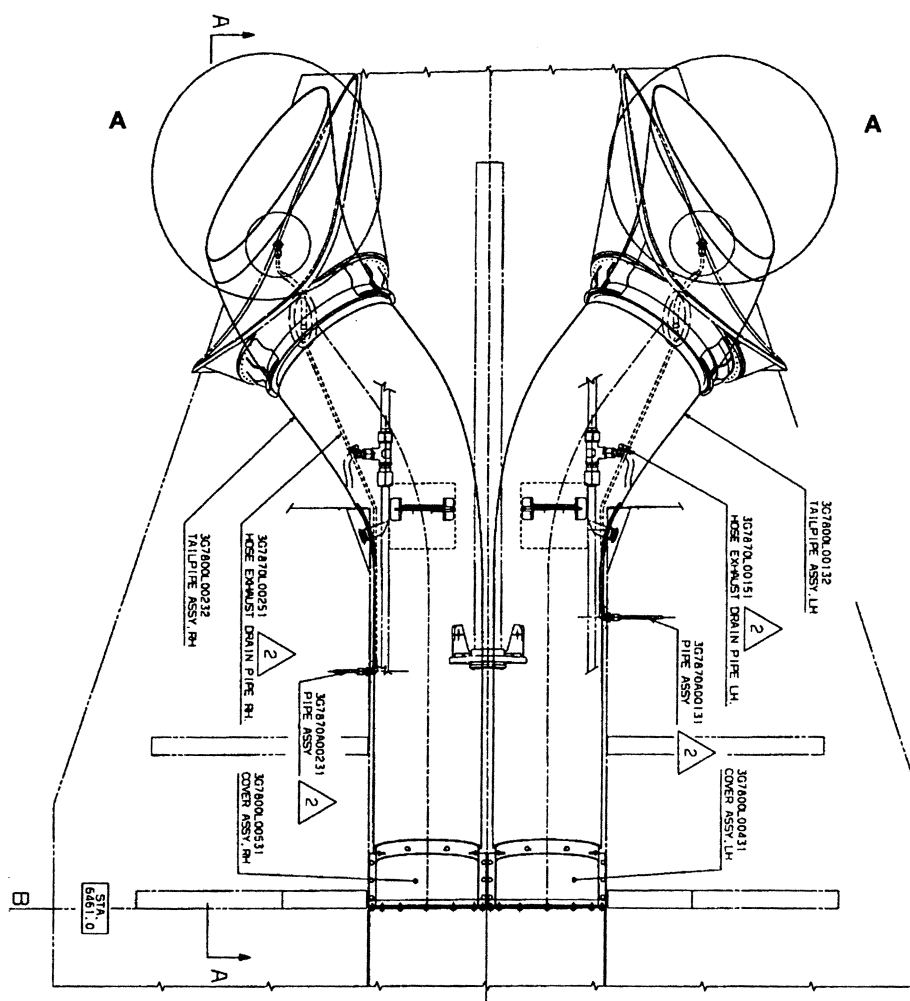
Figure 1

(2) Inspect the structure surrounding each tailpipe assembly for overheating. If you find areas of overheating, inspect for heat damage to the surrounding structure. Inspect for overheating in the area of each tailpipe assembly outside the cowl area. Inspect the internal part of each tailpipe assembly in the areas depicted in Areas A, Figure 1, of this AD.

(i) Clean the end of each tailpipe assembly with a cloth. While applying slight pressure on it, inspect for a crack using a flashlight.

(ii) Inspect each tailpipe assembly toward the centerline of the helicopter for a crack using a flashlight.

(iii) Inspect each tailpipe assembly toward the outboard side of the helicopter for a crack using a mirror and a flashlight.

(3) If you find a crack, before further flight, replace the tailpipe assembly with an airworthy tailpipe assembly.
