DEPARTMENT OF TRANSPORTATION**Federal Aviation Administration****14 CFR Part 39**

[Docket No. FAA–2006–25760; Directorate Identifier 2006–CE–48–AD; Amendment 39–14757; AD 2006–18–51]

Airworthiness Directives; Raytheon Aircraft Company Models 1900, 1900C, and 1900D Airplanes

APPENDIX TO AD 2006-18-51

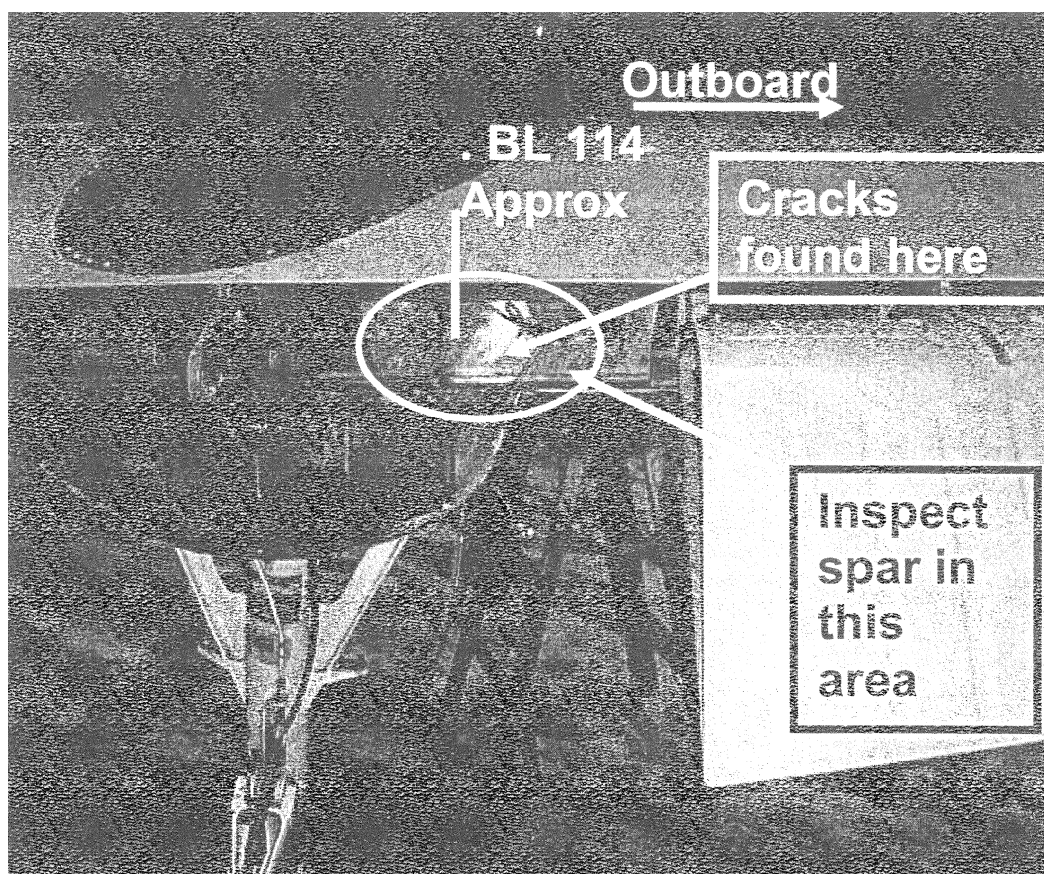
Step 2. Using a strong, high-intensity light visually inspect the area of the wing rear spar

identified in Figure 1. There is ample visually visual access from above the upper surface of the flap. Look for cracks (like those shown in Figures 2 and 3) and loose or missing fasteners.

Figure 1: View of R/H wing rear spar at BL 114 area looking forward (The inboard flap is removed in this figure, but removal of the flap is not required to do the inspection).

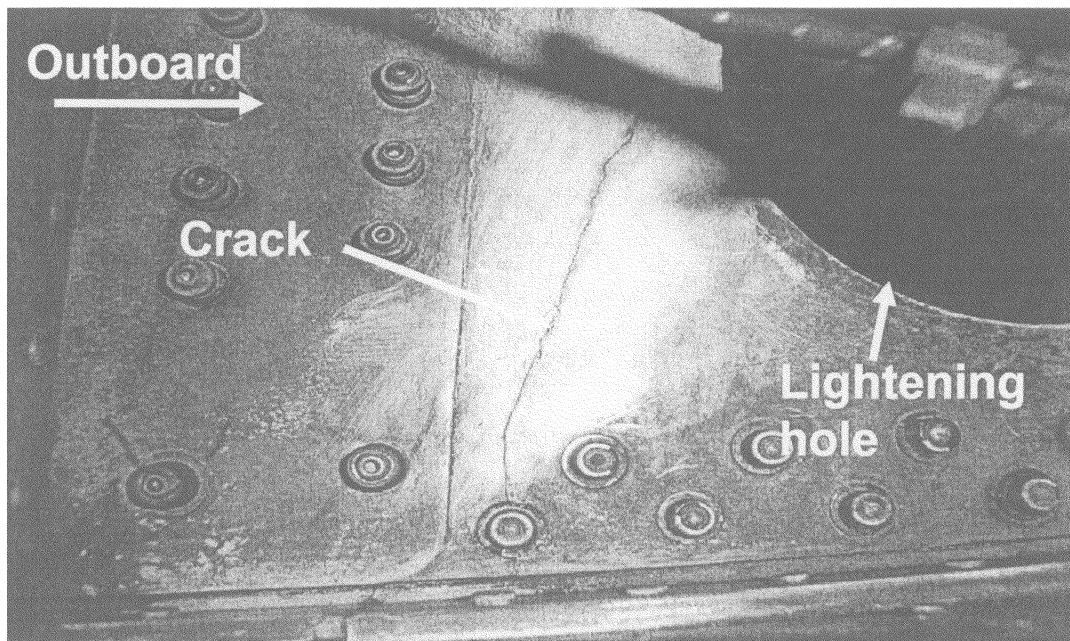
One airplane had 19,126 hours TIS when cracks were found. The cracks were in the lower aft spar cap flange, but the cracks extended upward into the web and terminated at the lightening hole in the spar web. Fasteners were also found missing in the spar cap and wing cove splice plate. There were no discrepancies recorded from the initial inspection at 17,500 hours TIS on this airplane.

Figure 2: Closeup view of R/H wing rear spar web crack at BL 114 area looking forward (The inboard flap is removed in this figure, but removal of the flap is not required to do the inspection).

(3) Repair any cracks or other damage such as loose or missing fasteners found during the inspection required in paragraph (e)(1) of this AD. Do this by obtaining and incorporating an FAA-approved repair scheme from RAC.	Before further flight after the inspection required by paragraph (e)(1) of this AD.	Contact RAC at Post Office Box 85, Wichita, Kansas 67201-0085; phone: 316-676-8366; fax: (316) 676-8745; e-mail: tom_peay@rac.ray.com .

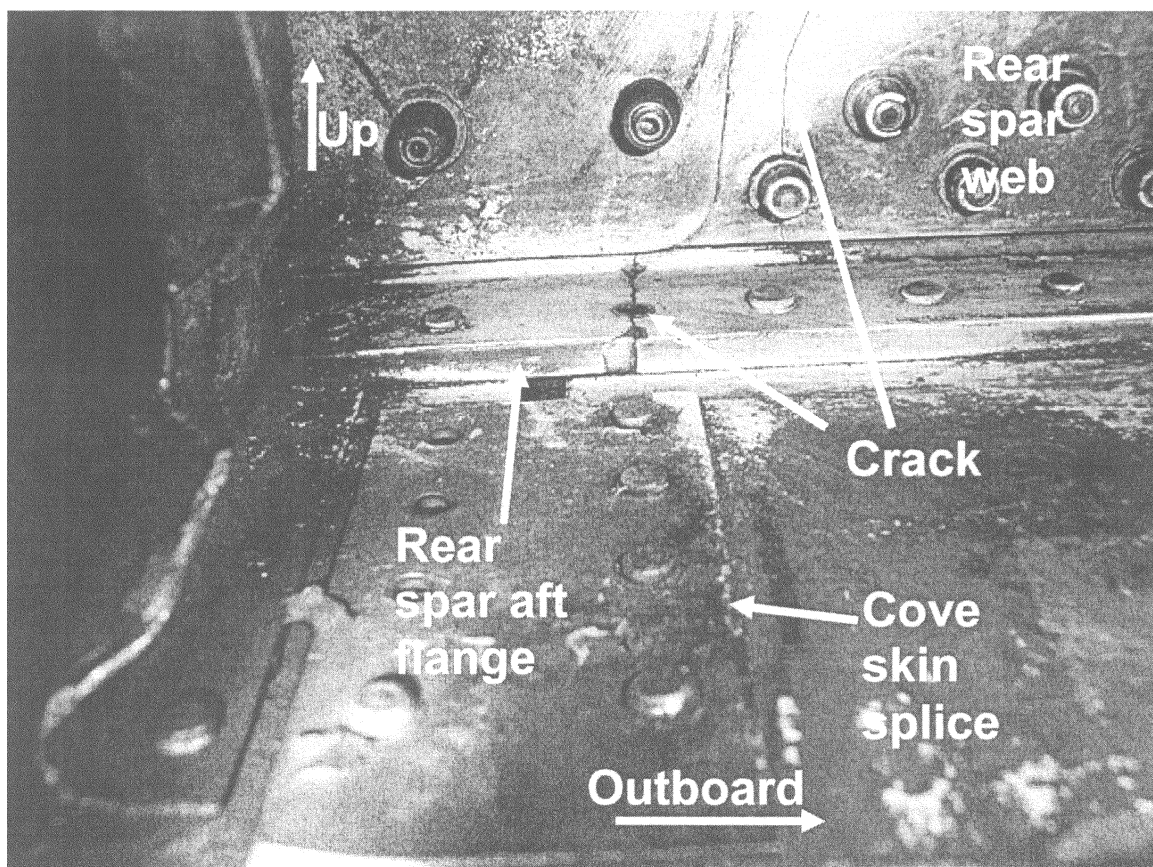
Figure 3: Closeup view of R/H wing rear spar cracks at BL 114 area looking forward (The inboard flap is removed in this figure, but removal of the flap is not required to do the inspection).
