[Docket No. FAA-2006-25097; Directorate Identifier 2005-SW-19-AD; Amendment 39-14762; AD 2006-19-05]

**Airworthiness Directives; Arrow Falcon Exporters, Inc. (Previously Utah State University); Firefly Aviation Helicopter Services (Previously Erickson Air-Crane Co.); California Department of Forestry; Garlick Helicopters, Inc.; Global Helicopter Technology, Inc.; Hagglund Helicopters, LLC (Previously Western International Aviation, Inc.); International Helicopters, Inc.; Precision Helicopters, LLC; Robinson Air Crane, Inc.; San Joaquin Helicopters (Previously Hawkins and Powers Aviation, Inc.) S.M.&T. Aircraft (Previously U.S. Helicopters, Inc., UNC Helicopter, Inc., Southern Aero Corporation, and Wilco Aviation); Smith Helicopters; Southern Helicopter, Inc.; Southwest Florida Aviation International, Inc. (Previously Jamie R. Hill and Southwest Florida Aviation); Tamarack Helicopters, Inc. (Previously Ranger Helicopter Services, Inc.); U.S. Helicopter, Inc. (Previously UNC Helicopter, Inc.); West Coast Fabrication; and Williams Helicopter Corporation (Previously Scott Paper Co.) Model HH-1K, TH-1F, TH-1L, UH-1A, UH-1B, UH-1E, UH-1F, UH-1H, UH-1L, and UH-1P Helicopters; and Southwe

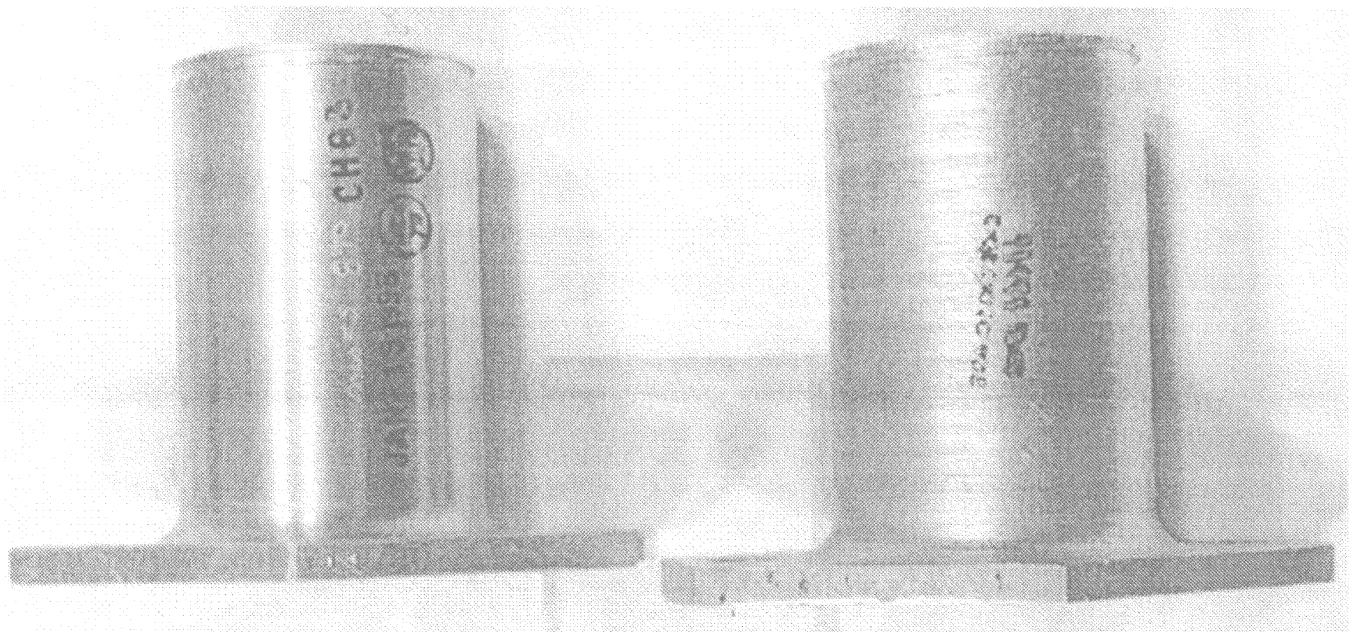
**FIGURE 1**

**Note 1:** T/R sliders manufactured by Forest Scientific, Inc., were produced under a military contract and do not meet the OEM specifications. The machining process resulted in excess surface roughness. See Figure 1 of this AD.

Tail rotor sliders manufactured by Bell Helicopter Textron, Inc. (left) and Forest Scientific, Inc. (right). Note the rough finish of the Forest Scientific, Inc.-manufactured T/R slider compared to the one shown on the left.

(iii) On or before accumulating 1000 hours TIS or on or before 12 months, whichever occurs first, replace each T/R slider that has an illegible CAGE code or Code 15716 or 26098 with an FAA approved airworthy slider without a CAGE code or with a legible CAGE code other than 15716 or 26098. Any T/R slider removed from service based on the requirements of this paragraph is not eligible for installation on any helicopter.
